Your Inspection Report

1185 My Street
Wasilla, AK 99655

INSPECTION DATE:
Tuesday, August 4, 2009

RE: Report No. 1008, v.3
1185 My Street
Wasilla, AK
99655

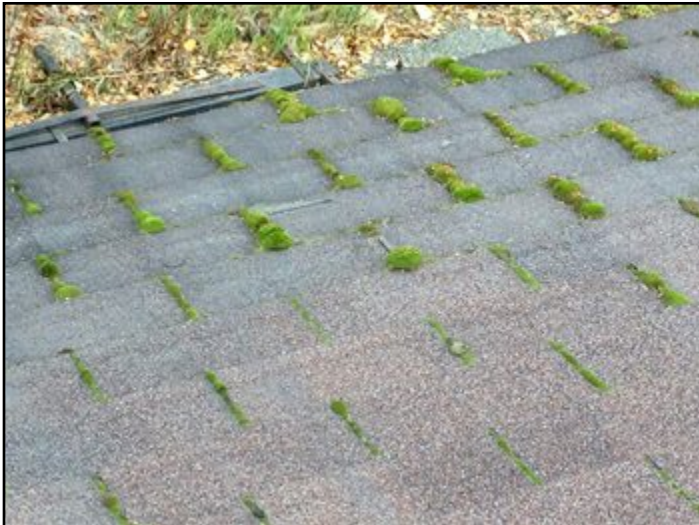
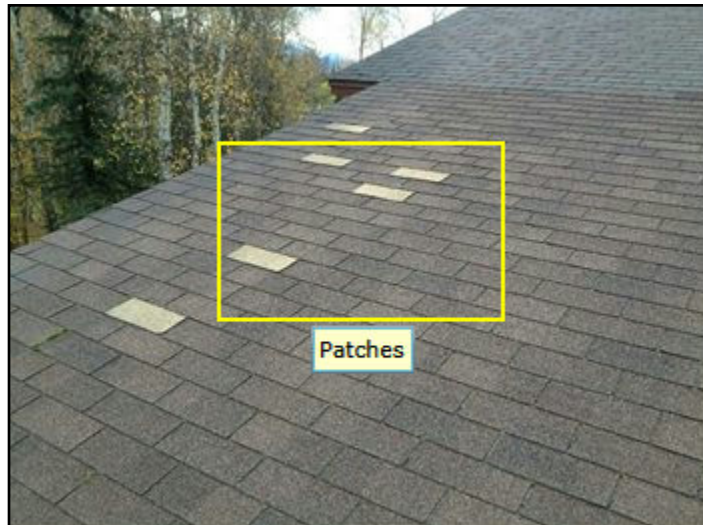
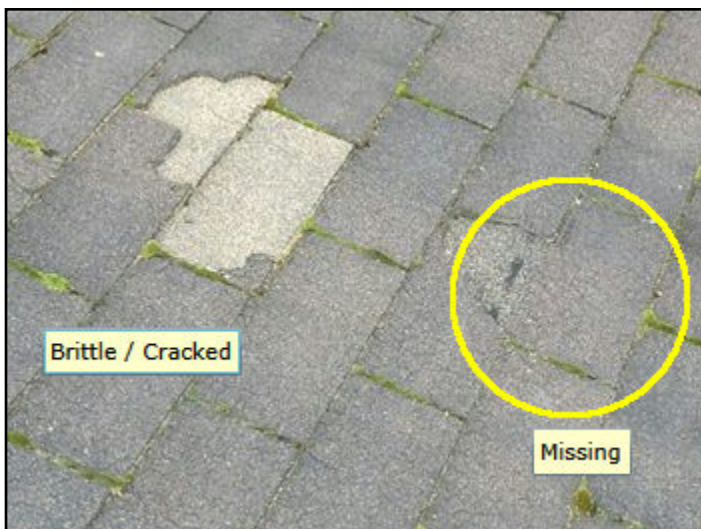
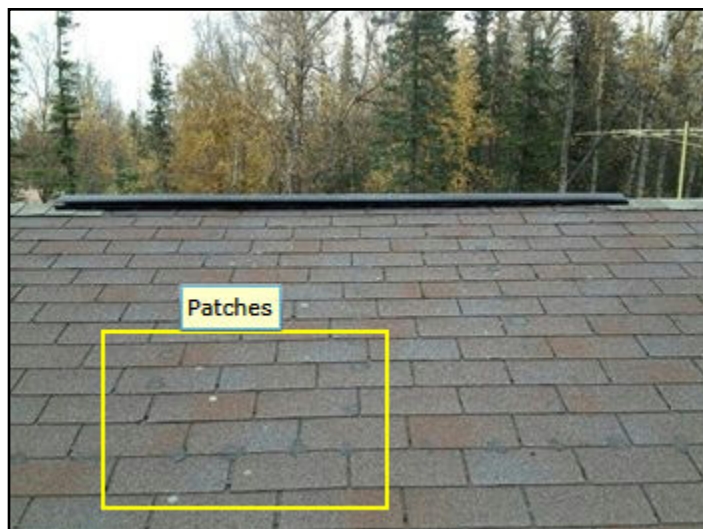
Numerous patches, brittle shingles and cracks. Penetration

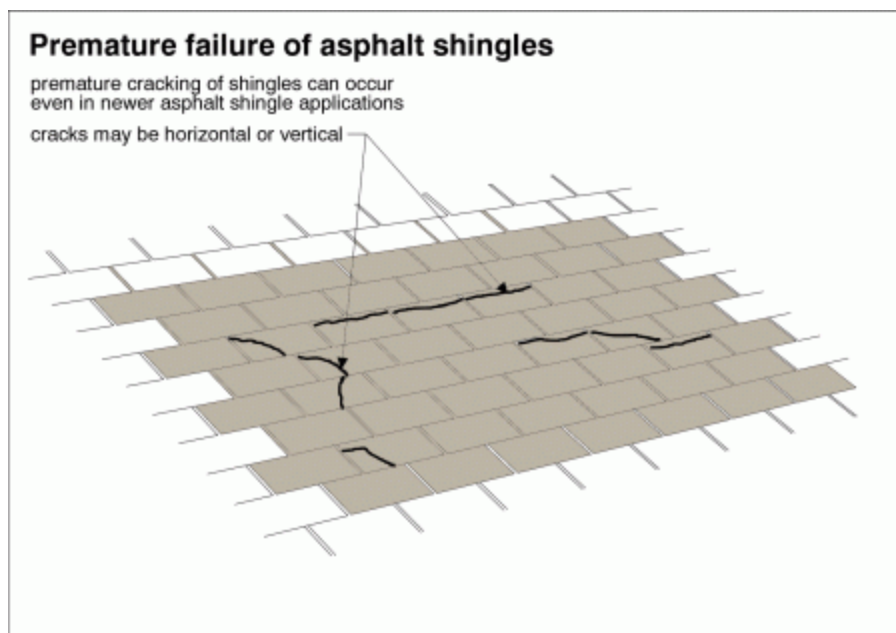
Condition: • [Cracked](#)

Condition: • [Brittle](#)

Task: Monitor

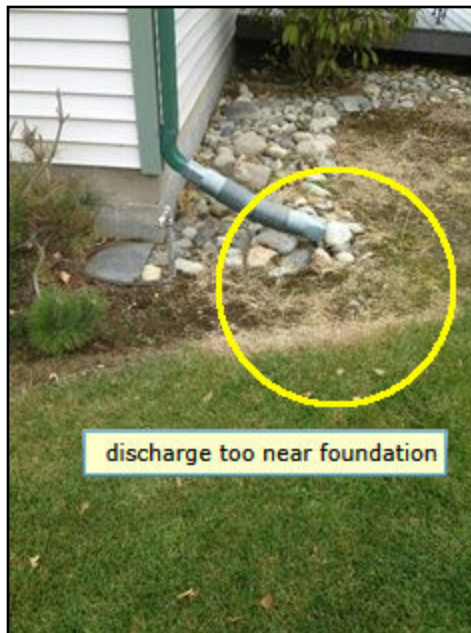
Downspout discharges above grade too close to the building.

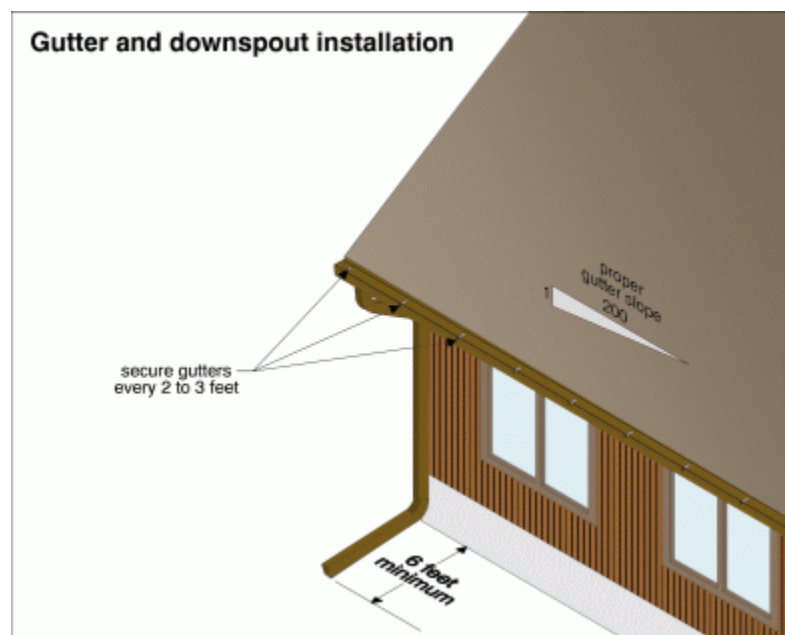
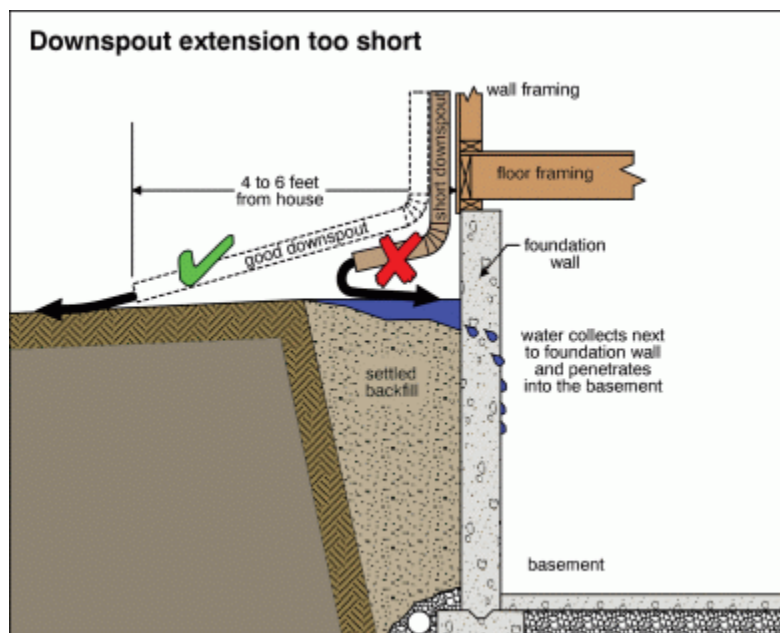
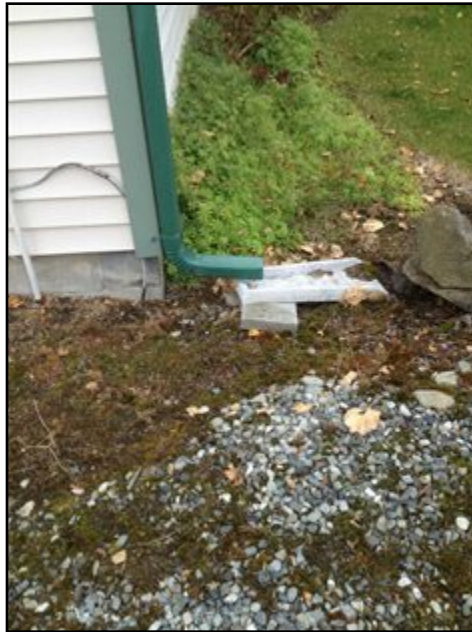
Condition: • [Downspouts end too close to building](#)

Downspouts end too close to building

Condition: • Should discharge 6ft. from home

Task: Replace

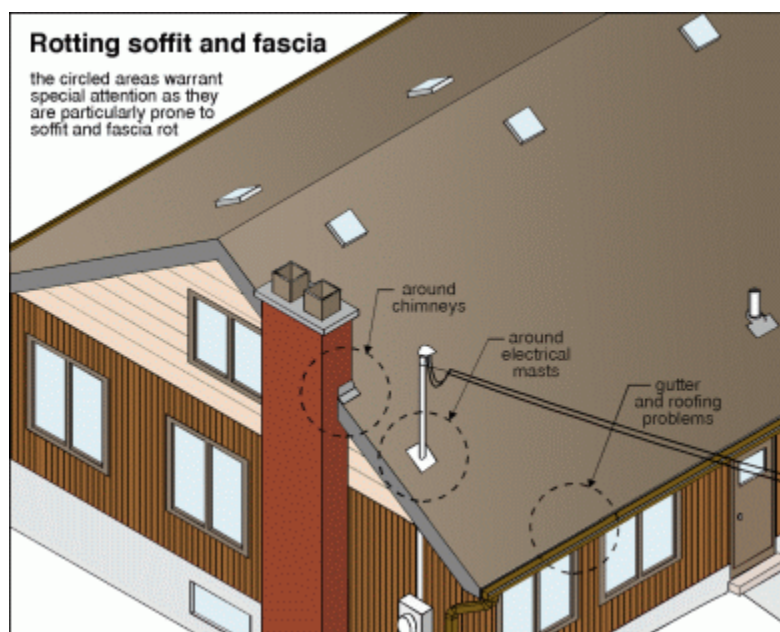
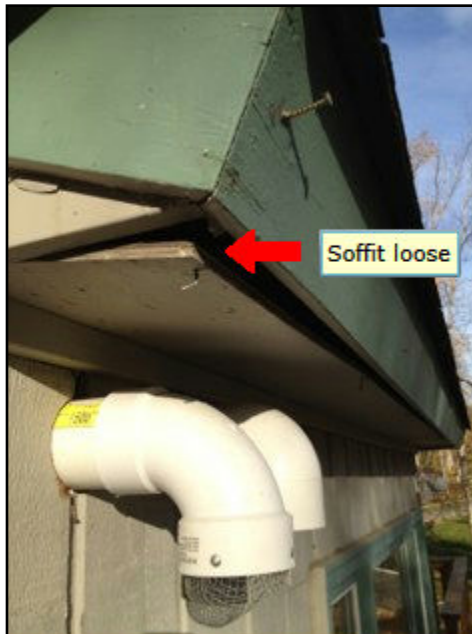
Loose soffit

Condition: • [Loose or missing pieces](#)

Loose or missing pieces

Task: Repair

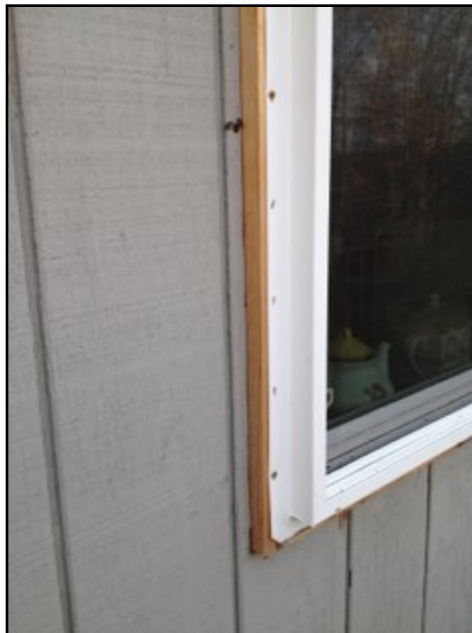
Condition: • [Missing](#)

Missing

Task: Install trim around window and caulk.

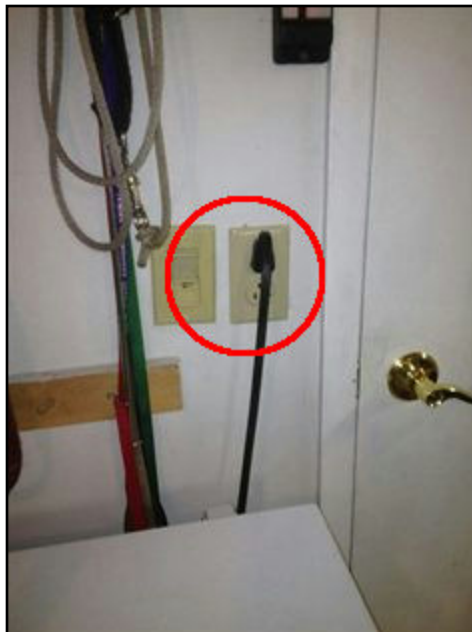
No GFCI

GFCI Missing in Garage

Task: Replace

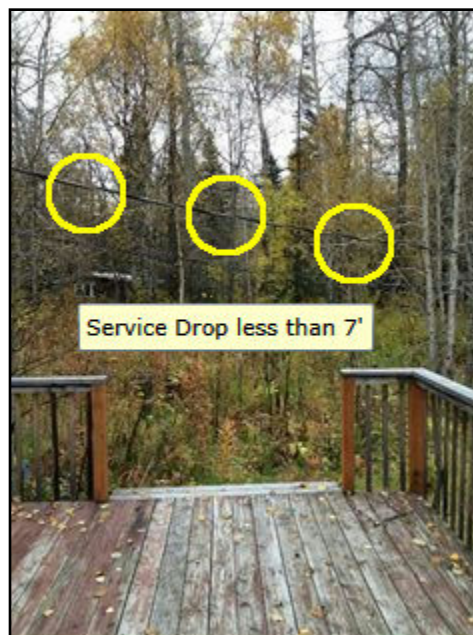
Condition: • [Height over walking area](#)

LIFE SAFETY

The service can easily be touched from the deck that was added after the electrical installation. Addition of another pole could possibly fix the problem, but it should be evaluated by an electrician.

Height over walking area

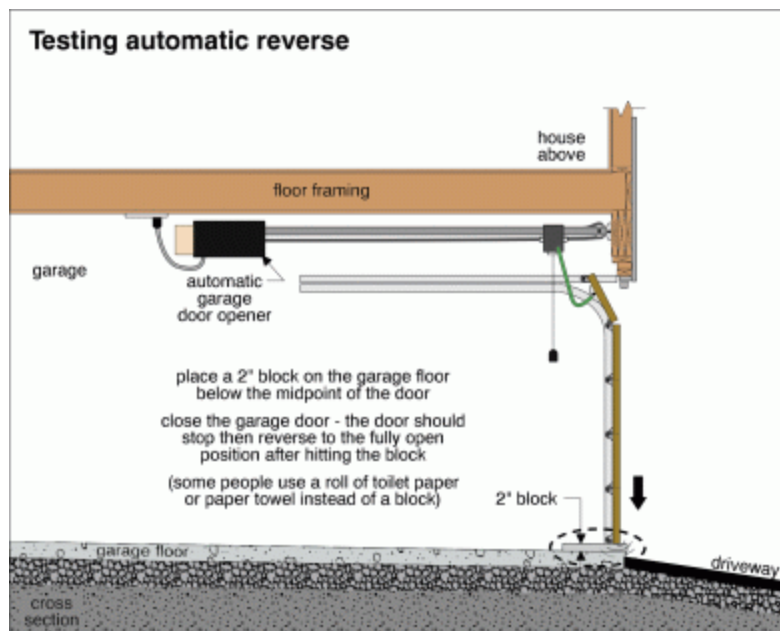
Condition: • [Fails to auto reverse](#)
