Your Inspection Report

7 Greenmount Rd
Toronto, ON

INSPECTION DATE:
Thursday, February 23, 2017

RE: Report No. 56908
7 Greenmount Rd
Toronto, ON

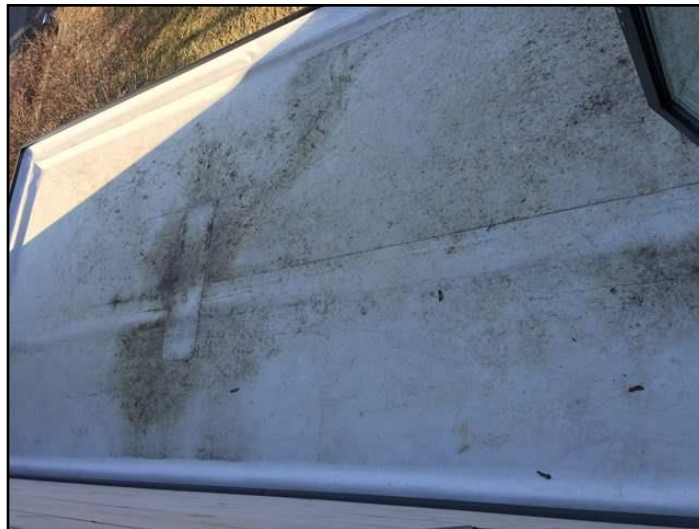
ROOF COVERING \ Porch

Condition: • Patched

Patched

Task: Monitor

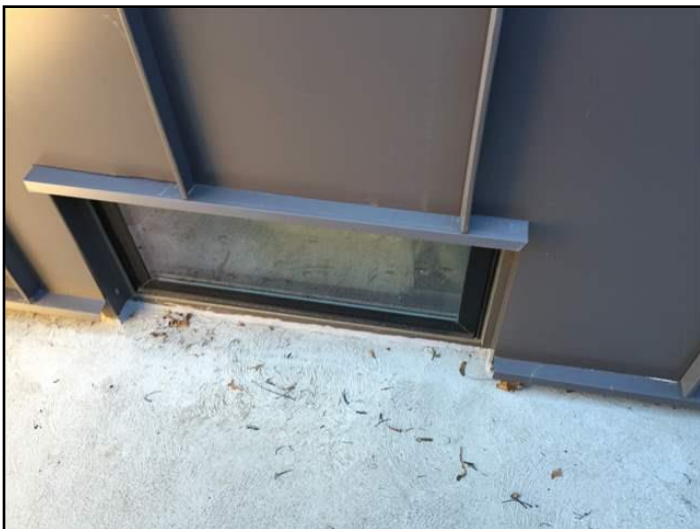
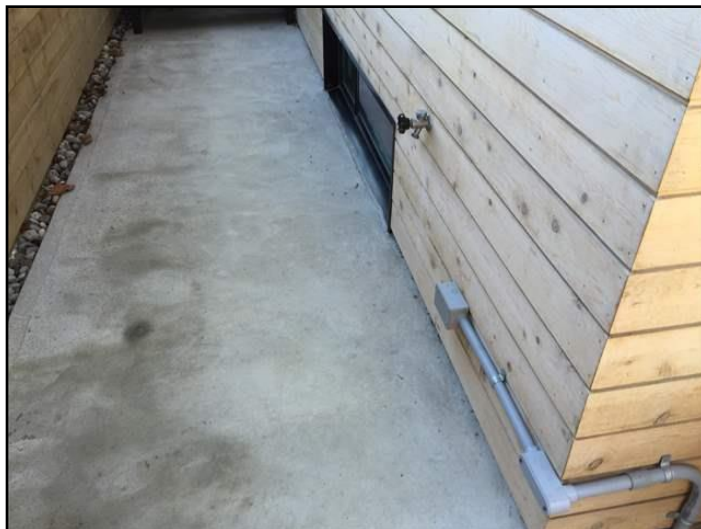
Condition: • Sill - clearance inadequate (above grade level)

Sill - clearance inadequate (above grade...

Task: Monitor / Improve

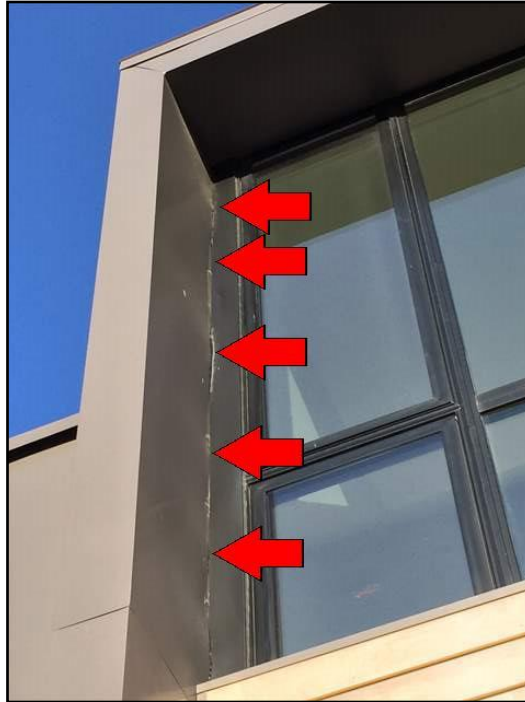
Condition: • Gap at wall should be sealed

Gap at wall should be sealed

Task: Repair

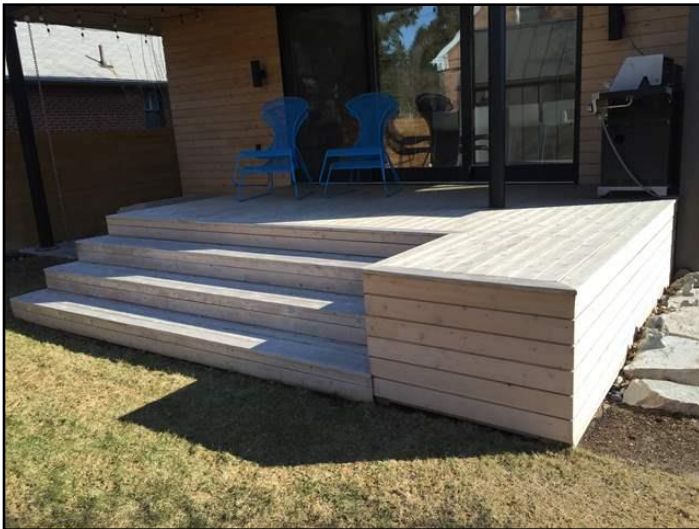
Condition: • [Missing](#)

Missing hand and guard rails

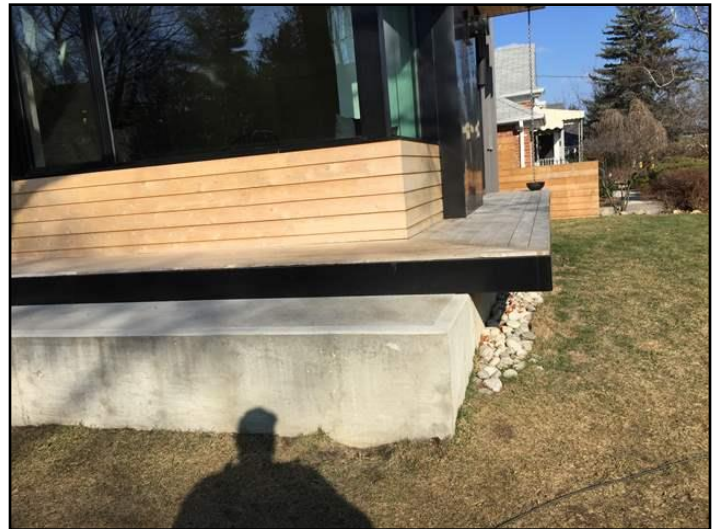
Missing guardrails

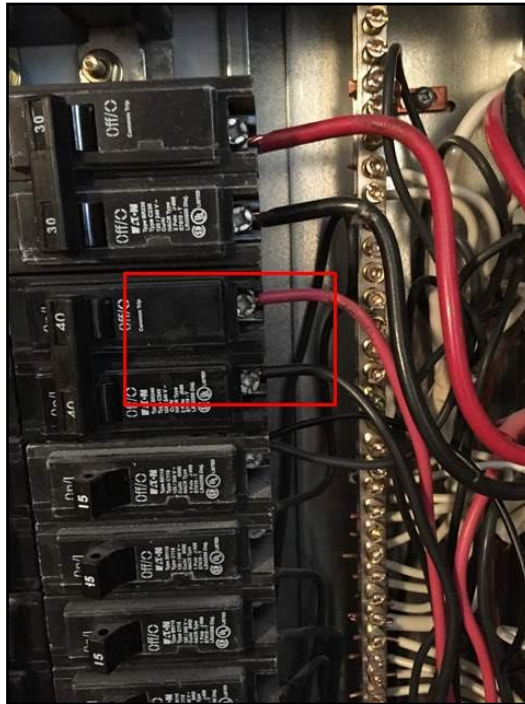
Condition: • [Wrong size to protect wire](#)

Wrong size to protect wire

Time: Immediate

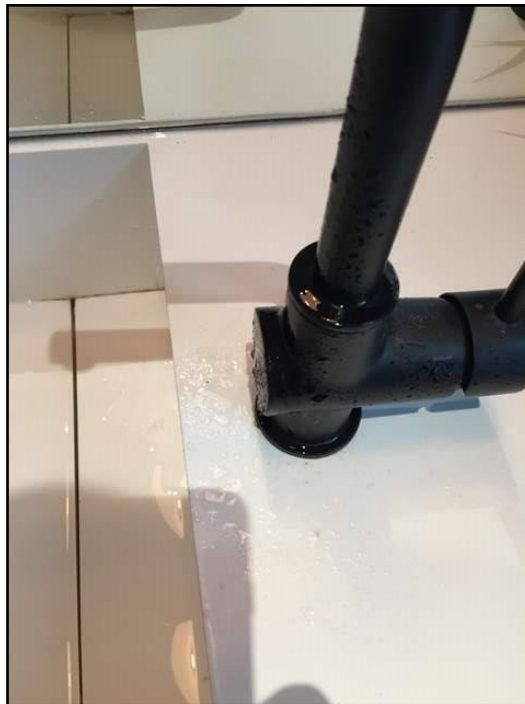
Condition: • [Leak](#)

Leak

Task: Repair / Replace

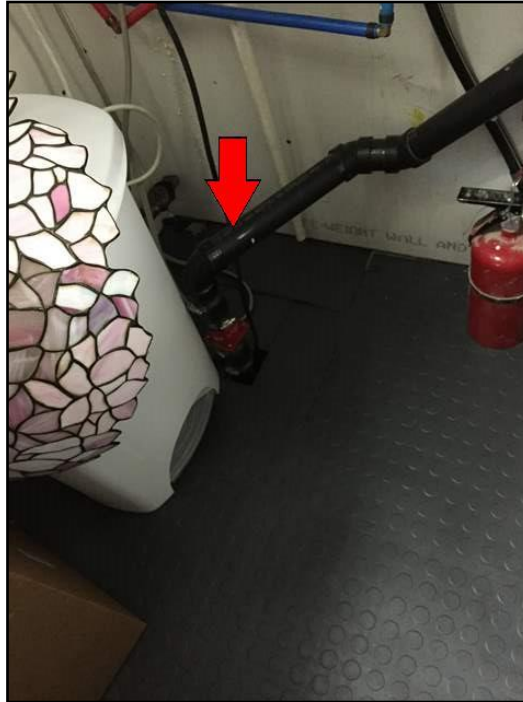
Condition: • Lid - obstructed

Lid - obstructed

Task: Provide access and inspect / Test regularly

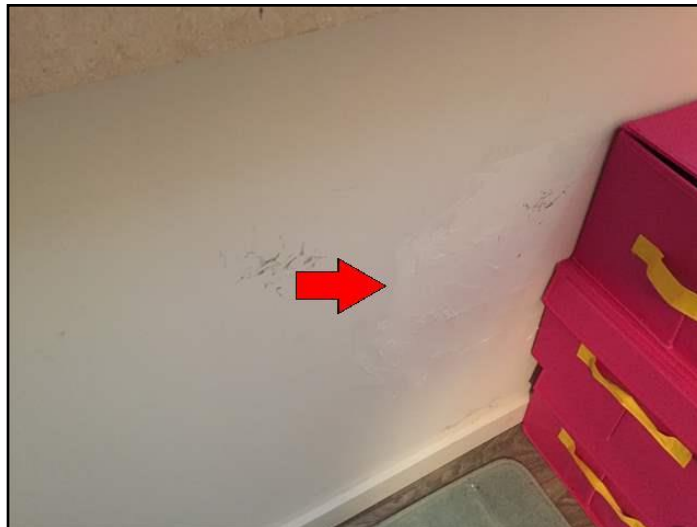
Condition: • Patched (dry when tested with Moisture Meter)

Patched (dry when tested with Moisture Meter)

Task: Monitor

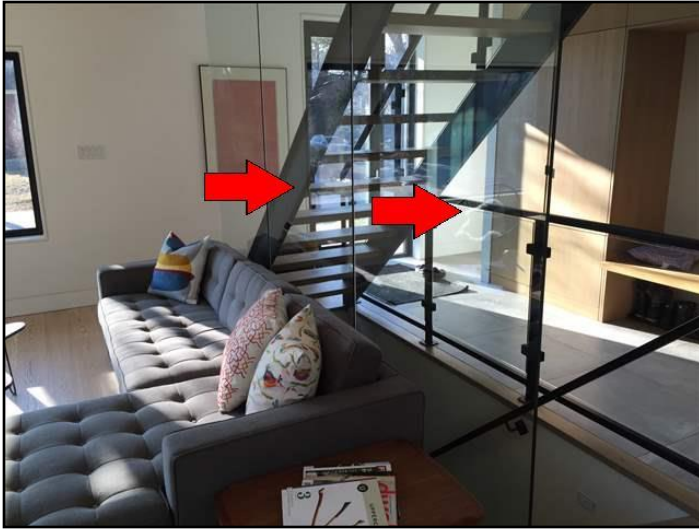
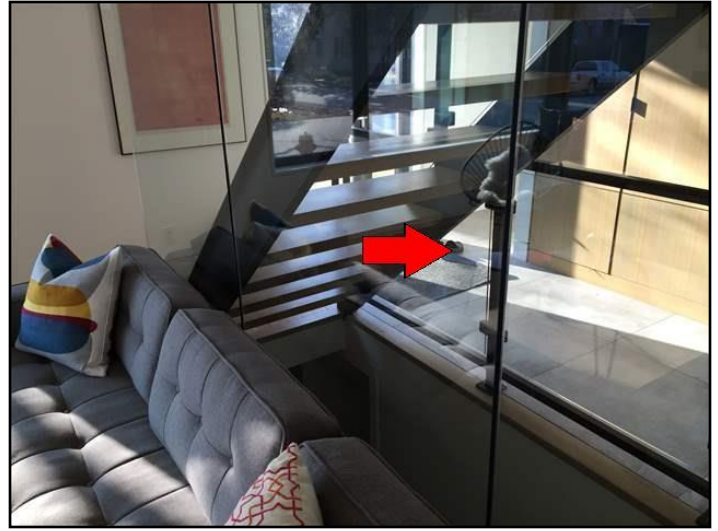
Condition: • Glass Guard partitions wobble/moves easily when pushed.

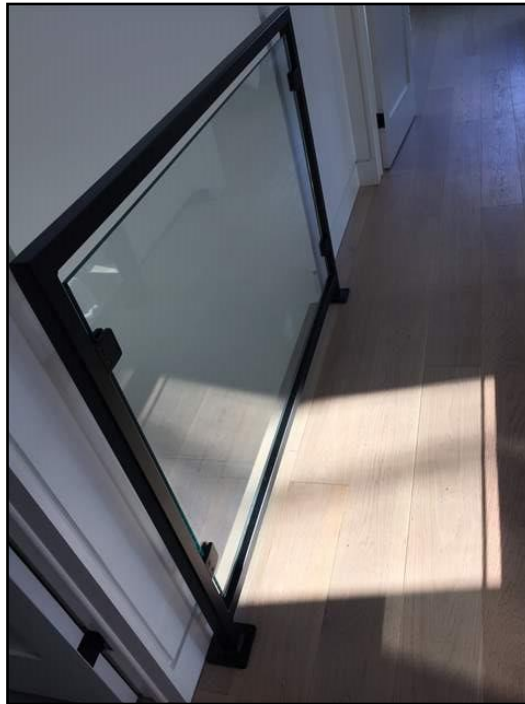
Location: Second Floor Hall

Condition: • [Railing - loose](#)

Railing - loose

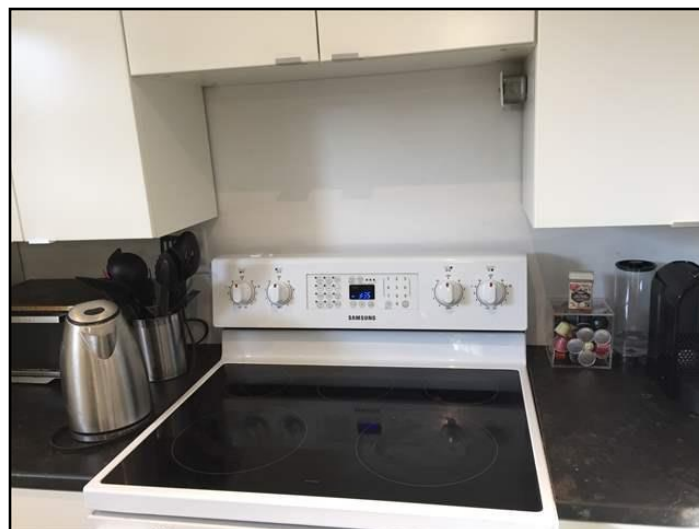
Condition: • Oven hood recommended to provide fire protection and ventilation

Task: Provide Oven Hood
