YOUR INSPECTION REPORT

30 Aileen Avenue
Toronto, ON M6M 1E6

INSPECTION DATE:
Thursday, August 31, 2023

RE: Report No. 7264
30 Aileen Avenue
Toronto, ON
M6M 1E6

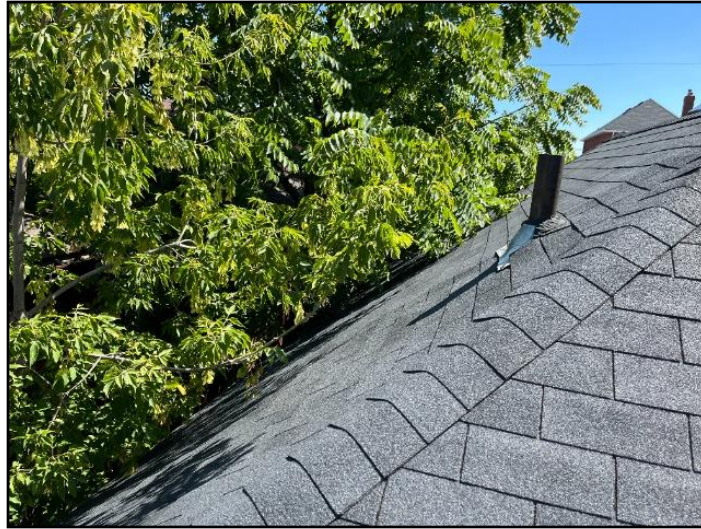
Condition: • Tree branches touching roof

3. Tree branches touching roof

Task: Improve

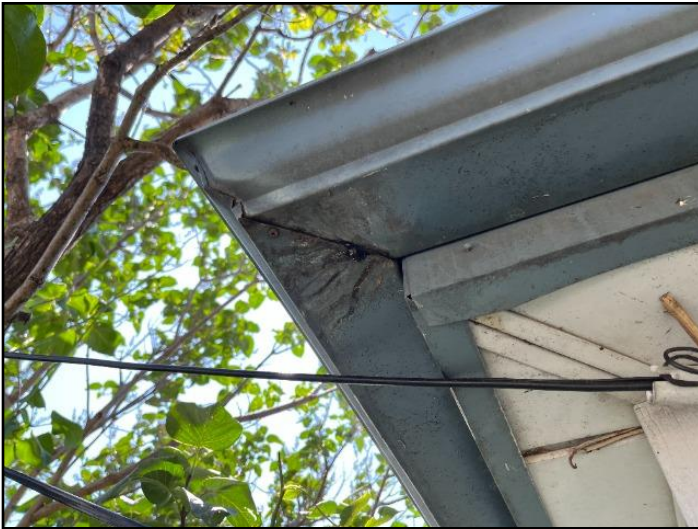
The gutters are damaged in various areas at rear and side. Leaky joints noted. Overall, the gutters have reached the end of the typical and useful lifespan. Replace throughout using a 5-inch gutter system

4. Leaky joints

Task: Repair / Replace

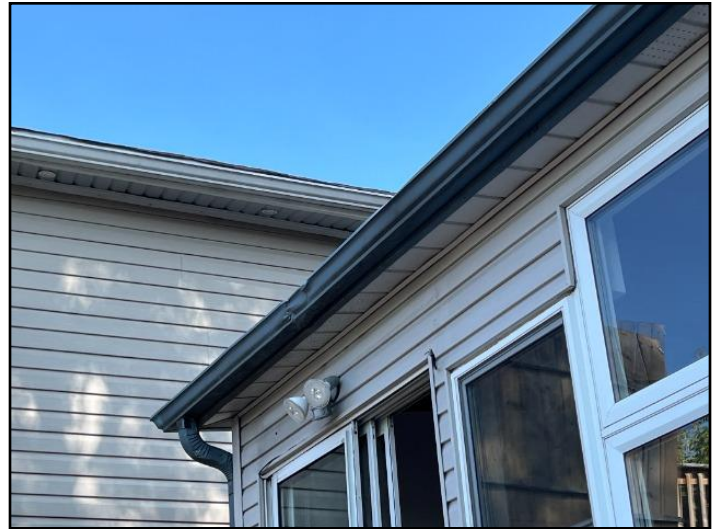
5. Damage

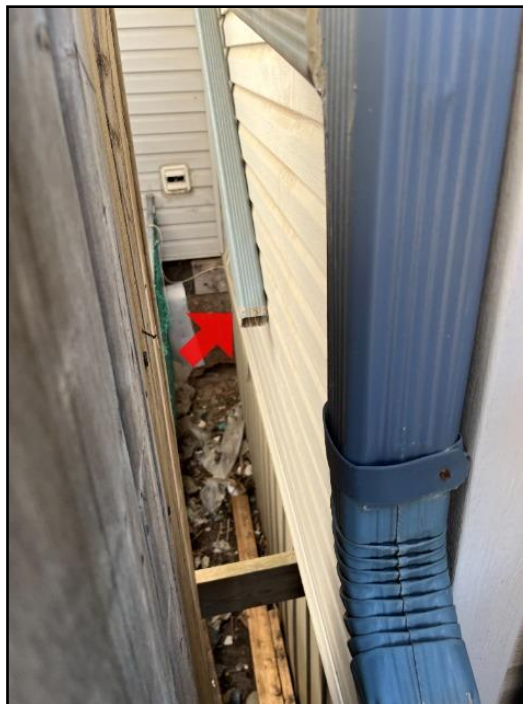
Condition: • [Discharge too close to building](#)

7. Discharge too close to building

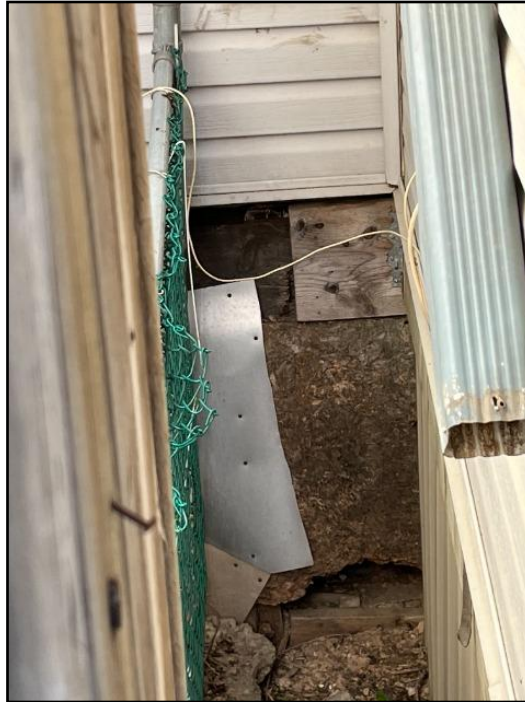
Condition: • Siding - incomplete / missing

8. Siding - incomplete / missing

Task: Correct

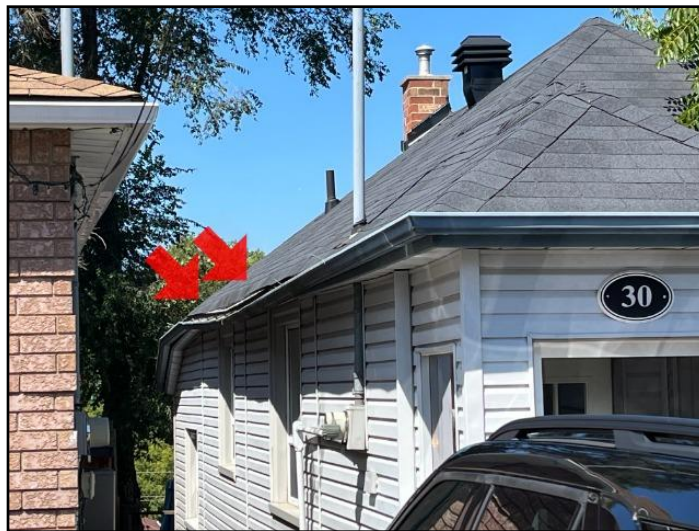
Fascia and gutter is loose/damaged

9. Damage

Task: Repair / Replace

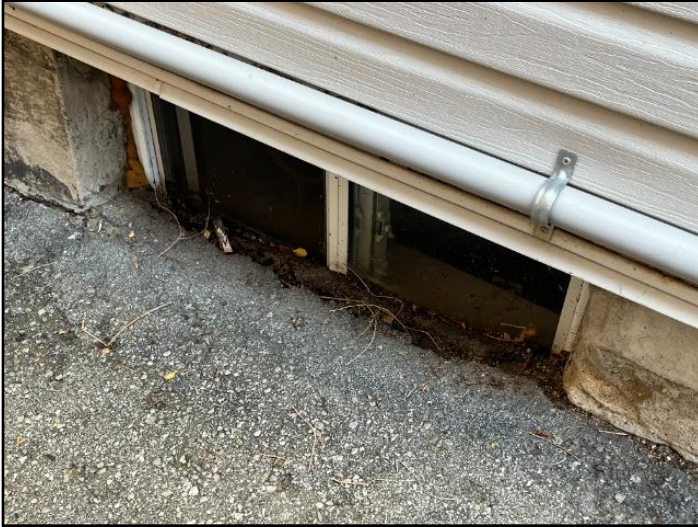
Condition: • Sill - Near or at Grade Level

10. Sill - Near or at Grade Level

Task: Provide window wells as soon as practical

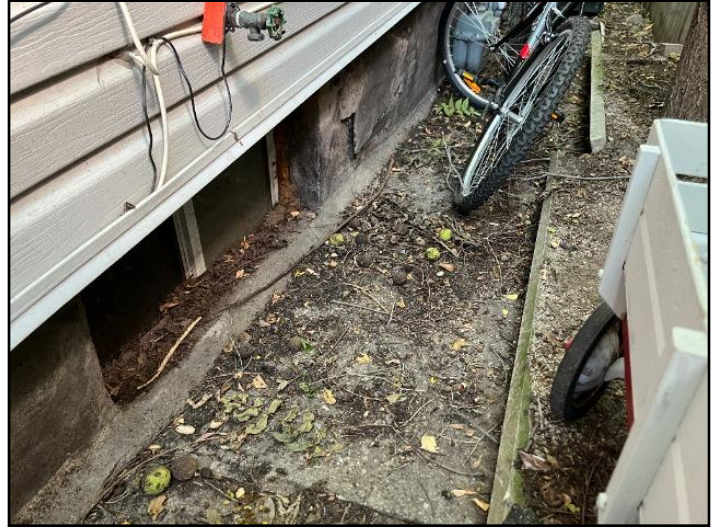
11. Sill - Near or at Grade Level

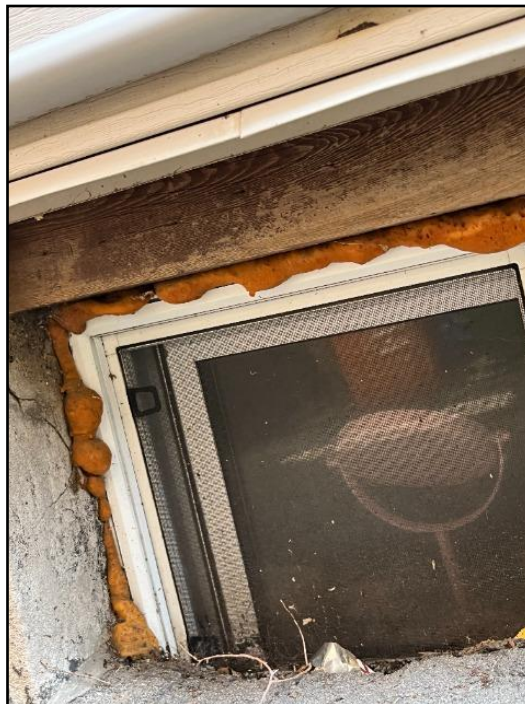
Condition: • [Flashing loose, missing or deteriorated](#)

12. Flashing loose, missing or deteriorated

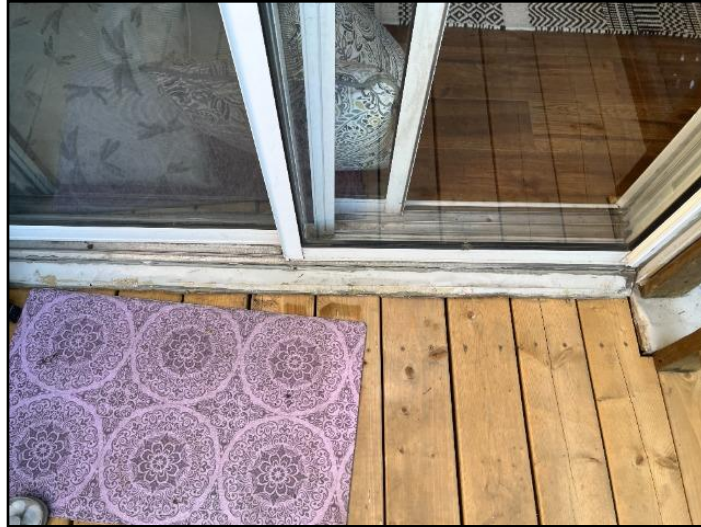
Condition: • Threshold too low

On the other hand, it also makes it more prone to snow buildup/leakage.

13. Threshold too low

While it is probably not practical to improve the current situation (unless rebuilding the deck), it will be important to keep any weatherstripping/caulking in good condition.

Task: Monitor / Improve

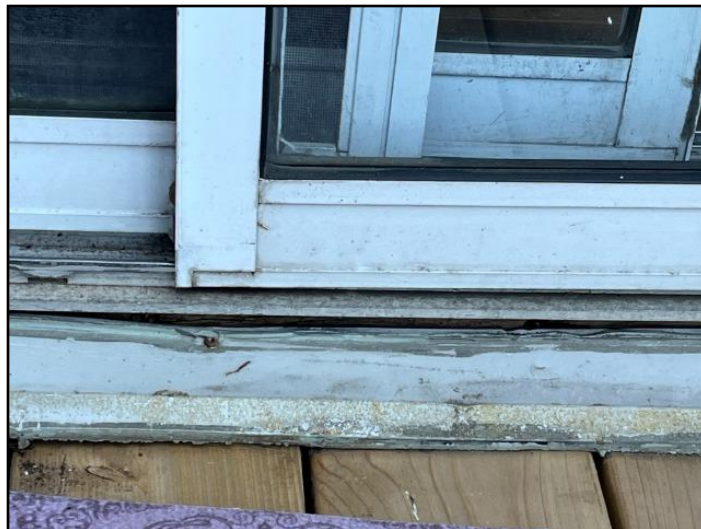
Condition: • [Sill deteriorated](#)

14. Sill deteriorated

Task: Repair or replace

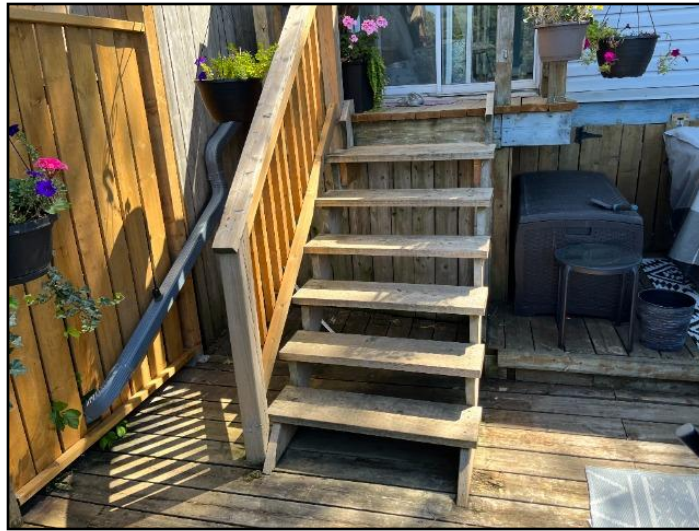
Condition: • [Missing](#)

Also noted: At deck landing, spindles are too far apart and lattice was used at guard which is not suitable for use.

15. Missing on open side

Task: Provide Handrail on open side and provide spindles at deck

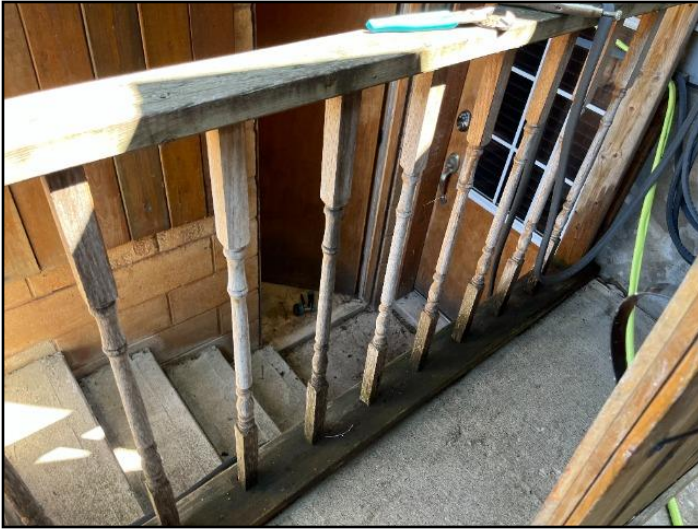
Guardrail is loose and space between spindles is too large.

16. Guard

Task: Correct

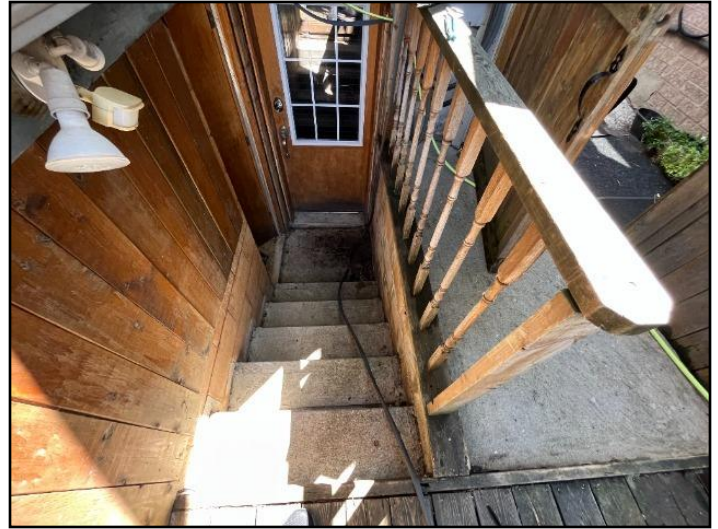
17. Walkout

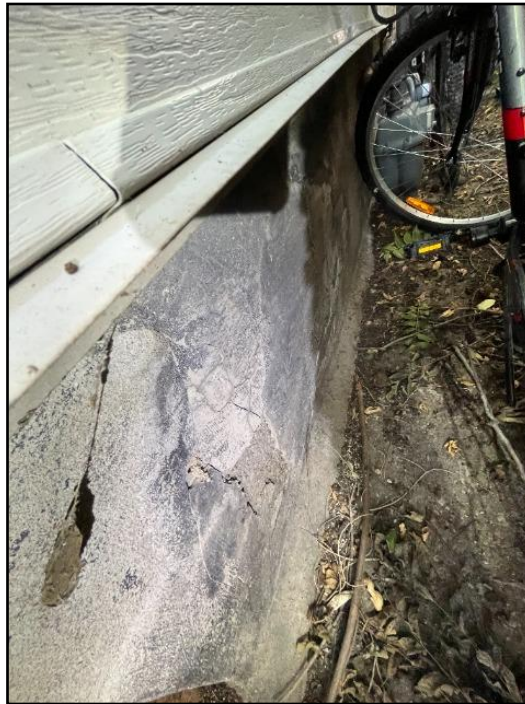
Condition: • [Parging damaged or missing](#)

18. Parging damaged or missing

Task: Repair

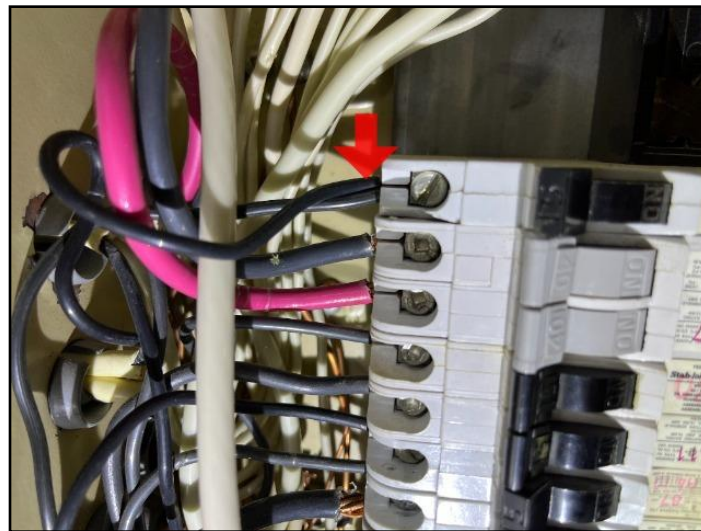
Condition: • [Double taps](#)

21. Double taps

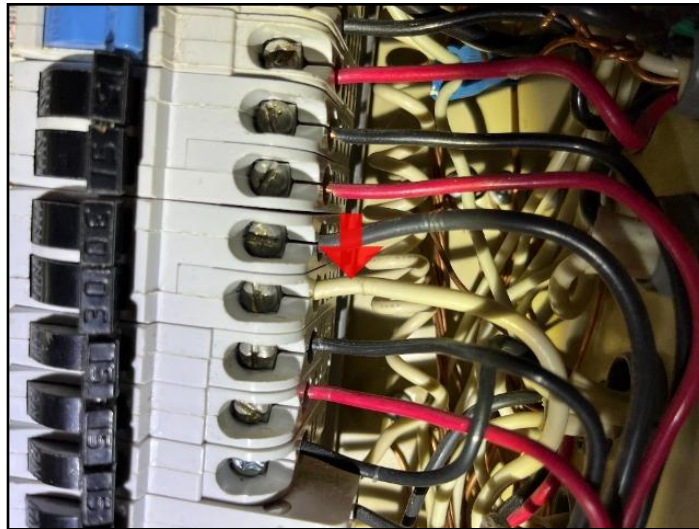
Condition: • White wires connected to breakers not identified as hot/live/ungrounded
White wire used as hot wire not marked

22. White wires connected to breakers not...

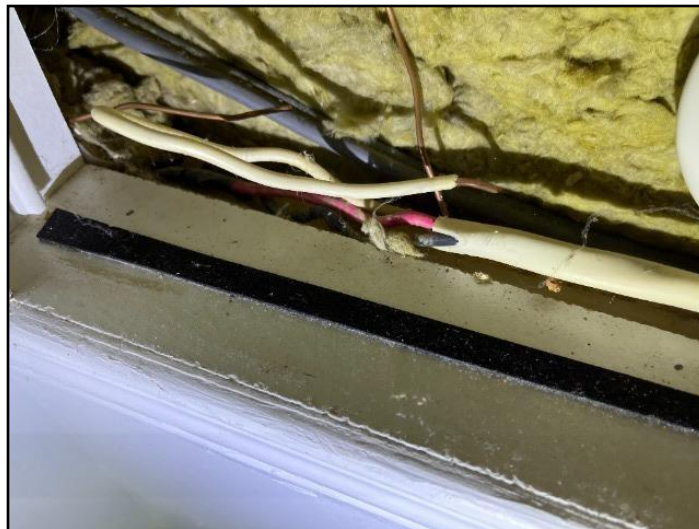
Condition: • [Abandoned wire](#)

Location: Basement below panel

23. Abandoned wire

Task: Remove or Provide junction box

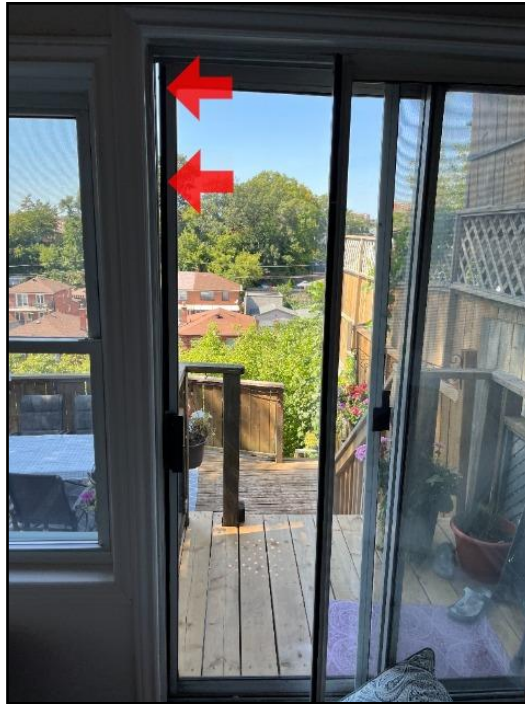
Condition: • [Racked/out-of-square](#)

25. Racked/out-of-square

Task: Adjust or replace

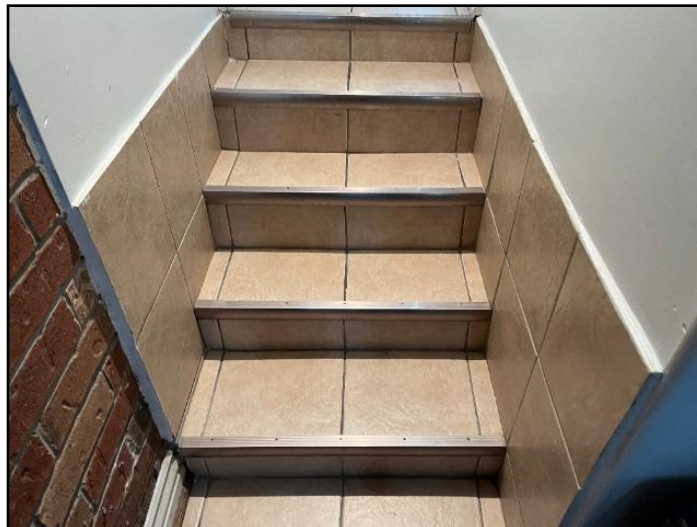
Condition: • [Missing](#)

26. Missing

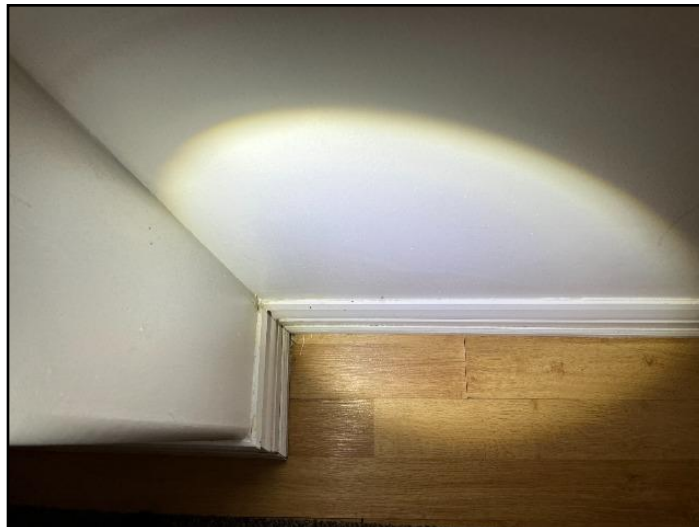
Condition: • [Dampness on floor or walls](#)

Dampness noted using moisture meter at small localized area of wall. No standing water present. It is very common to find moisture and/or condensation in basements walls and/or floors of homes of this age and can be anticipated from time to time. Always ensure all gaps at adjacent exterior areas are well sealed.

27. *Dampness on floor or walls*

Task: Monitor / Repair
