# Your Inspection Report

Sea View Dr  
Mill Bay, BC

**INSPECTION DATE:**  
Wednesday, October 6, 2021

RE: Report No. 2857  
Sea View Dr  
Mill Bay, BC

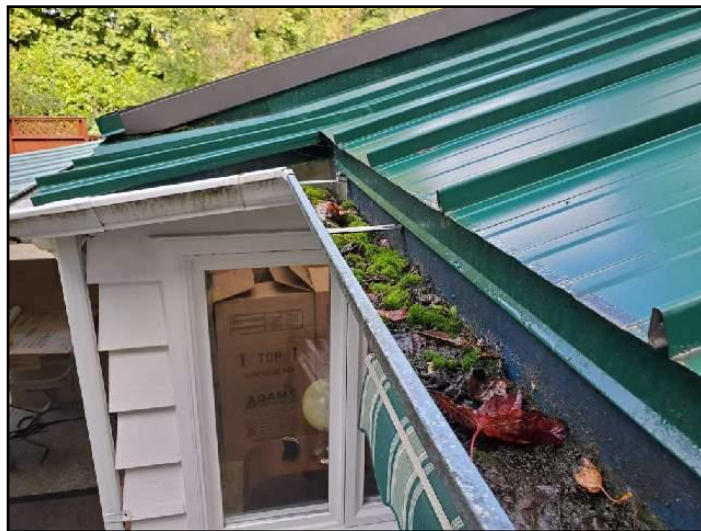
14.

**Condition:** • [Clogged](#)

**Implication(s):** Chance of water damage to structure, finishes and contents

**Location:** Throughout

**Task:** Correct

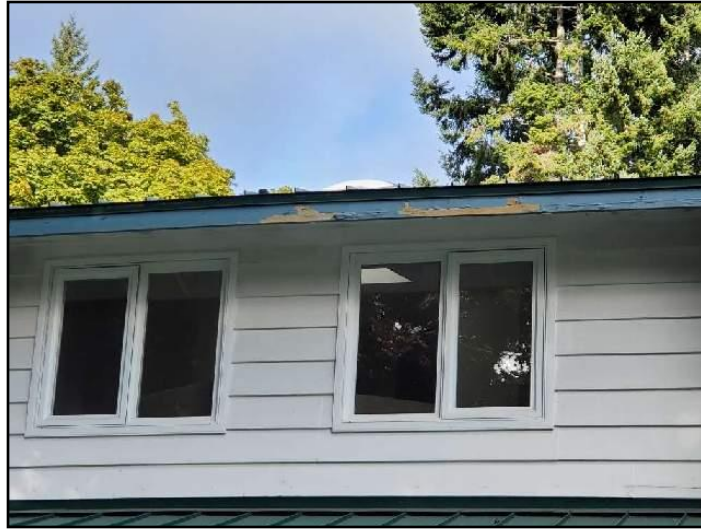
15.

**Condition:** • Paint or stain needed

**Implication(s):** Material deterioration | Chance of water damage to structure, finishes and contents

**Location:** Front

**Task:** Provide

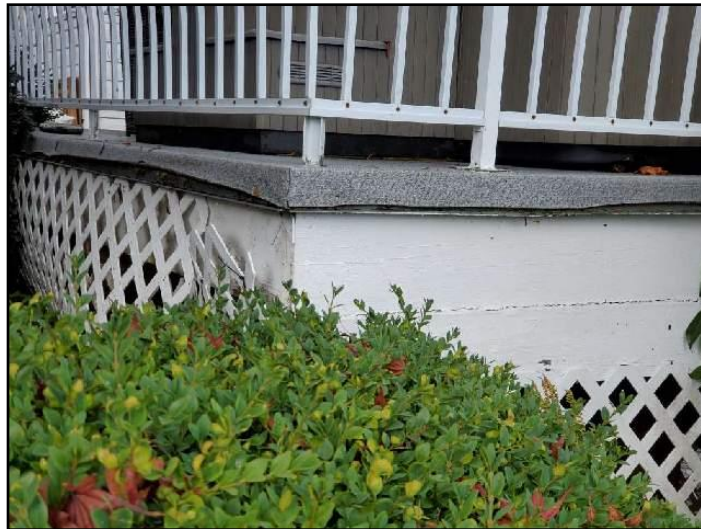
16.

**Condition:** • Open seams

**Location:** Front Exterior

**Task:** Repair or replace

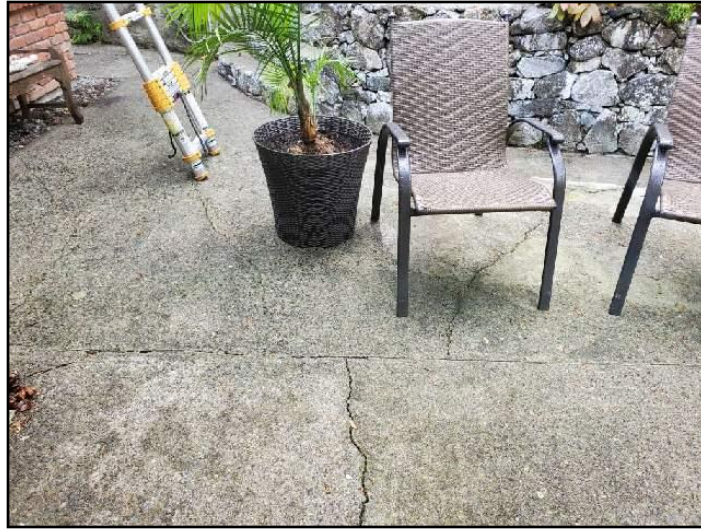
17.

**Condition:** • Cracked or damaged surfaces

**Implication(s):** Physical injury

**Location:** Various Exterior

**Task:** Repair

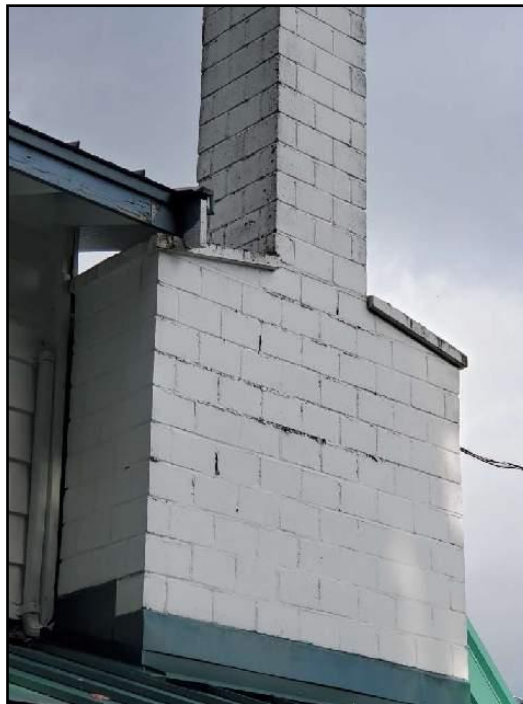
33.

**Condition:** • Loose, missing or deteriorated mortar: Further Evaluation by qualified masonry professional to provide scope and cost for repairs before winter to prevent further deterioration.

**Implication(s):** Material deterioration, cost

**Task:** Repair

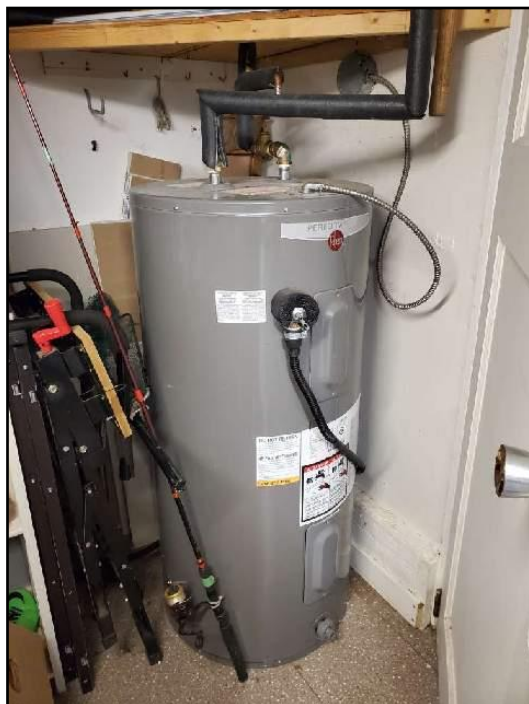
37. Rheem 178L 2007

Water heater typical life expectancy: • 8 to 12 years
