Your Inspection Report

15940 Sample Street
Your City, CA

INSPECTION DATE:
Wednesday, September 5, 2012

PREPARED BY:
Jorel N. Keefauver

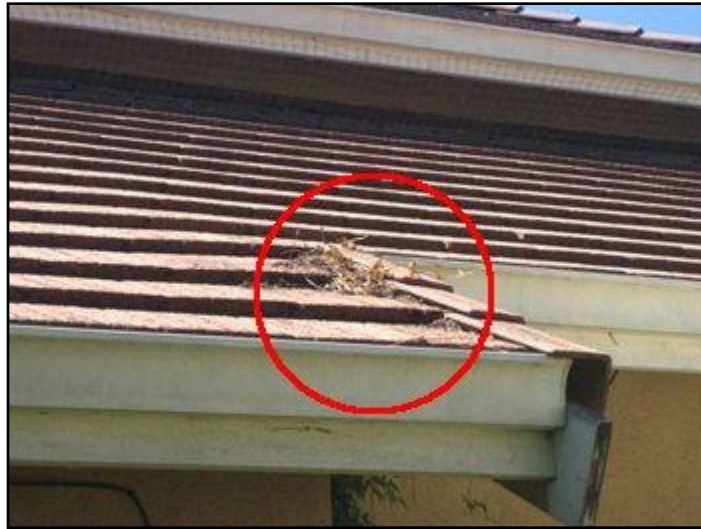
2. Condition: • Debris present on roof

Implication(s): Material deterioration

1. Debris present on roof

Task: Improve

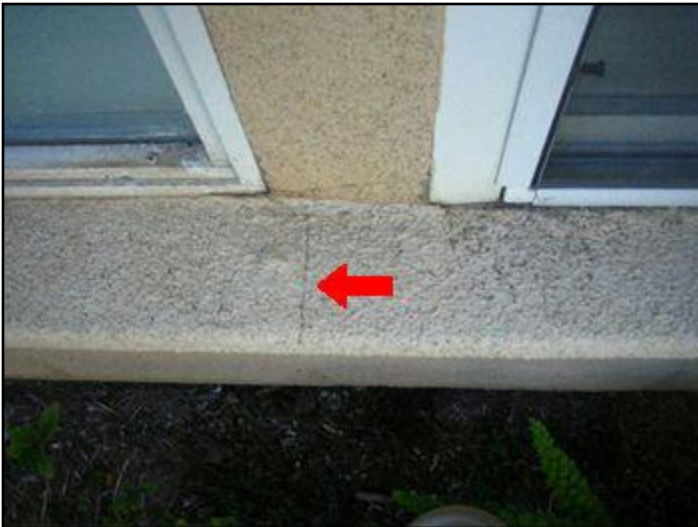
6. Condition: • Cracked and/or damaged. Any cracks or damage may allow water to enter the wall cavity which may cause fungal growth (mold) or wood deterioration. The inspector cannot determine the condition behind the wall covering. Further study advised

2. Cracked

Task: Improve & Monitor

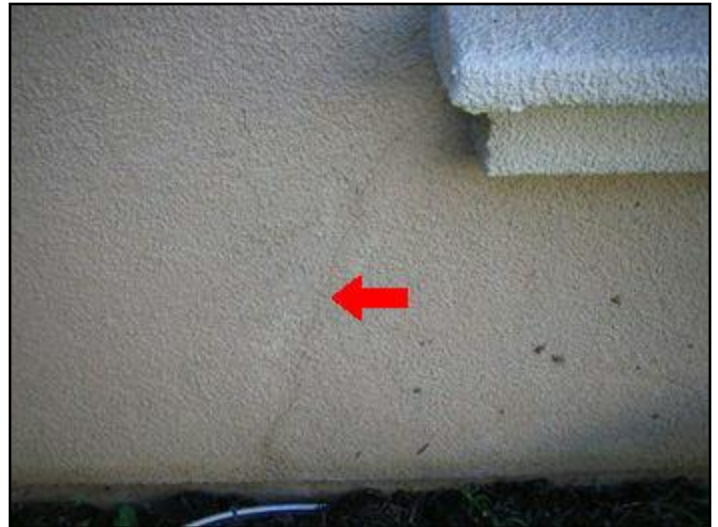
3. Cracked

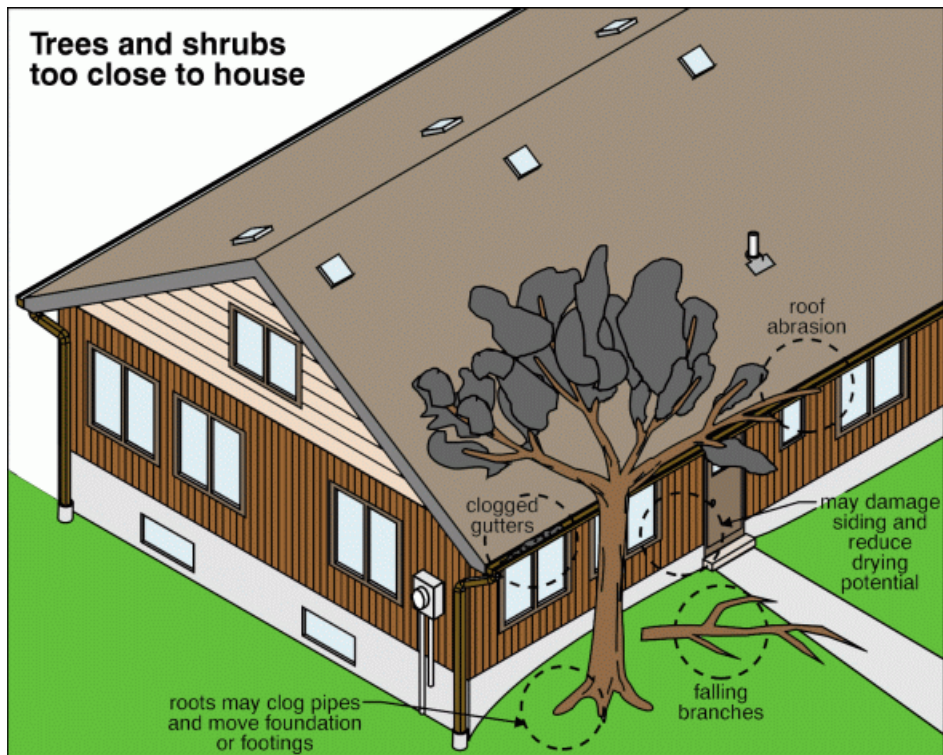
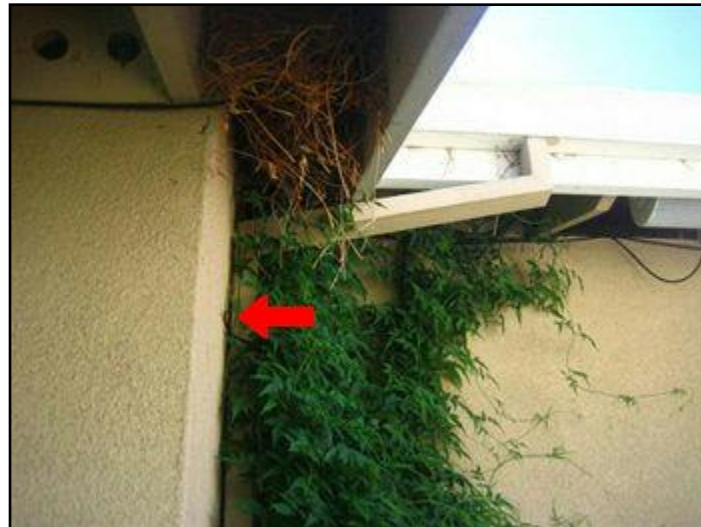
7. Condition: • [Trees or shrubs too close to building](#)

Implication(s): Chance of water damage to contents, finishes and/or structure | Chance of pests entering building | Material deterioration

4. Trees or shrubs too close to building

Task: Improve & Monitor

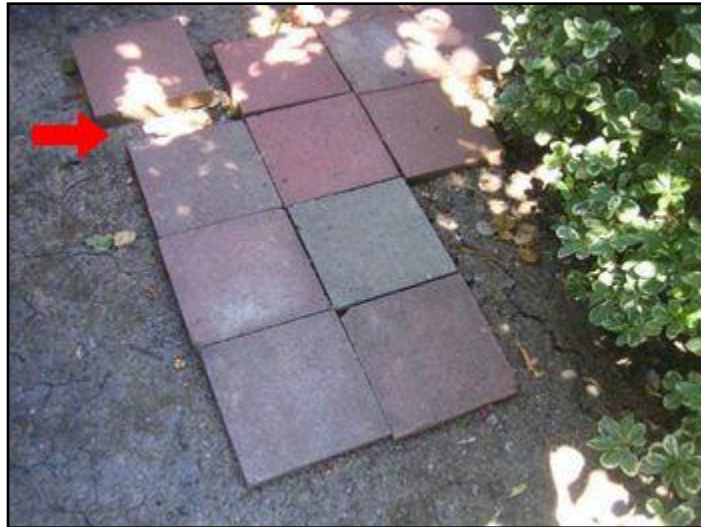
8. Condition: • [Uneven \(trip hazard\)](#)

Implication(s): Physical injury

5. Uneven (trip hazard)

Task: Improve

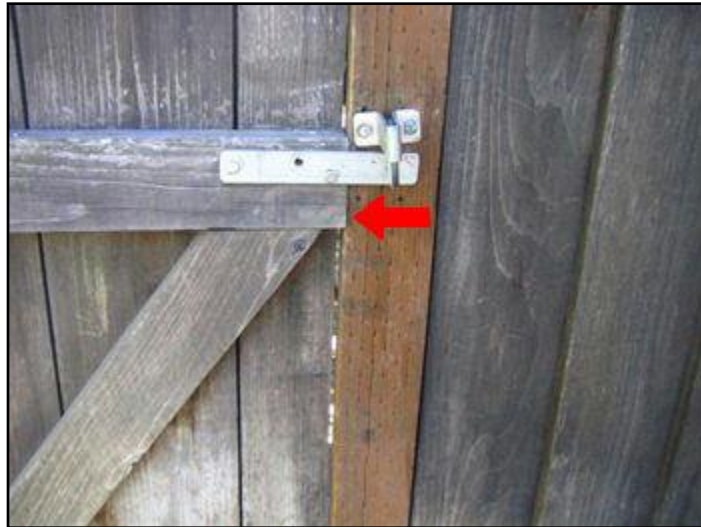
10. Condition: • Gate - adjustment needed

Implication(s): Reduced operability

7. Gate - adjustment needed

Task: Improve

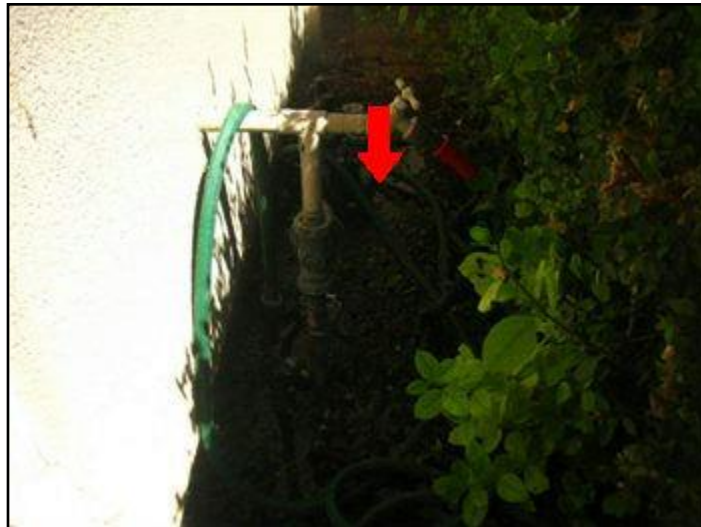
11. Condition: • Leak. These system are not fully evaluated by this company. Further study advised

Implication(s): Material deterioration, Chance of water damage to contents, finishes and/or structure

8. Leak

Task: Improve & Monitor

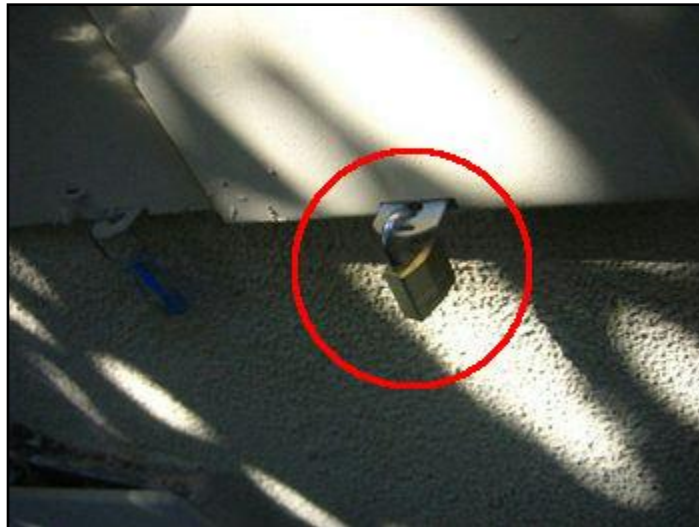
The main service panel was locked at the time of inspection. Further study is advised.

9. Restricted access

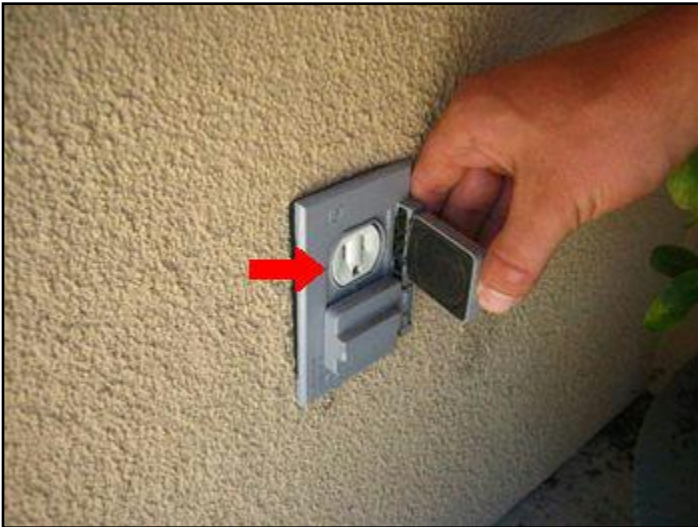
10. No GFCI apparent-Exterior

12. Condition: • Ground Fault Circuit Interrupters (GFCI): GFCI protection is recommended for any electrical outlet located at the exterior, bathrooms, kitchens, laundry areas, garages, unfinished basements, crawl spaces and/or within 5' of any water source. These safety devices should be tested regularly in accordance with the manufacturer's specifications. The inspector does not determine if areas are protected up/downstream by outlets hidden from view

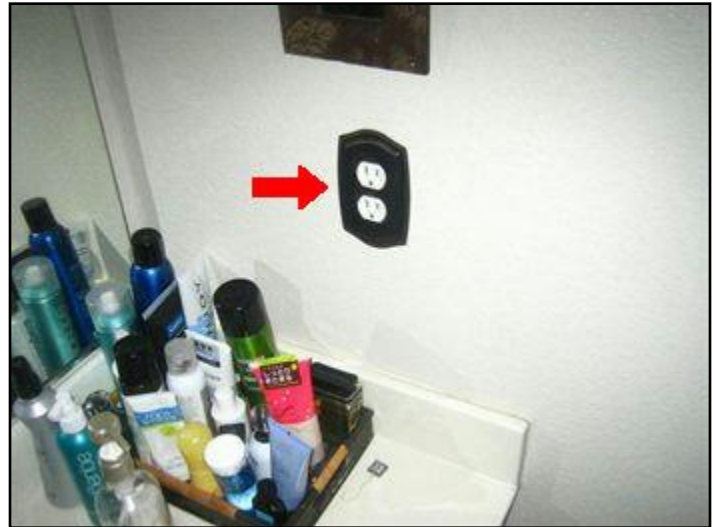
11. No GFCI apparent-Bathroom

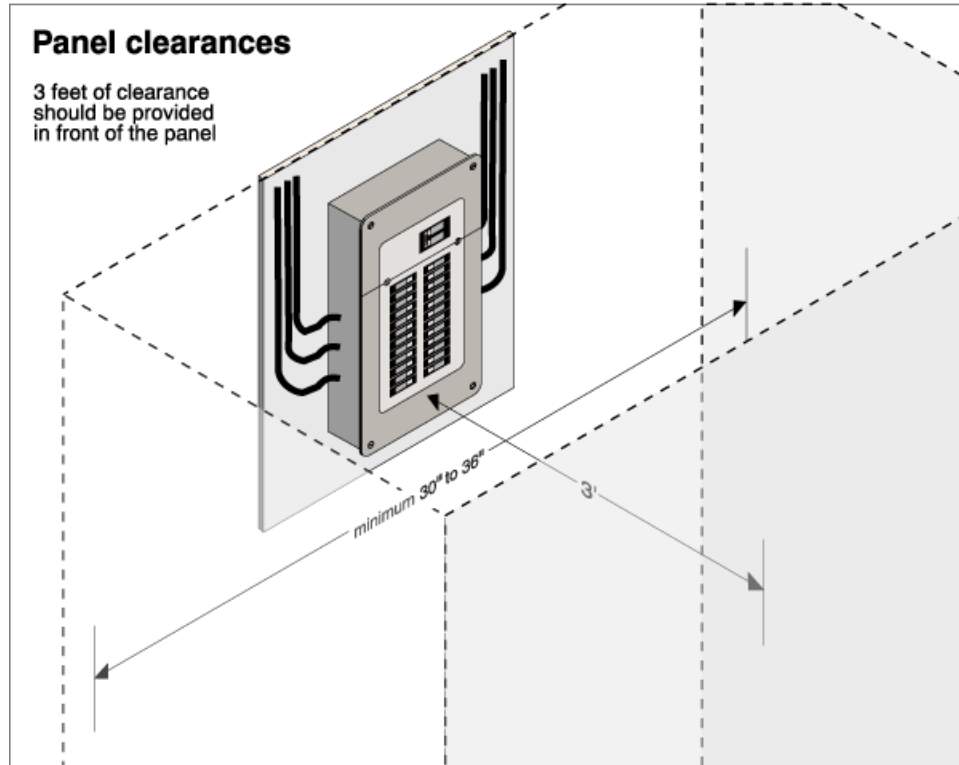
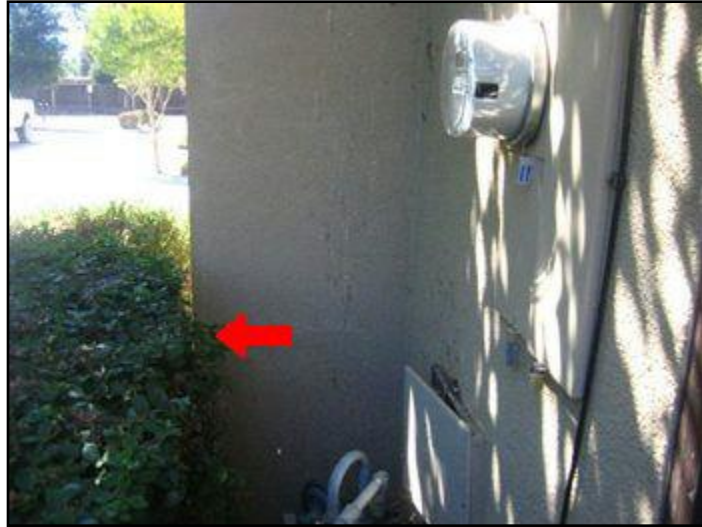
13. Condition: • [Poor access](#)

Implication(s): Difficult to service

12. *Poor access*

Recommended cutting back plants/shrubs to provide adequate access

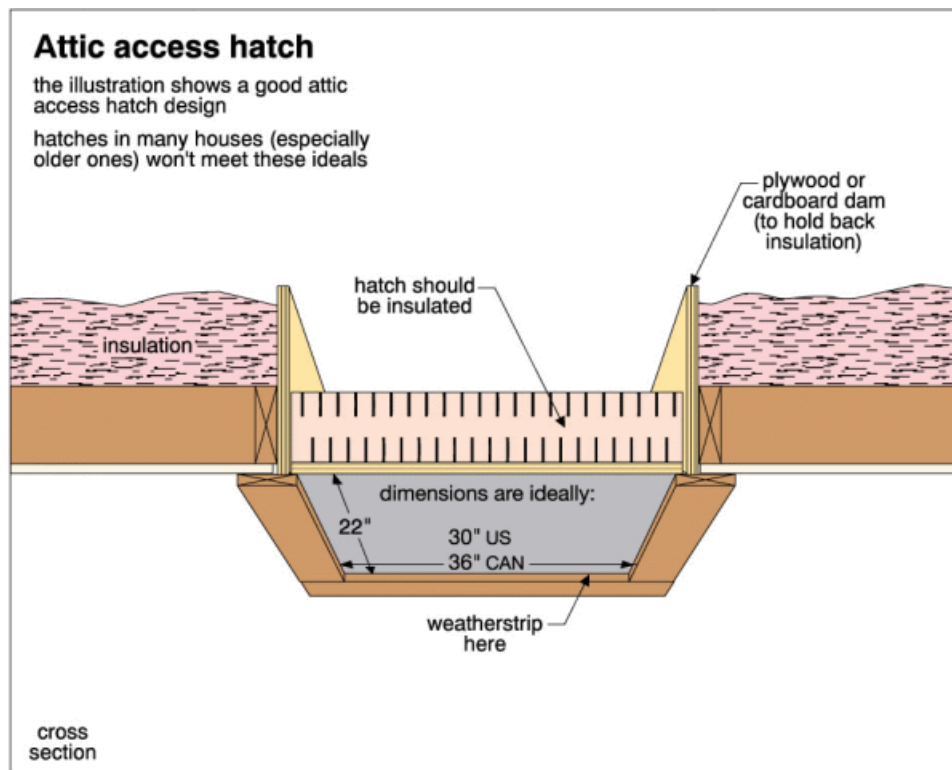
16. Condition: • Not insulated

Implication(s): Reduced efficiency

Task: Improve

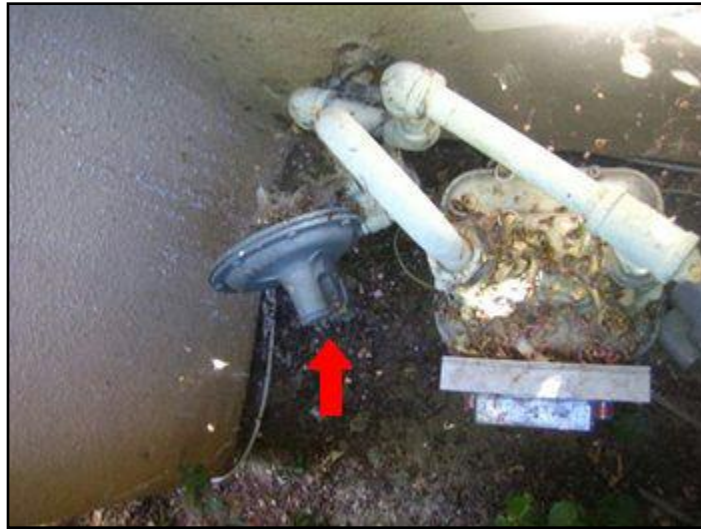
18. Condition: • No wrench for gas meter shutoff valve: A wrench for the gas meter shutoff valve was not located in the vicinity of the gas meter as recommended in seismically active zones. Securing a properly sized wrench to the gas meter or nearby piping to provide a convenient means of shutoff in an emergency is suggested.

Implication(s): Potential safety hazard

13. No wrench for gas meter shutoff valve

Task: Improve

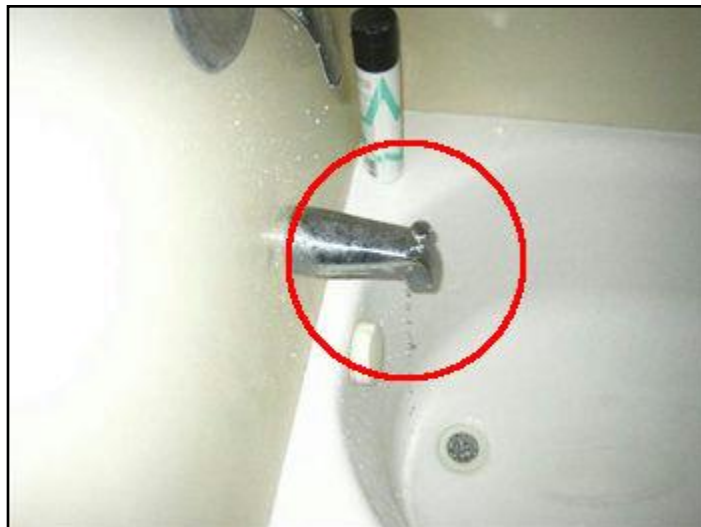
19. Condition: • [Shower diverter inoperative or defective](#)

Implication(s): Equipment failure

14. Shower diverter inoperative or defective

Task: Improve

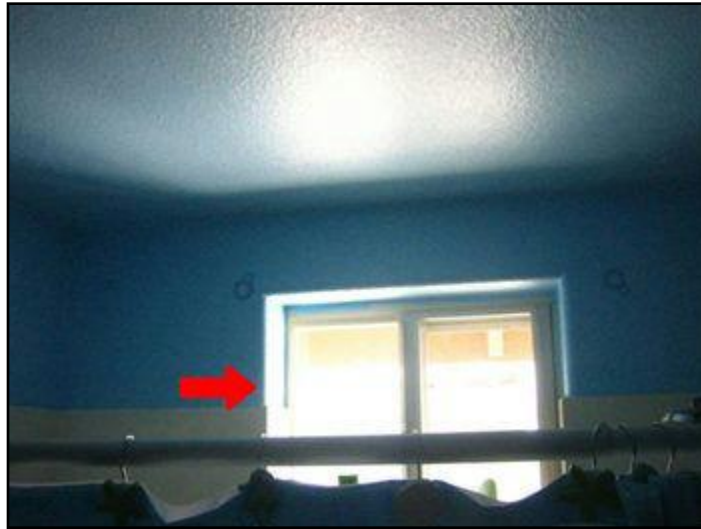
20. Condition: • Shower head above window. This type of construction can allow moisture intrusion into the wall if this area is not properly sealed and maintained

Implication(s): Chance of water damage to contents, finishes and/or structure

15. Shower head above window

Task: Monitor

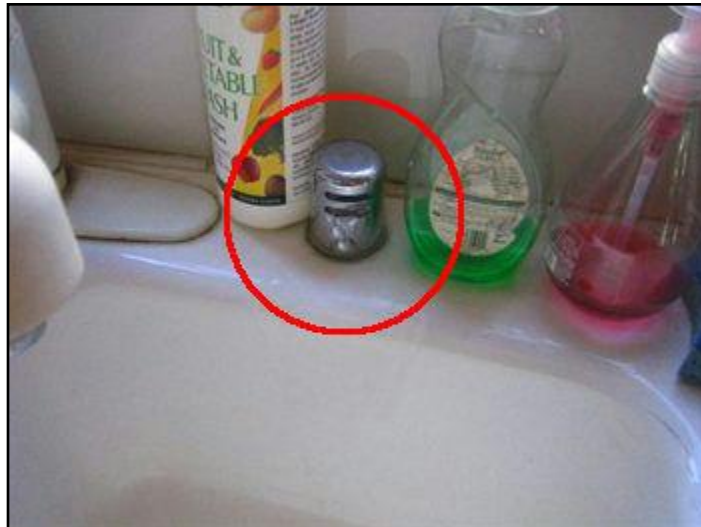
21. **Condition:** • Dishwasher airgap leaks

Implication(s): Chance of water damage to contents, finishes and/or structure, Contaminated dishwater

16. Backflow prevention defective

Task: Improve

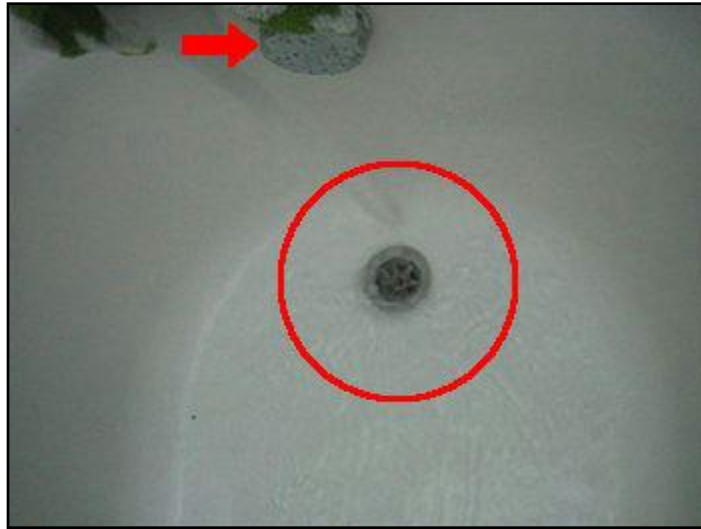
22. **Condition:** • Drain stop ineffective

17. Drain stop ineffective

Task: Improve

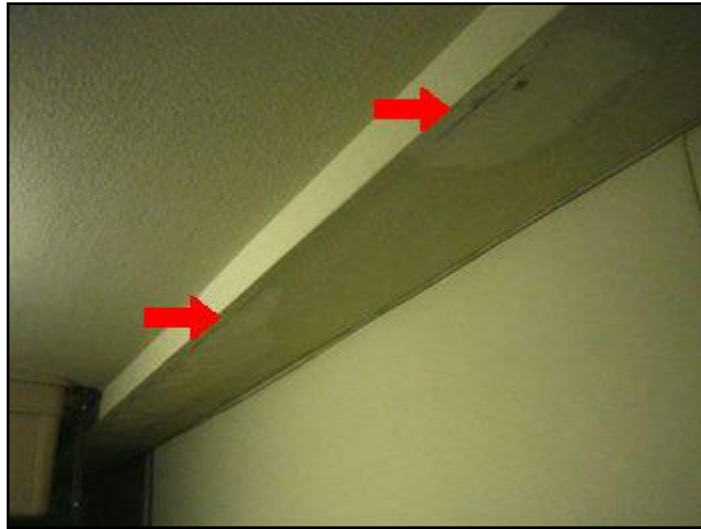
23. Condition: • Water stain(s) noted on interior surface This condition may indicate active roof leakage. Further study advised

Implication(s): Material deterioration, Chance of water damage to contents, finishes and/or structure

18. Water stain(s) noted

Task: Improve & Monitor

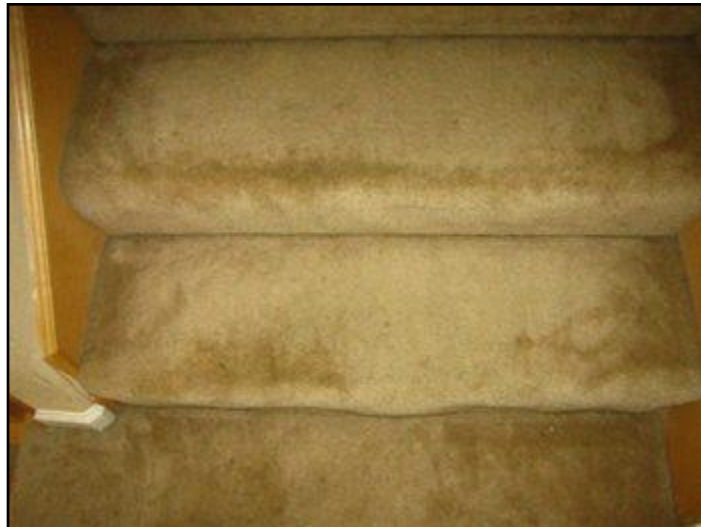
24. Condition: • Buckled

Implication(s): Trip hazard

19. Buckled

Task: Improve

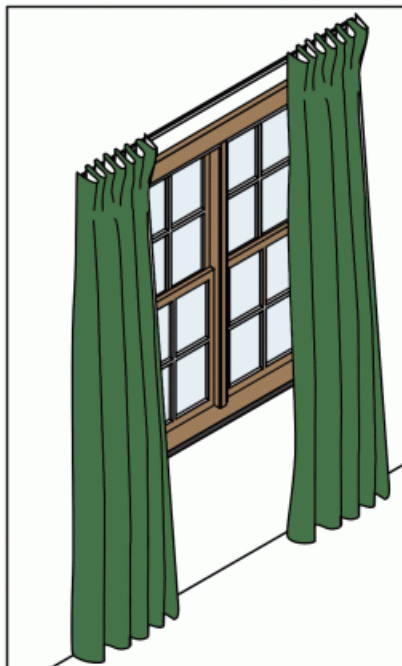
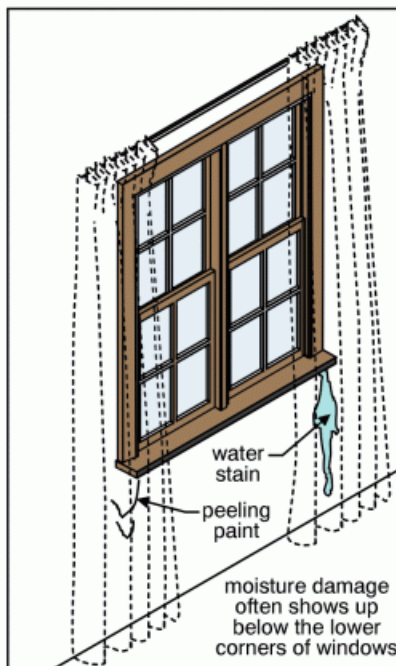
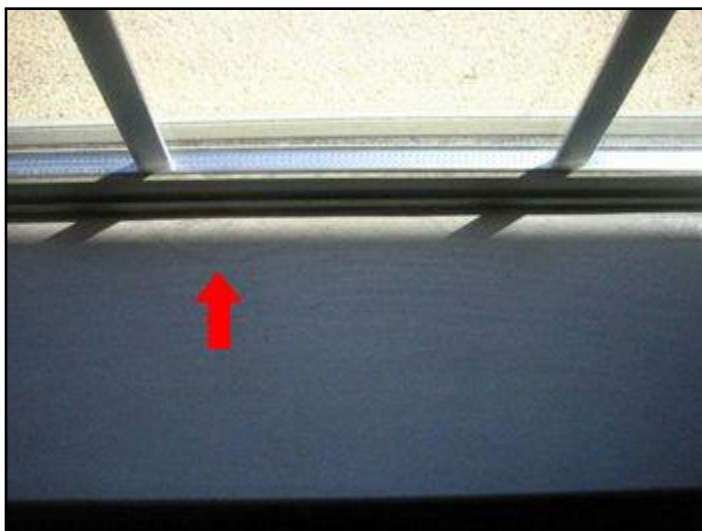
27. Condition: • [Stained](#)

This condition may indicate active window leakage. Further study advised

Implication(s): Chance of water damage to contents, finishes and/or structure

20. Stained

Task: Improve & Monitor

Look behind window treatments

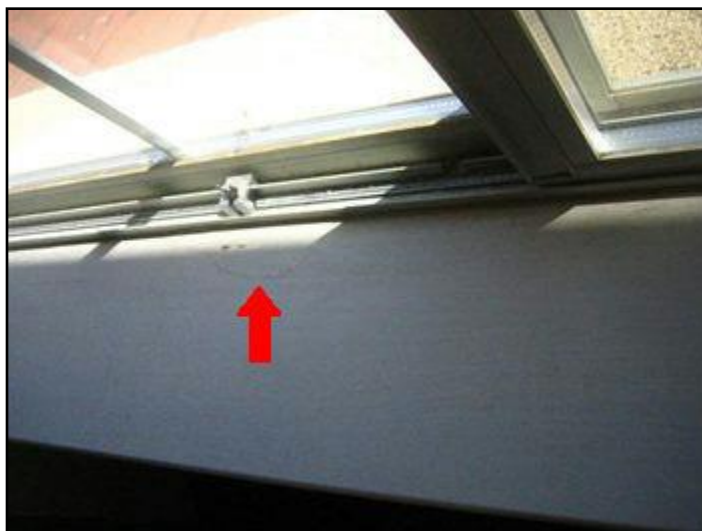
21. Stained

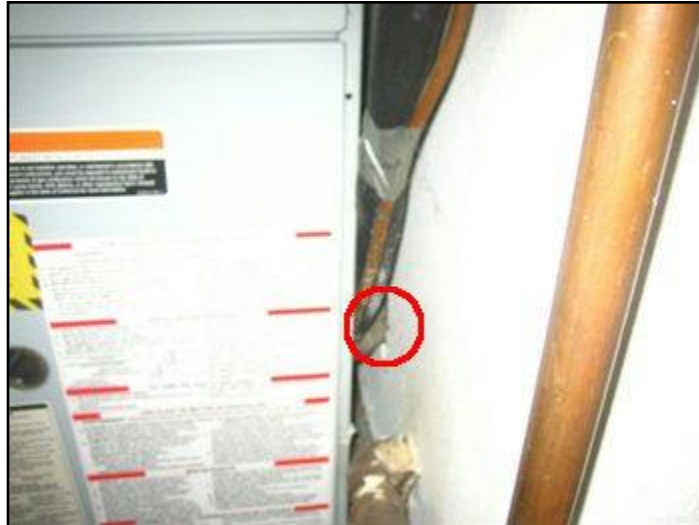
28. Condition: • Fire resistant wall or ceiling damaged / holed / not properly sealed / firestopped

Implication(s): Increased fire risk, Chance of hazardous combustion products entering living space

22. *Wall holed*

Task: Improve

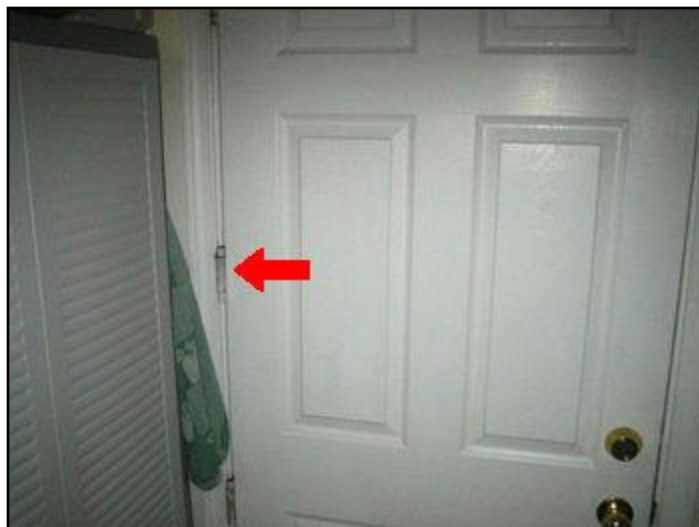
29. Condition: • No self closer

Implication(s): Increased fire risk, Chance of hazardous combustion products entering living space

23. *No self closer*

Task: Improve
