YOUR Inspection Report

gladewater
My Village, TX

Thursday, April 14, 2016

RE: Report No. 1003, v.4
gladewater
My Village, TX

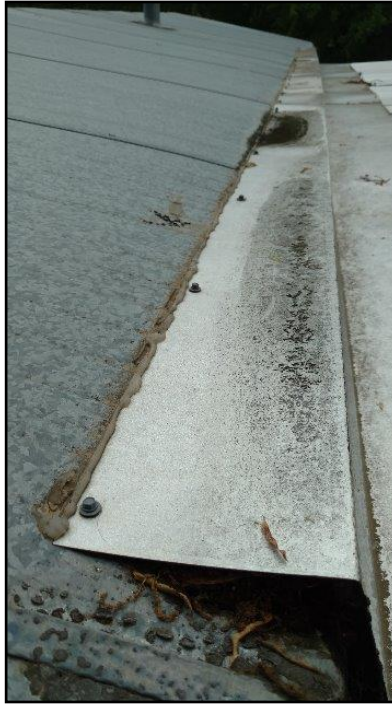
4. Metal

Flashing on this roof with its arched slope depends on roofing sealers that must be monitored by home owner regularly they have a high probability of leaking.

Probability of leakage: • High

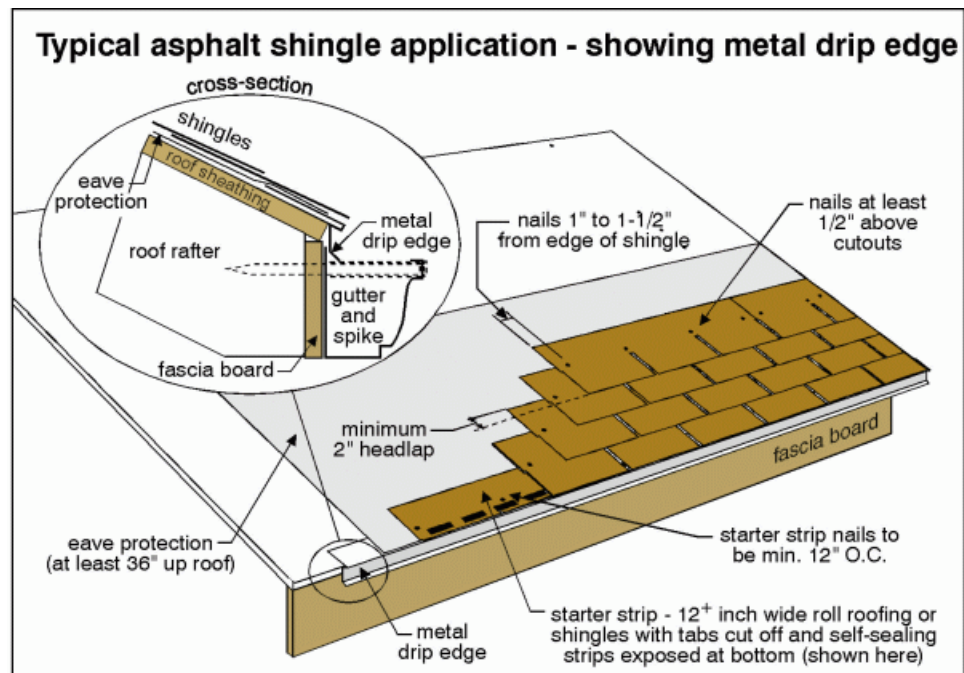
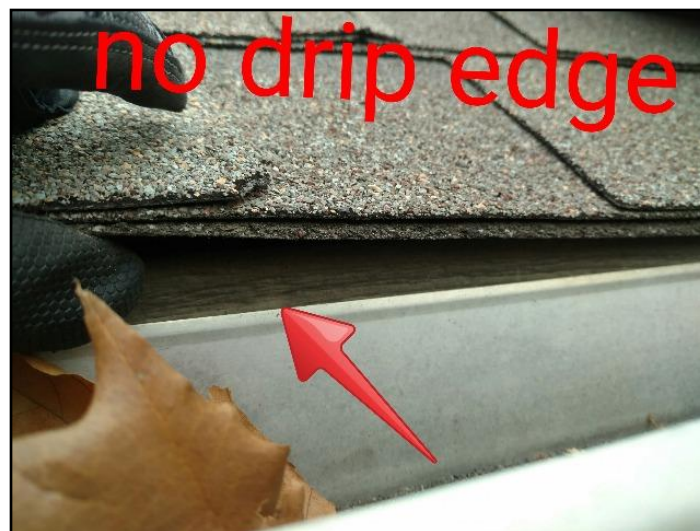
5. Missing

SLOPED ROOF FLASHINGS \ Drip edge flashings

2. Condition: • [Missing](#)

Implication(s): Chance of water damage to contents, finishes and/or structure

Task: Repair or replace

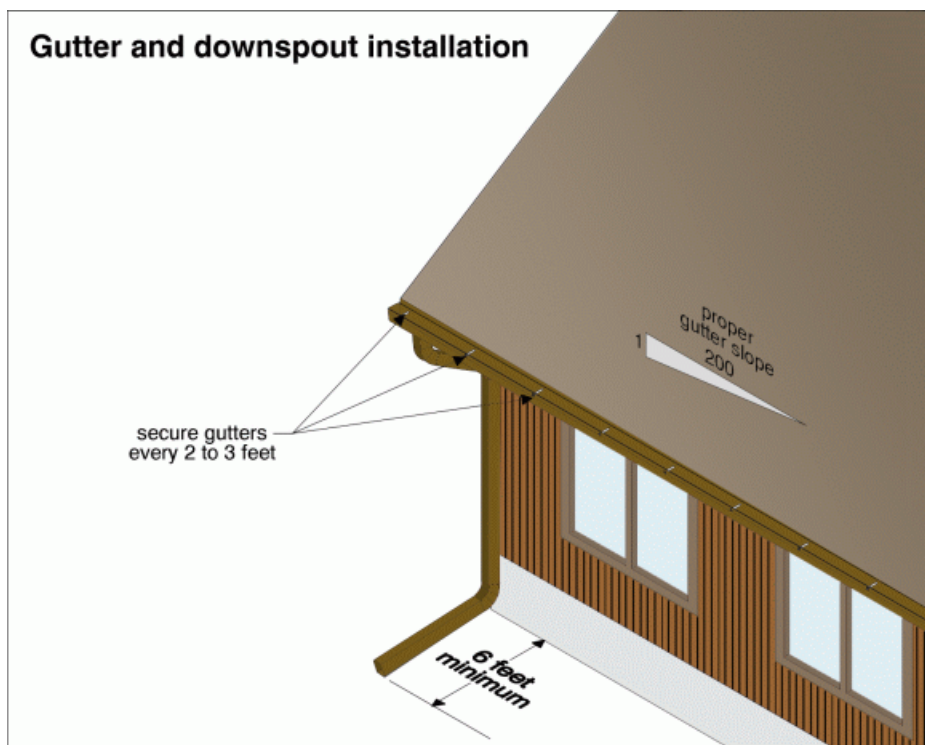
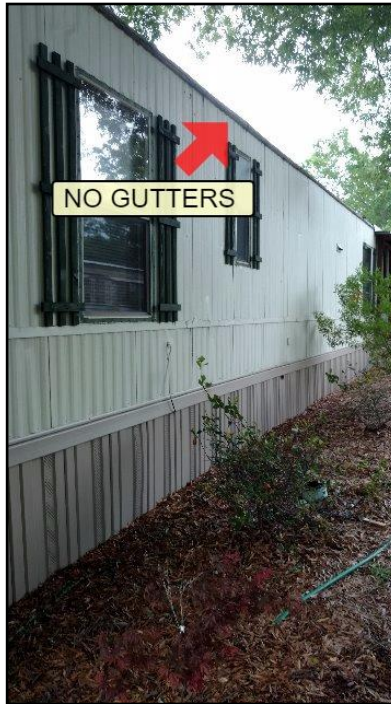
6. Missing

ROOF DRAINAGE \ Gutters

3. Condition: • [Missing](#)

Implication(s): Chance of water damage to contents, finishes and/or structure

Task: Upgrade

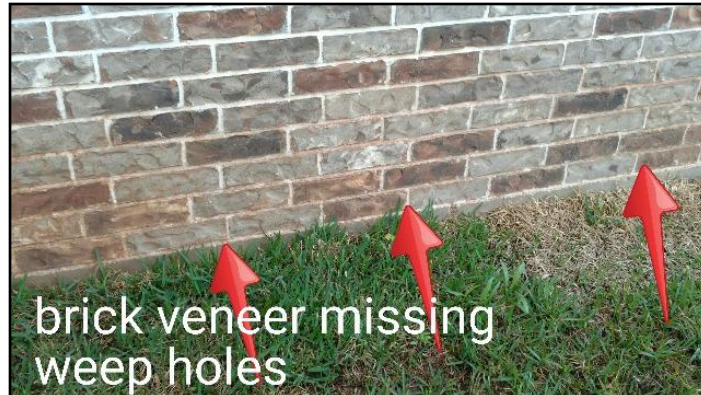
5. Condition: • [Missing, ineffective weep holes or flashings](#)

Implication(s): Chance of water damage to contents, finishes and/or structure | Material deterioration

7. Missing, ineffective weep holes or flashings

Task: Correct

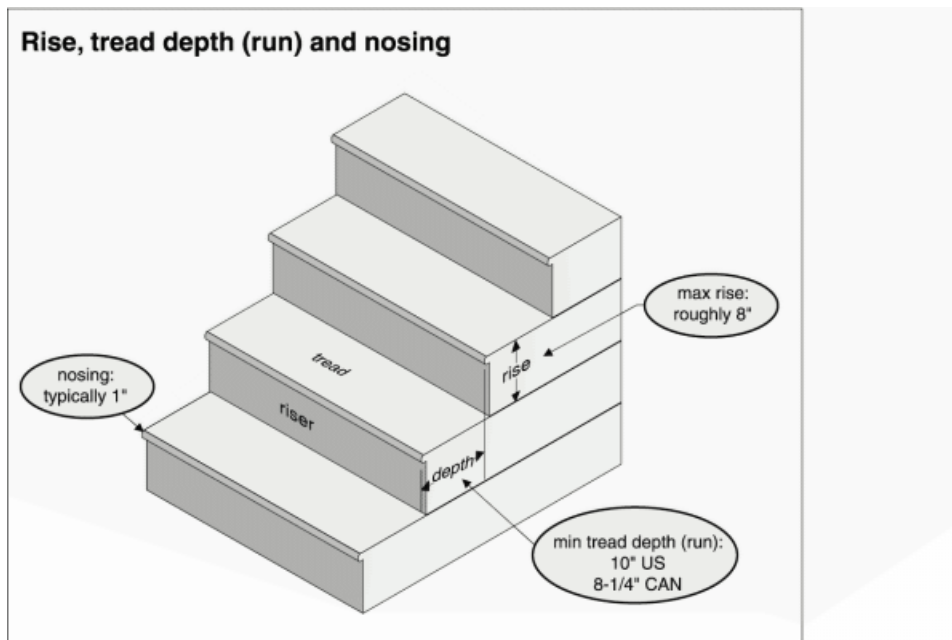
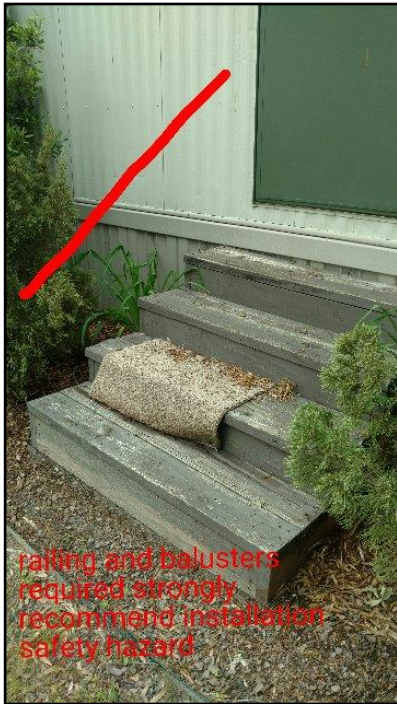
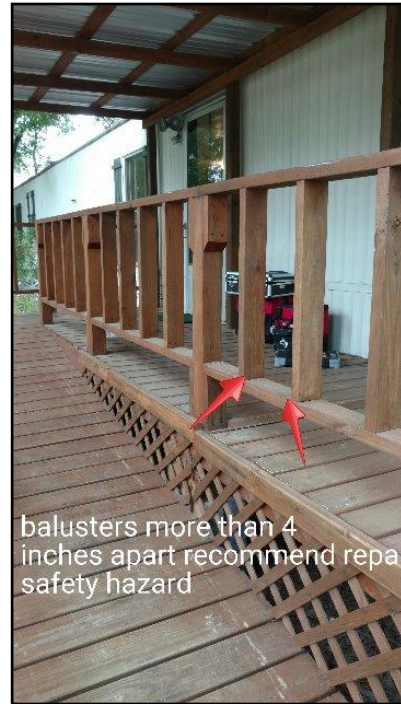
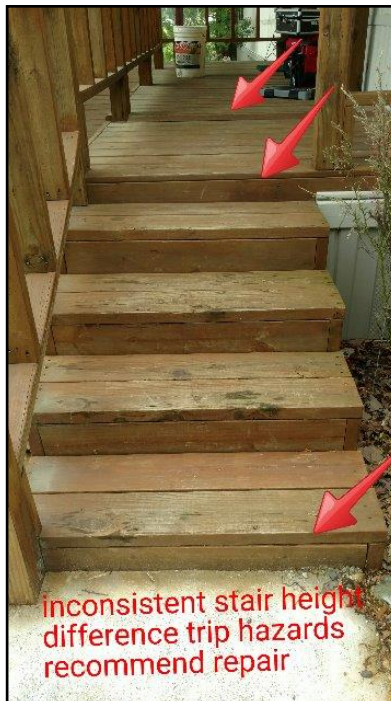
6. Condition: • [Stair run too small or not uniform](#)

Implication(s): Trip or fall hazard

8. Stair run too small or not uniform

Task: Repair Upgrade

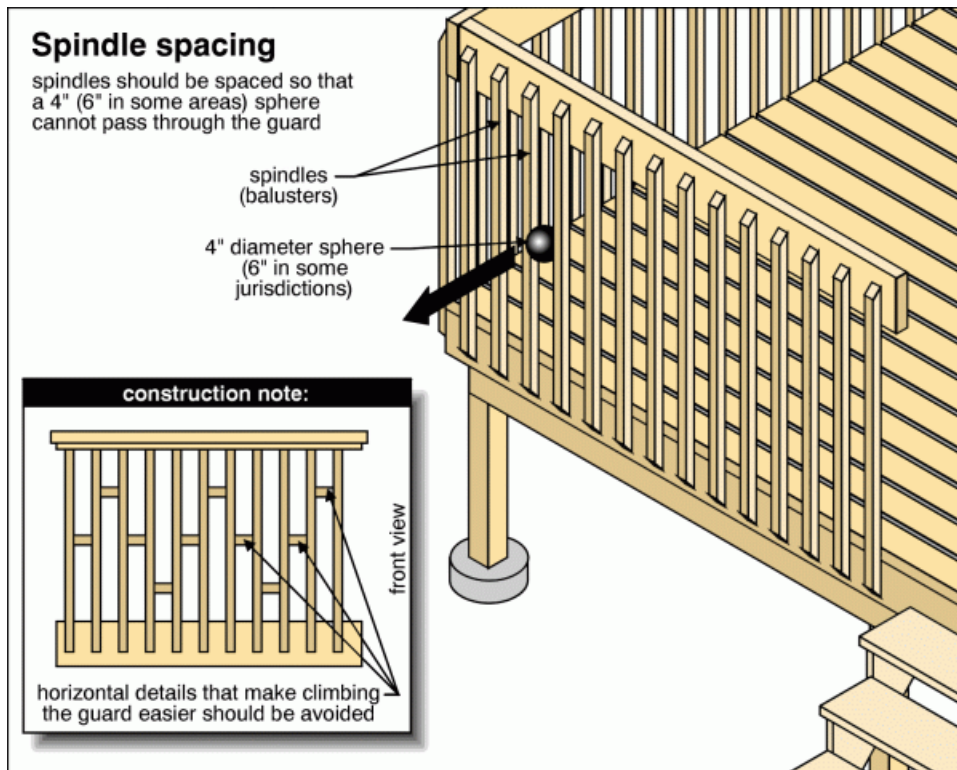
7. Condition: • [Spindles too far apart](#)

Implication(s): Fall hazard

Task: Repair Improve

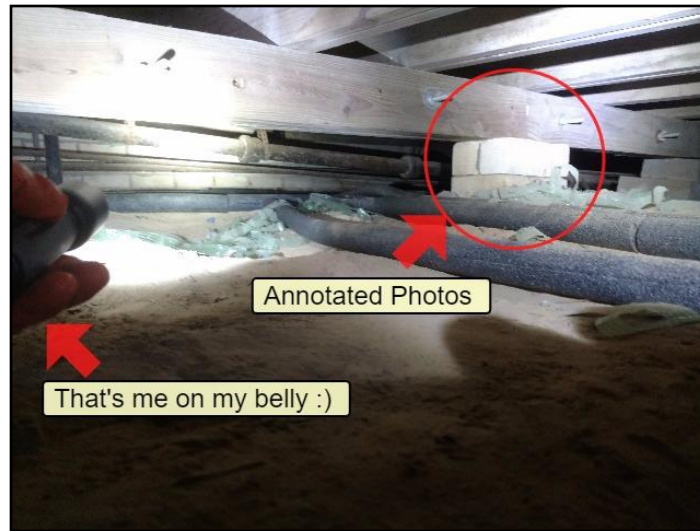
9. Condition: • No defects noted

11. Pier and beam

Task: Monitor

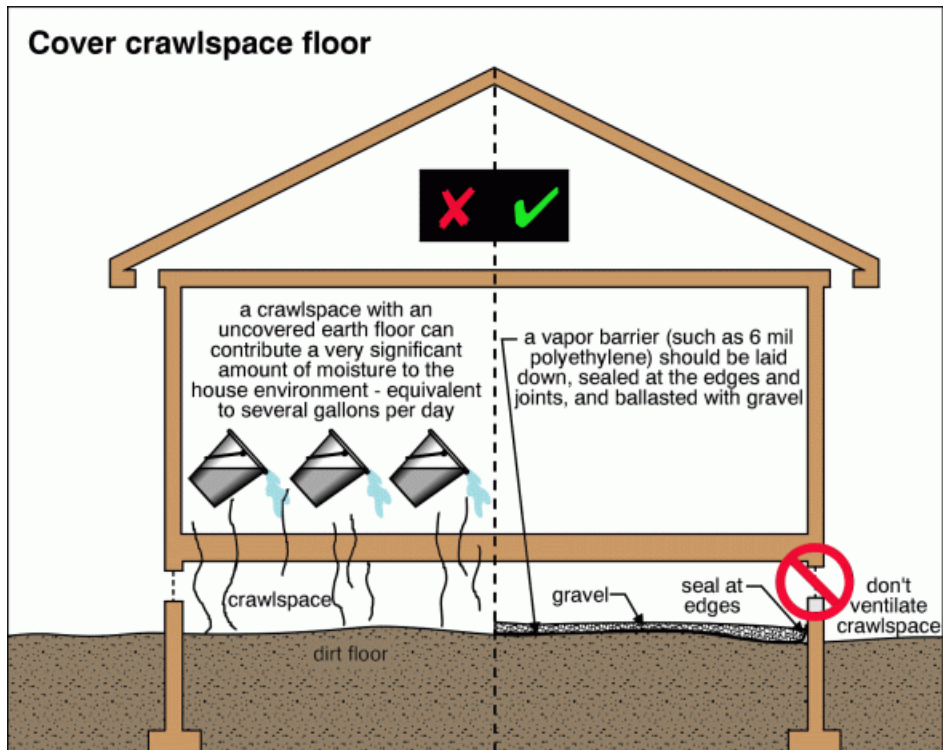
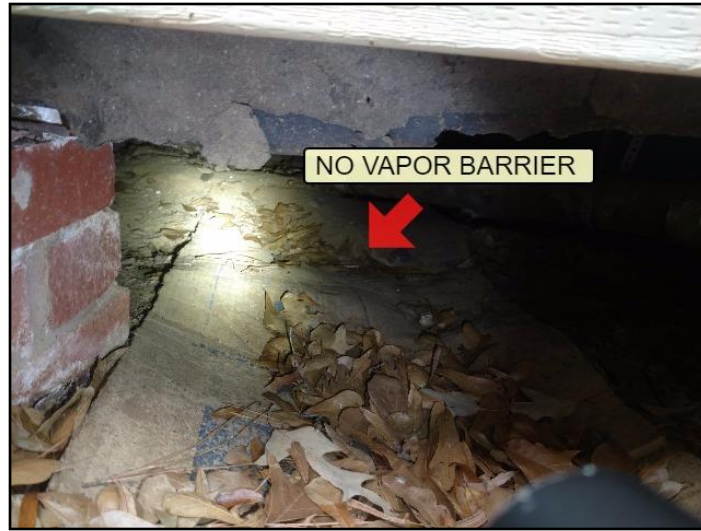
10. Condition: • No vapor barrier in the crawl space recommend upgrade installation for moisture control in the home and to prolong the life of wood members in the crawl space.

12. No vapor barrier in the crawl space...

Task: Upgrade

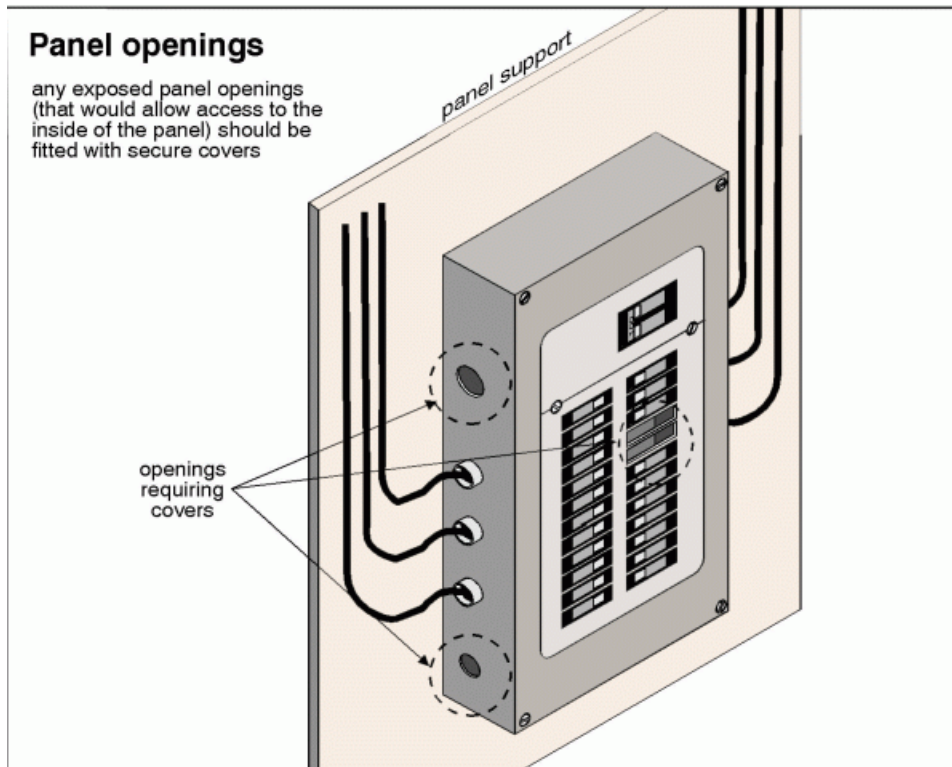
11. Condition: • [Openings in panel](#)

Implication(s): Electric shock | Fire hazard

Task: Repair

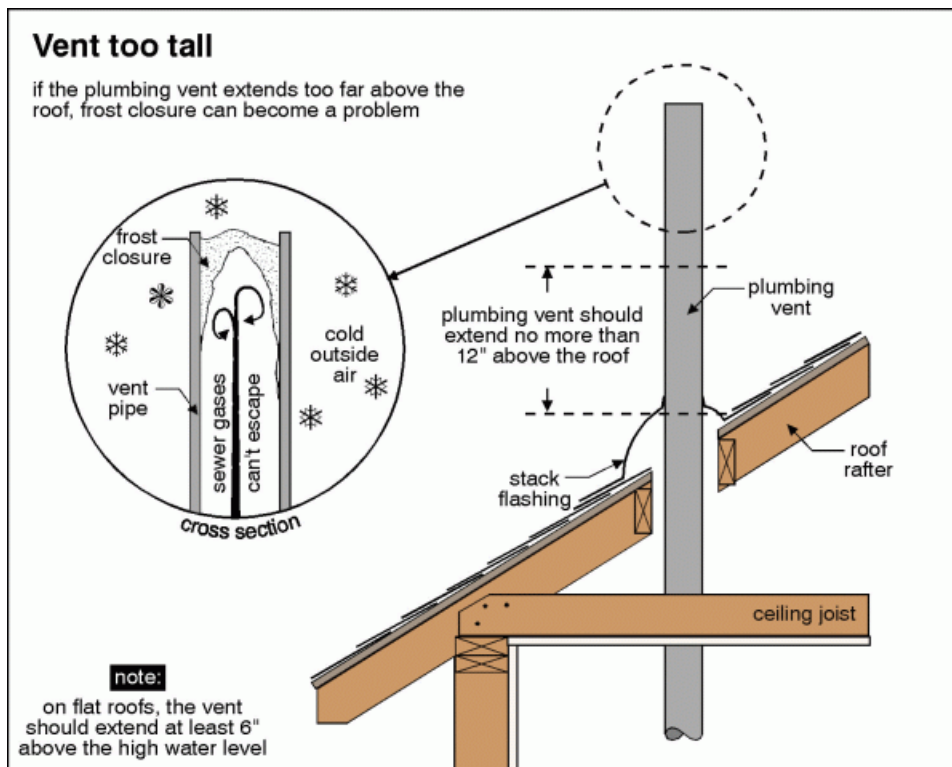
17. Condition: • [Vent termination problems](#)

Task: Repair Replace

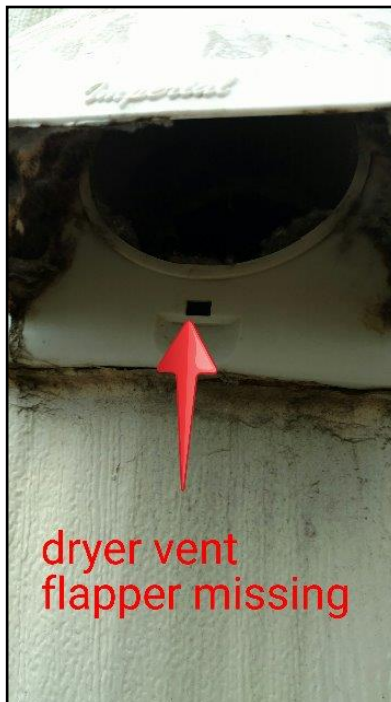
19. Condition: • Screen on vent termination

Implication(s): Equipment ineffective | Fire hazard

21. Screen on vent termination

Task: Repair
