# Your Inspection Report

2518 East Elsienna Way  
Anaheim, CA 92806

INSPECTION DATE:  
Saturday, March 2, 2024

Report No. 1529, v.3

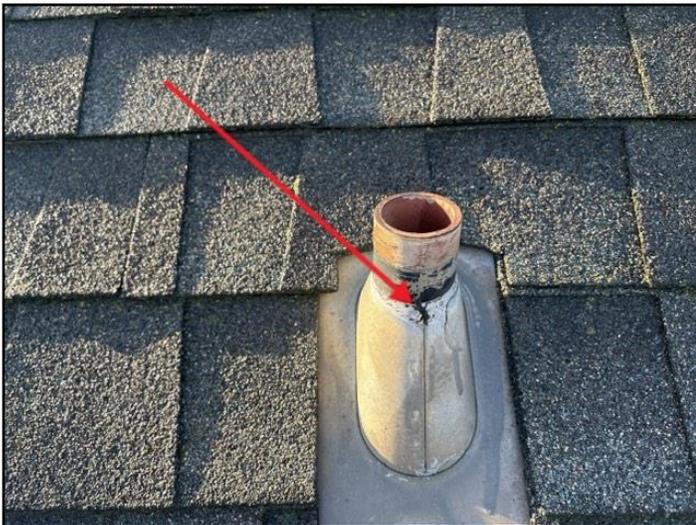
6. Leak

Condition: • [Leak](#)

There was one or more roof vents with missing boots, openings, or deterioration which will allow water penetration.

Task: seal vents with caulking to avoid water penetration

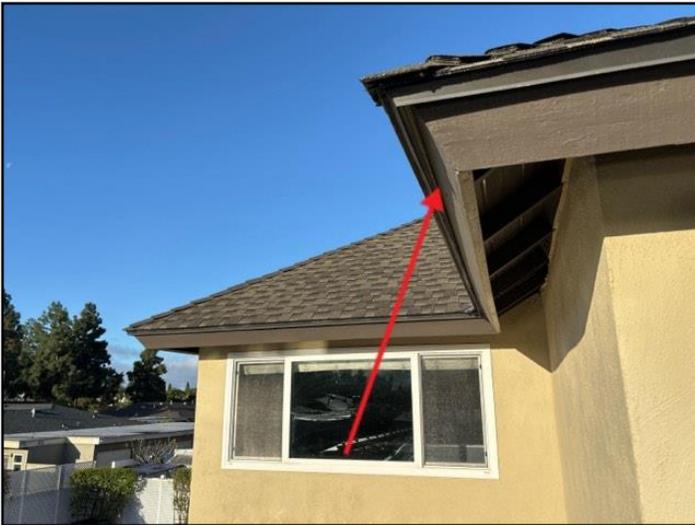
12. Missing

**Condition:** • Missing

Primary purpose of gutters and downspouts is to prevent mold, mildew, and other water damage. Gutters keep your home in place by directing rainwater away from your siding and foundation.

**Task:** Provide

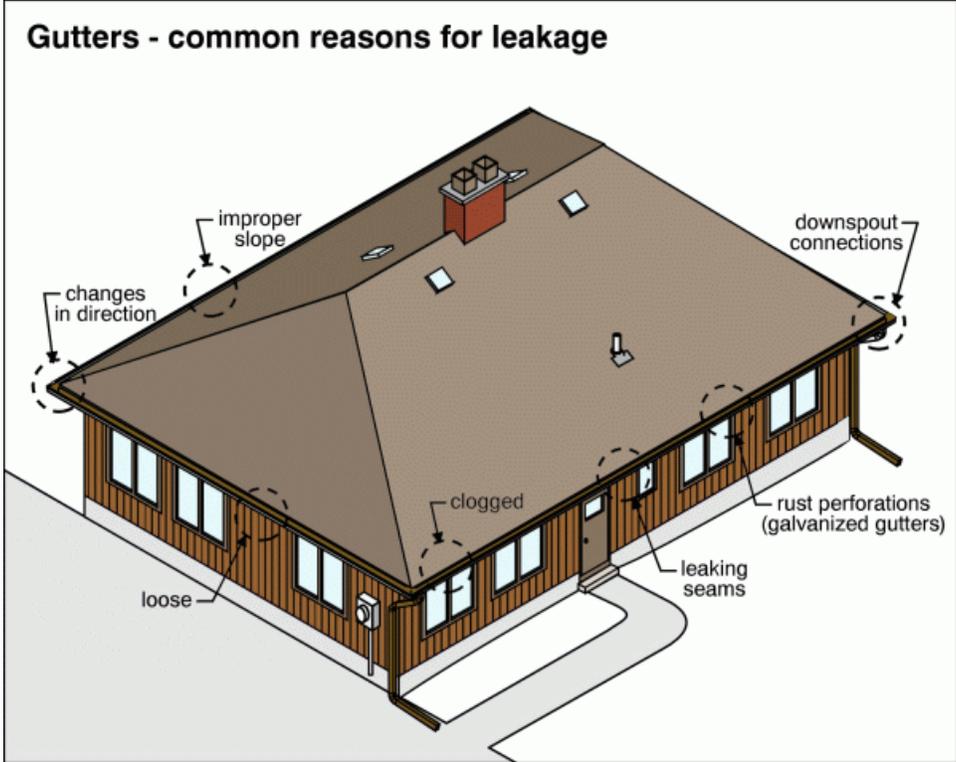
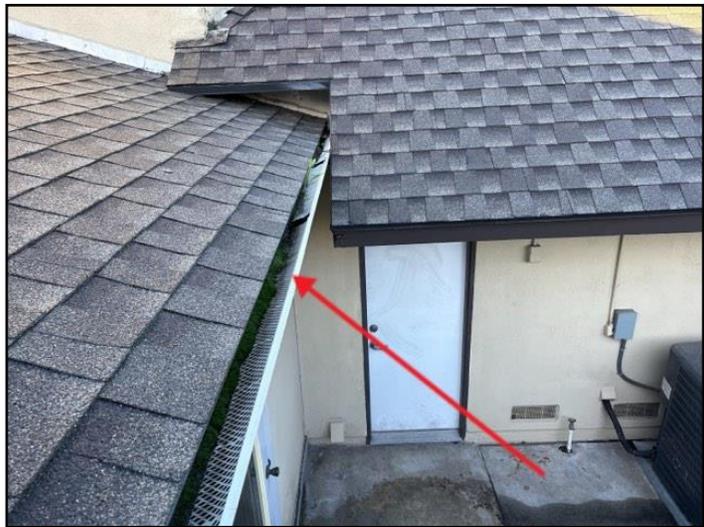
15. Clogged

**Condition:** • [Clogged](#)

The weight of the debris in gutter basket has damaged the screens. It is recommended to Clean gutters for proper roof

**Task:** Clean / Improve

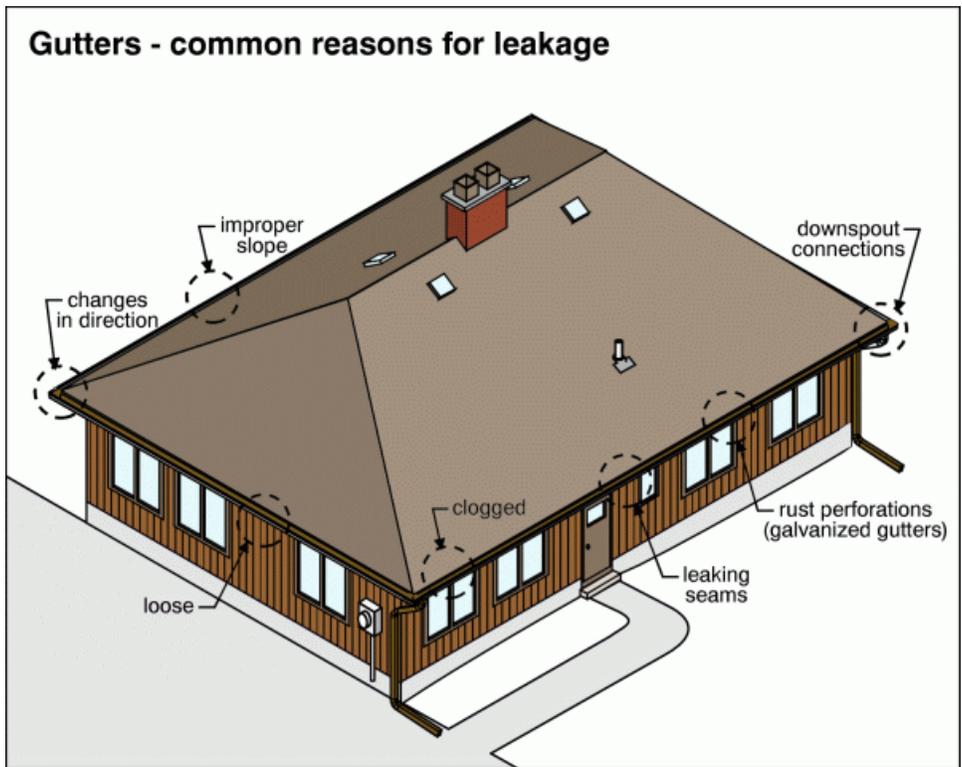
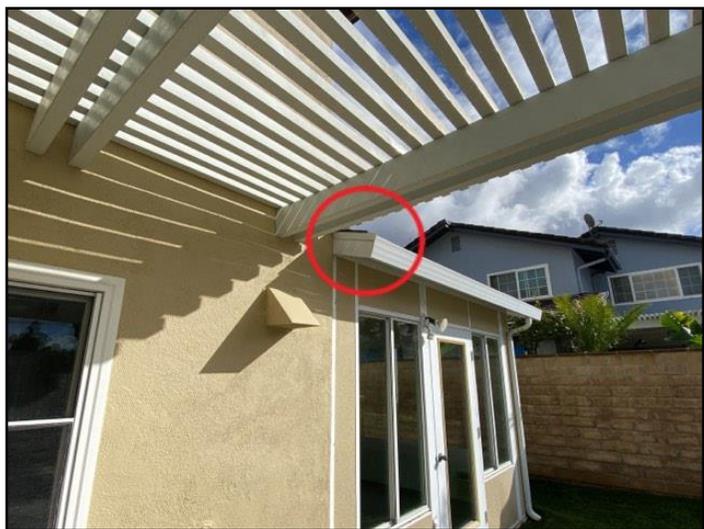
16. Leak

**Condition:** • [Leak](#)

A leak in the gutter system indicates that the gutters are not sufficiently diverting water away from the siding of the building as intended

**Task:** Repair or replace

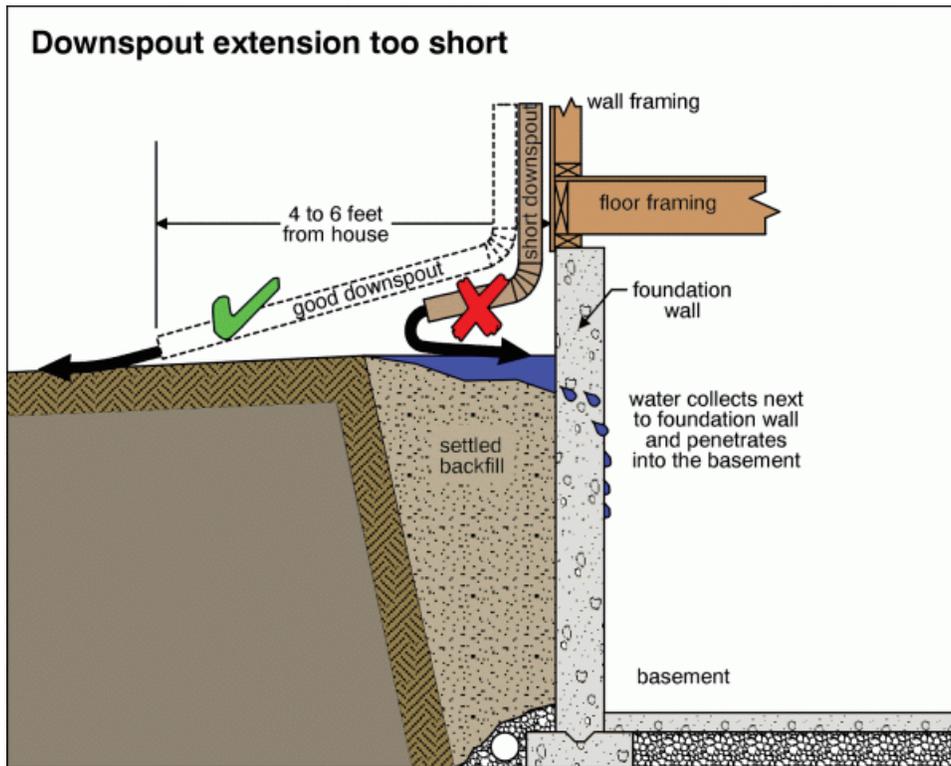
17. Discharge too close to building

**Condition:** • [Discharge too close to building](#)

Recommend adding extensions to downspouts to push water away from wall siding and to avoid future damage.

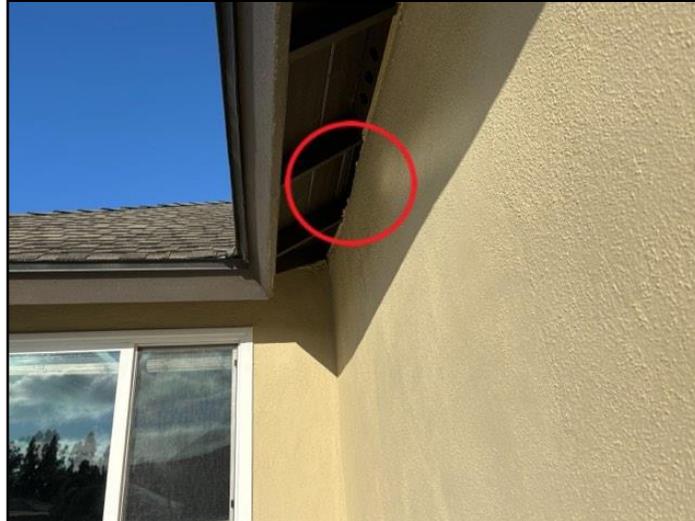
21. Cover missing

**Condition:** • Cover missing

Chance of pests entering building, Increased heating and cooling costs

**Task:** cover plate is needed

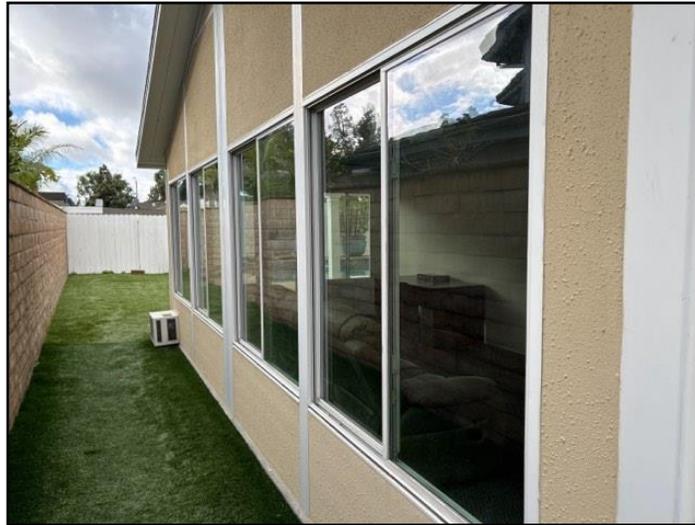
23. Missing

**Condition:** • [Missing](#)

**Task:** Provide

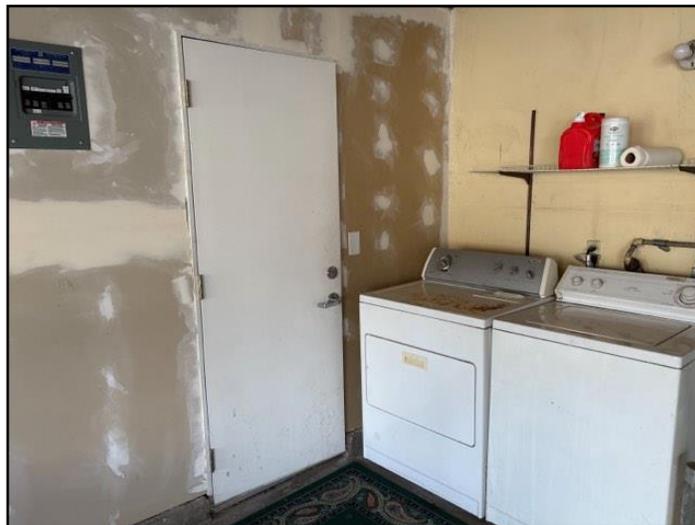
24. Loose or poor fit

**Condition:** • [Loose or poor fit](#)

**Task:** Repair

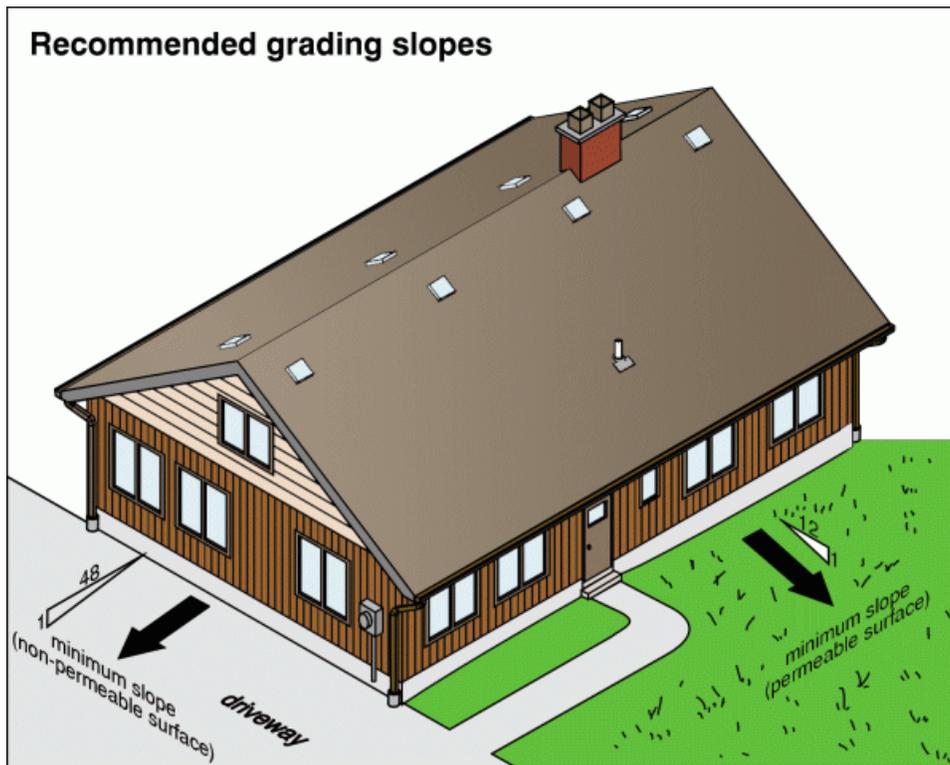
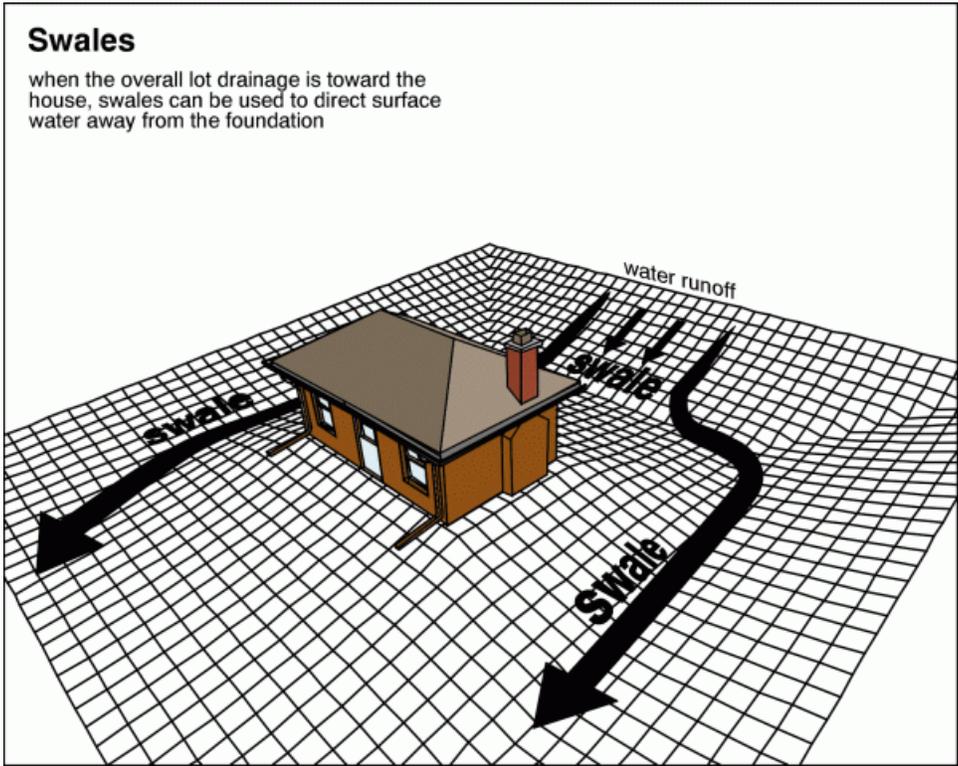
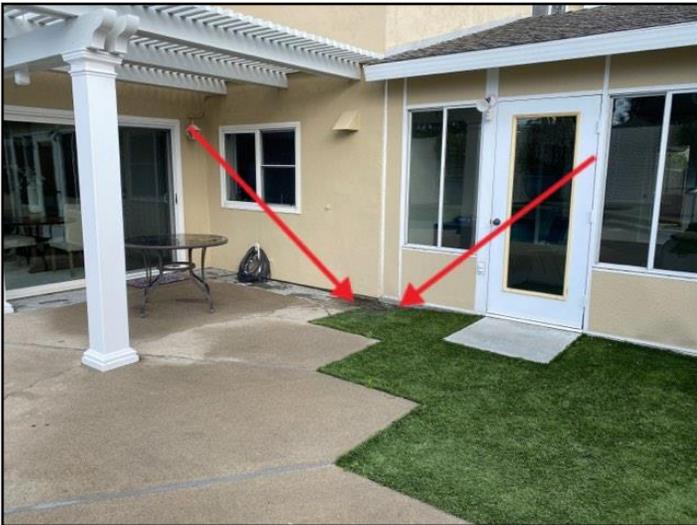
27. Improper slope or drainage

**Condition:** • [Improper slope or drainage](#)

A negative grade and lack of drainage around the foundation may allow water to collect and eventually deteriorate surfaces and lead to seepage in the foundation. It is recommended to tightly seal these areas at the base where water ponding is evident to prevent seepage.

**Task:** further evaluation

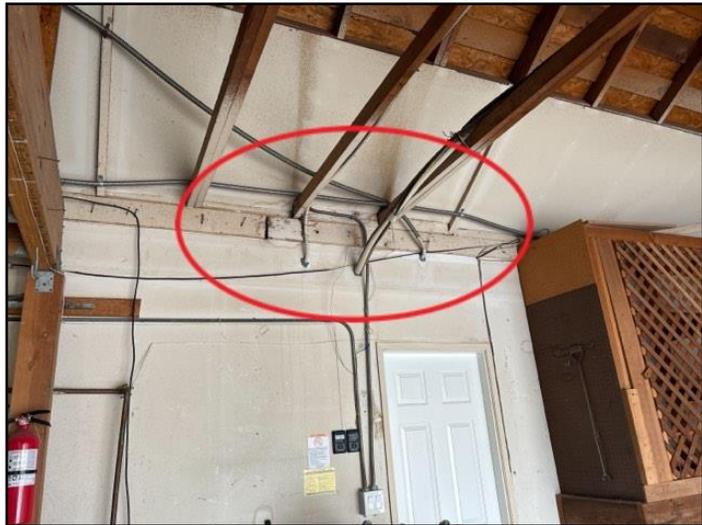
30. Water Stains

**Condition:** • Water Stains

Water stains tested dry with moisture meter at the time of inspection, however, it is recommended to monitor and inspect this area of the garage ongoing

**Task:** Monitor

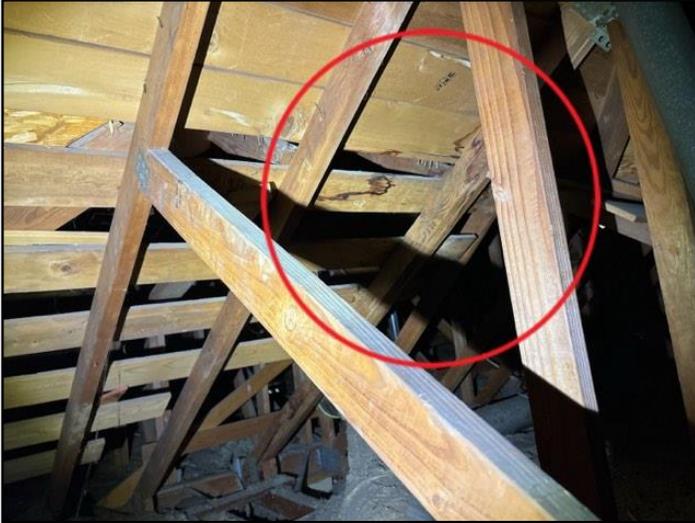
38. Water stains

**Condition:** • [Water stains](#)

There are areas of moisture stains noted. These are common in attics and may indicate past leaks.

**Task:** further evaluation

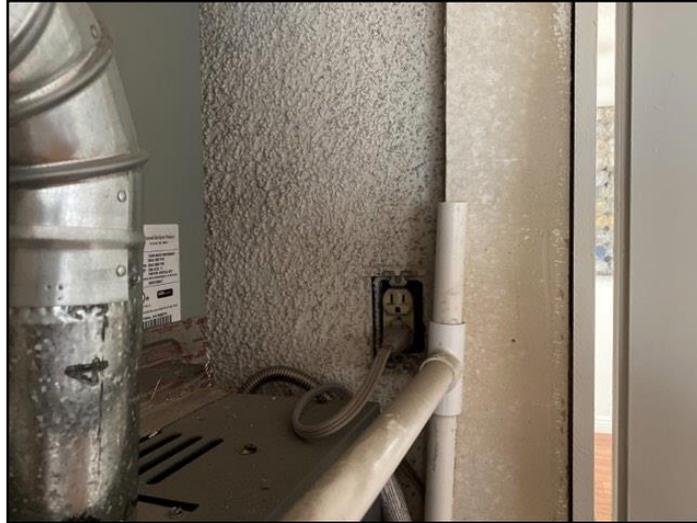
55. *Missing*

**Condition:** • [Missing](#)

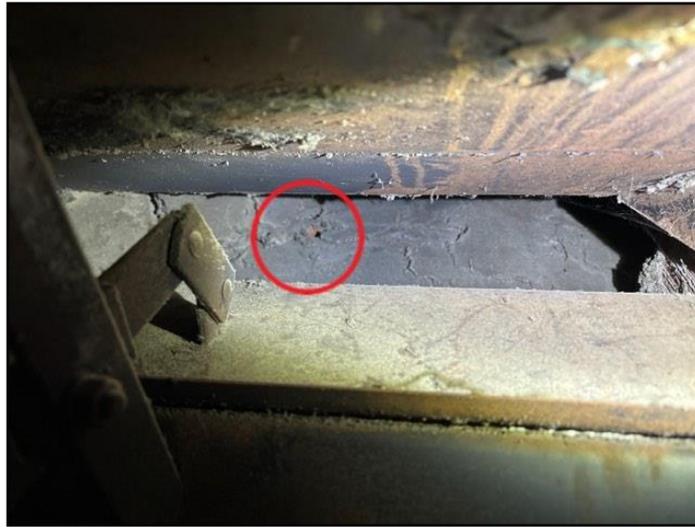
65. Loose, missing or deteriorated masonry

**Condition:** • [Loose, missing or deteriorated masonry](#)

A common repair for deteriorated mortar joints is called repointing. In this process, the existing mortar joint is cut to an appropriate depth and the joint is repacked with new mortar.

**Task:** Repair

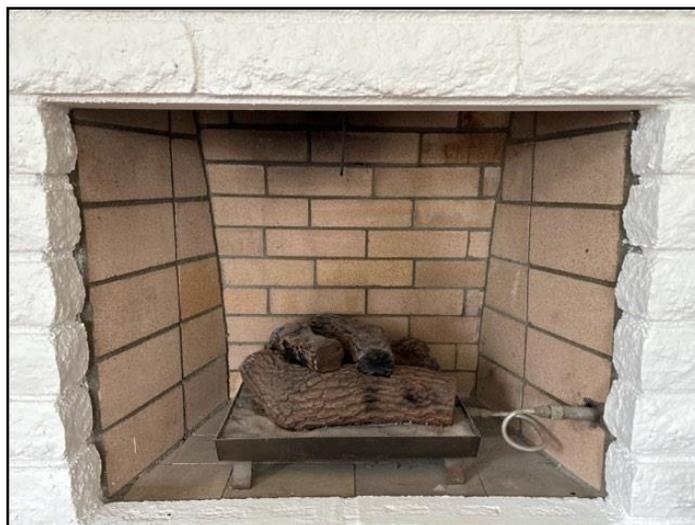
66. Missing/ damaged spark screen

**Condition:** • Missing/ damaged spark screen

A spark screen serves as a safety measure to prevent sparks or embers from escaping the firebox and potentially causing a fire hazard. It helps contain the fire within the designated area while still allowing air circulation for proper combustion. Additionally, a spark screen can also protect nearby flammable materials or structures from heat damage. Overall, it's a safety feature to minimize the risk of accidental fires and maintain a controlled environment during combustion.

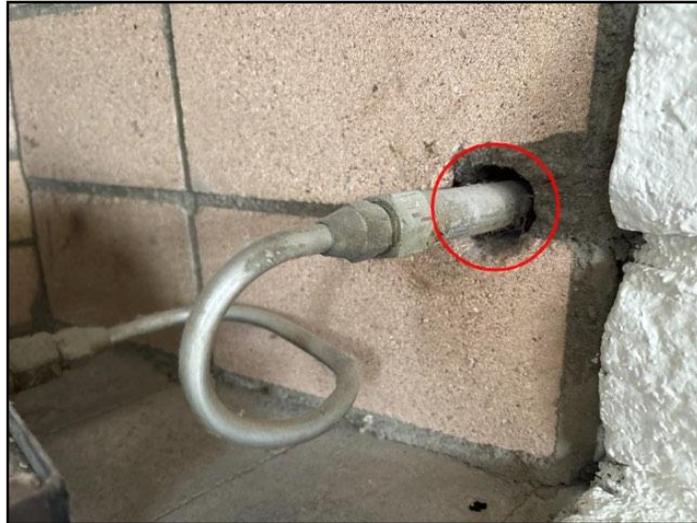
**67.** *Inadequate seal at firebox wall or floor*

**Condition:** • [Inadequate seal at firebox wall or floor](#)

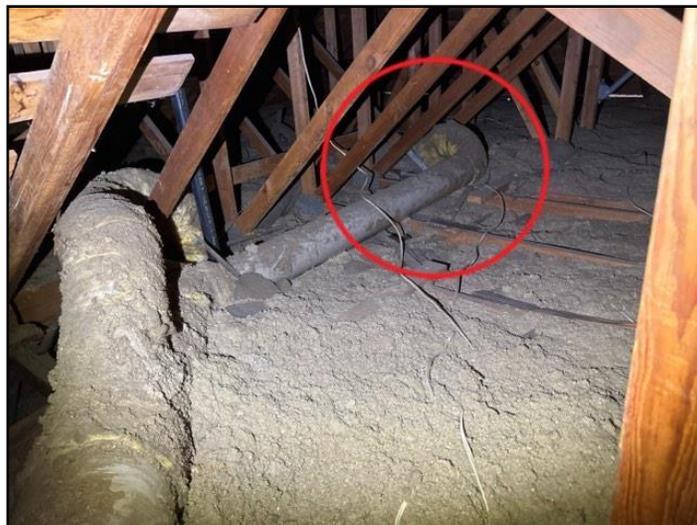
75. Disconnected or leaking

**Condition:** • [Disconnected or leaking](#)

There are areas around the ductwork that appear to be disconnected. It is recommended to repair all ductwork to avoid air leakage, insufficient heating/cooling and uneven airflow. An HVAC specialist is recommended for further evaluation.

**Task:** Repair, further evaluation

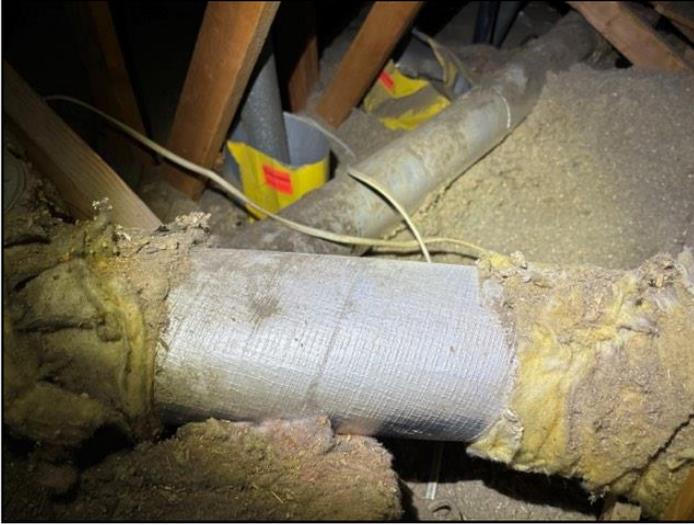
76. Possible Asbestos

**Condition:** • Asbestos

**Task:** Replace

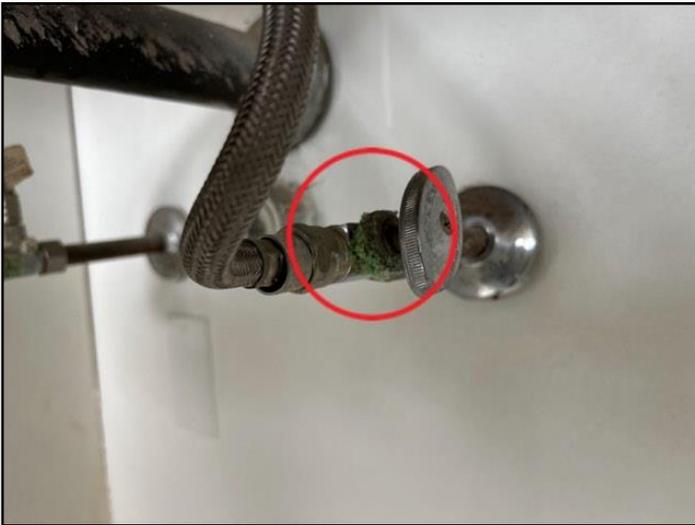
93. Corrosion

**Condition:** • Corrosion

Corrosion was noted at the water supply valves, this may lead to leaks over time. Further evaluation by a licensed plumber is recommended for servicing/correction.

**Task:** Monitor/ replace

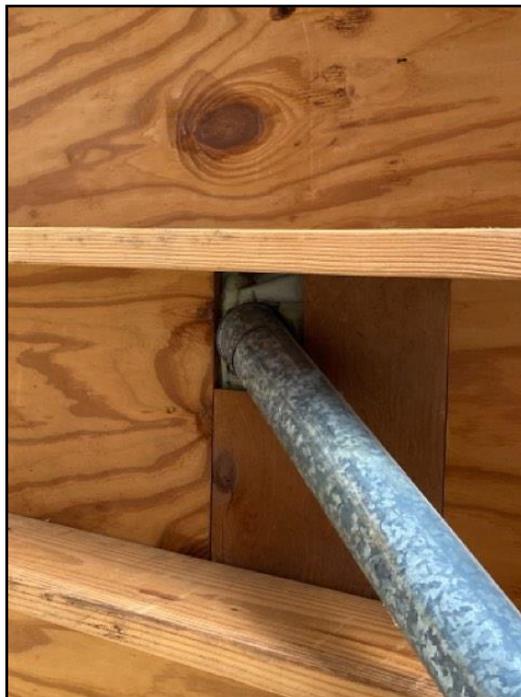
95. Inadequate

**Condition:** • [Inadequate](#)

A single wall vent should have a 6" clearance for combustibles due to direct heat transfer to surrounding materials that may increase the risk of fires hazards, this is correctable by adapting a double wall B vent that only requires a one inch clearance when venting through confined areas.

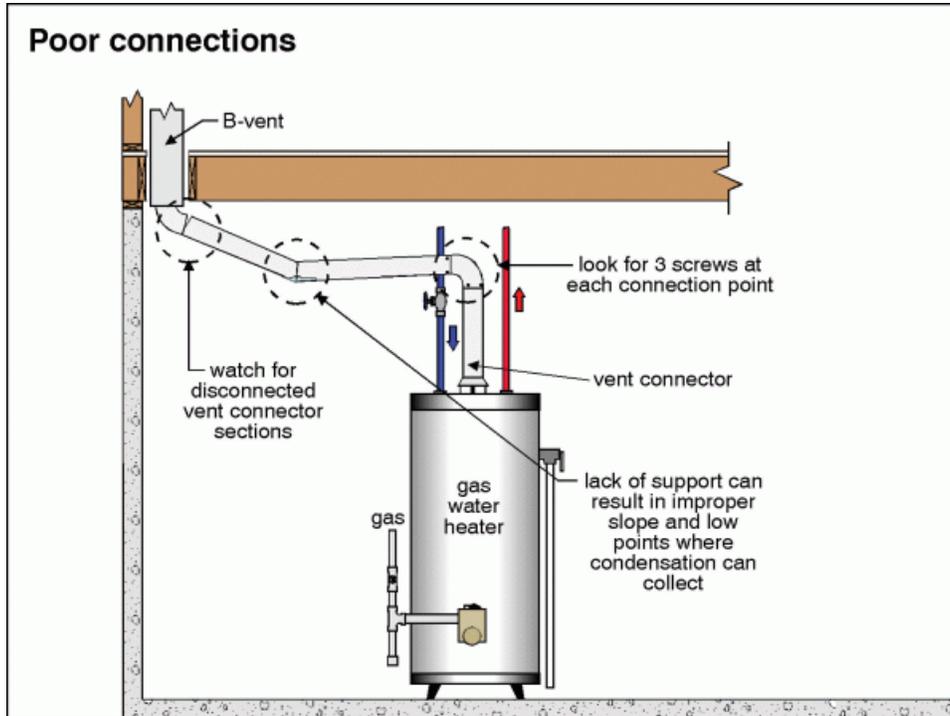
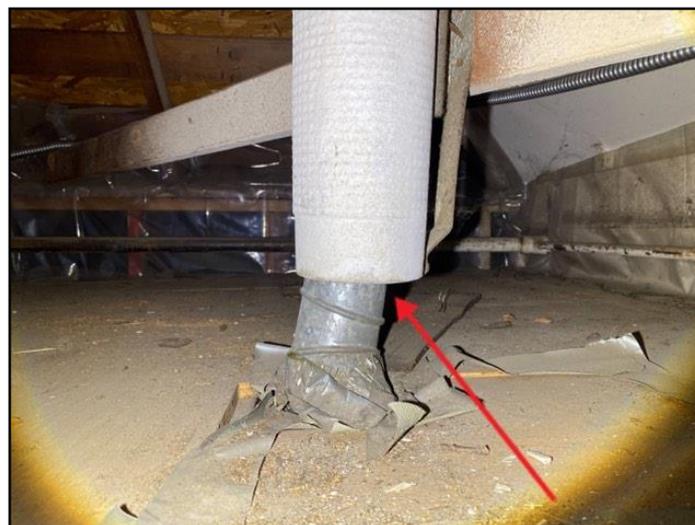
96. Poor connections

**Condition:** • [Poor connections](#)

There are gaps or loose connections at vent exhaust piping- potential for carbon monoxide to leak.

**Task:** Repair

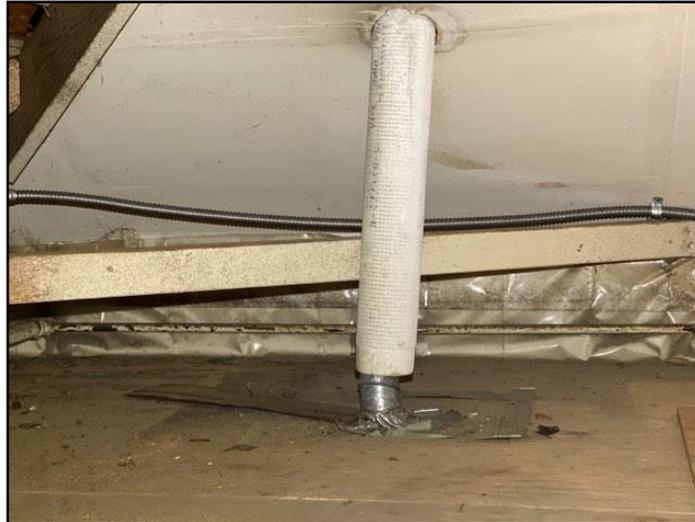
97. Improper material

**Condition:** • [Improper material](#)

**Task:** Service Upgrade

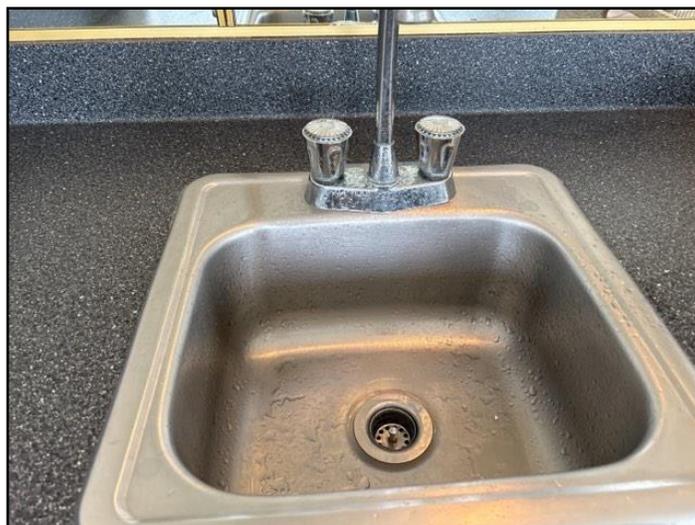
98. Stiff or inoperative

**Condition:** • [Stiff or inoperative](#)

**Task:** Repair

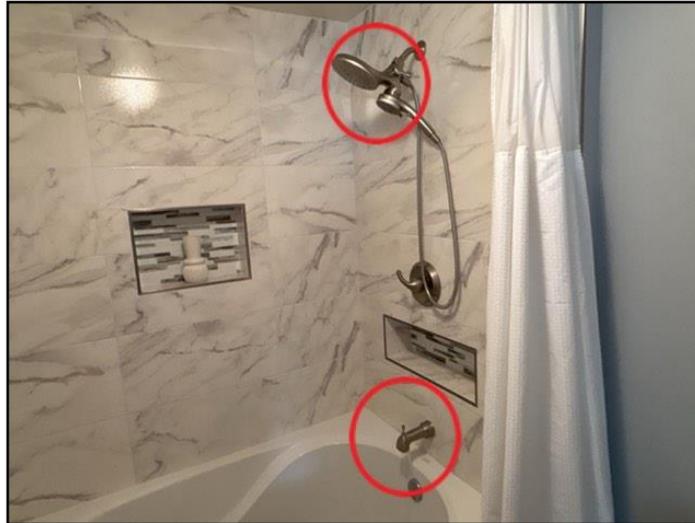
99. Shower diverter inoperative or defective

**Condition:** • [Shower diverter inoperative or defective](#)

**Task:** Repair

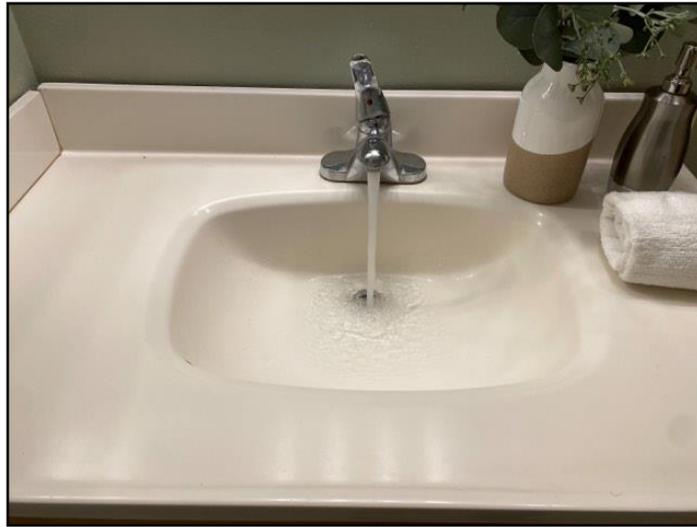
100. *Slow drains*

**Condition:** • [Slow drains](#)

A variety of issues can cause a slow running drain in a bathroom sink. Strands of hair, a buildup of soap scum and larger bits of debris can catch onto drain parts to create a mass over time that blocks the drain flow.

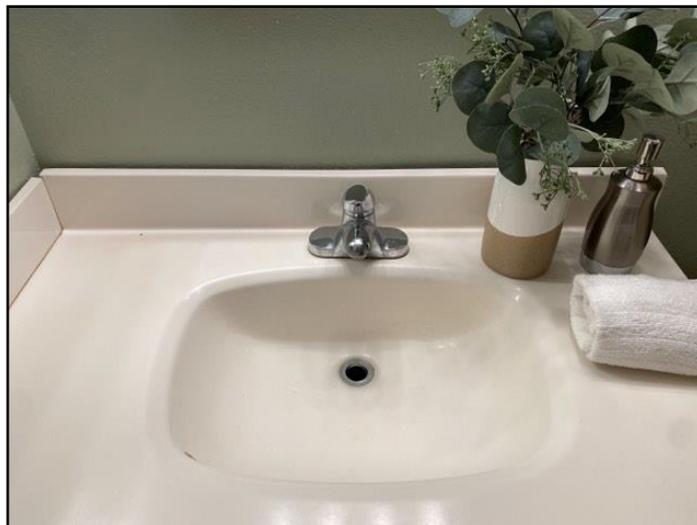
101. *Drain stop missing*

**Condition:** • Drain stop missing

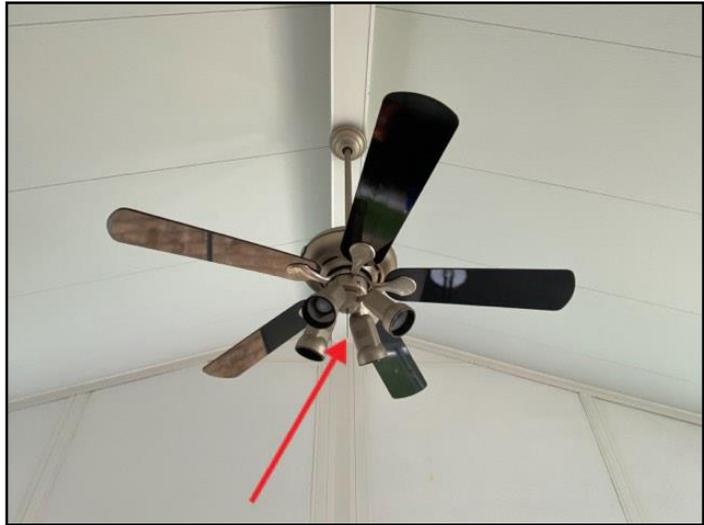
113.

**Condition:** • Fan string is damaged  
The fan/lights were not operated due to the fan strings being out of reach  
**Location:** Sunroom  
**Task:** Repair  
**Time:** As soon as practical  
**Cost:** minor

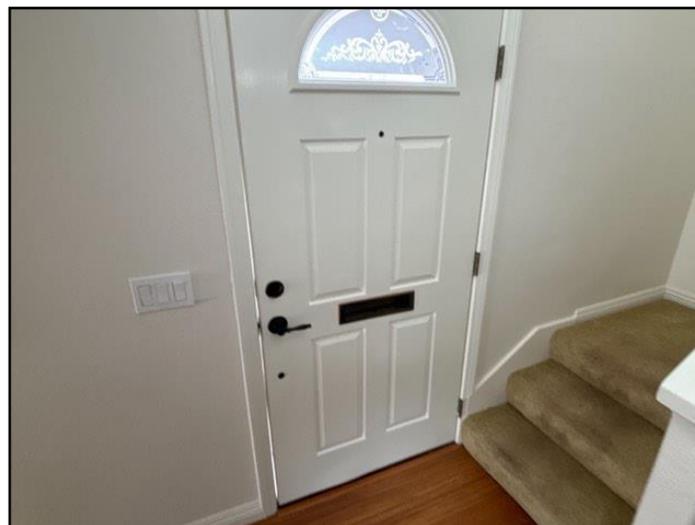
116. *Weatherstripping missing or ineffective*

**Condition:** • [Weatherstripping missing or ineffective](#)

Door has air gaps due to Weather stripping failure and will continue adding air/moisture to enter home if not corrected.

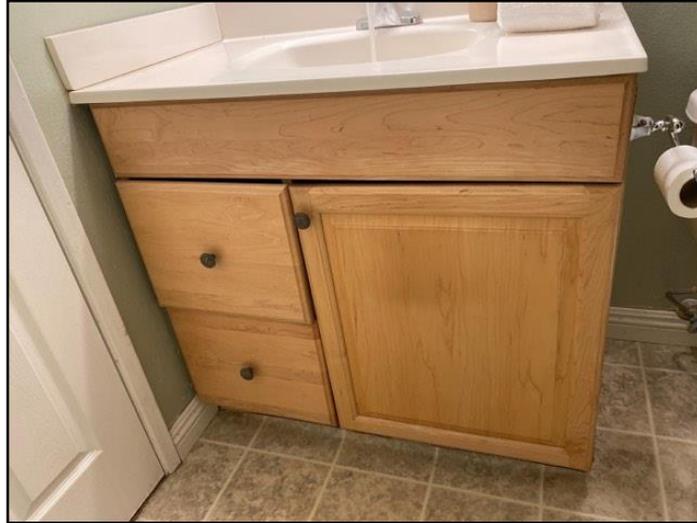
117. Drawers - missing or defective stops

**Condition:** • [Drawers - missing or defective stops](#)

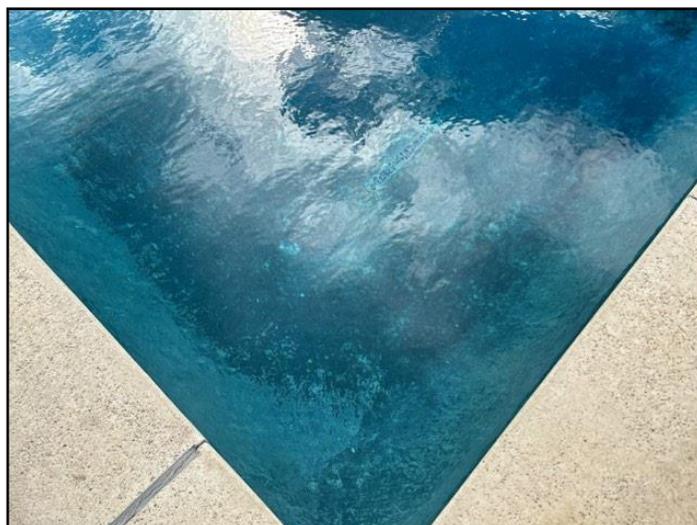
125. Surface defects noted

**Condition:** • Surface defects noted

If the pool bottom surface has minor cracks or is deteriorating, it may need to be patched or resurfaced. This involves filling in the cracks with appropriate materials such as epoxy or plaster, or completely resurfacing the bottom with a new layer of material like plaster, fiberglass, or vinyl. The specific repair needed depends on the extent of the damage and the type of pool surface. It's advisable to consult a professional pool technician for an accurate assessment and appropriate repair solution.

**Task:** Repair

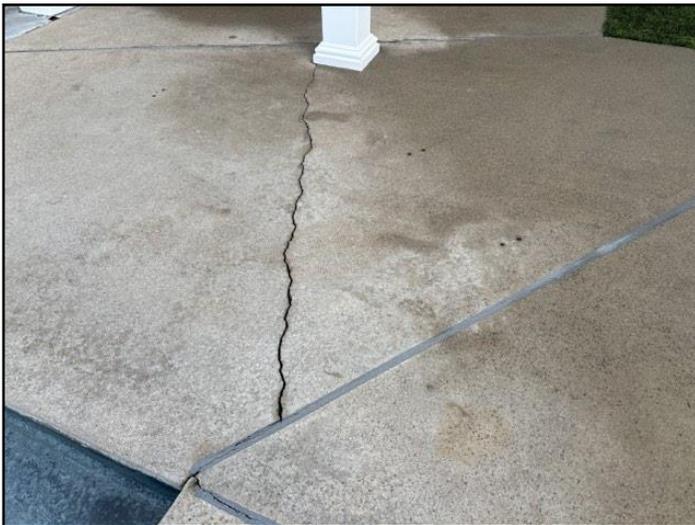
129. Major cracks

**Condition:** • Major cracks

Recommend repairs to avoid physical injury

**Task:** Repair

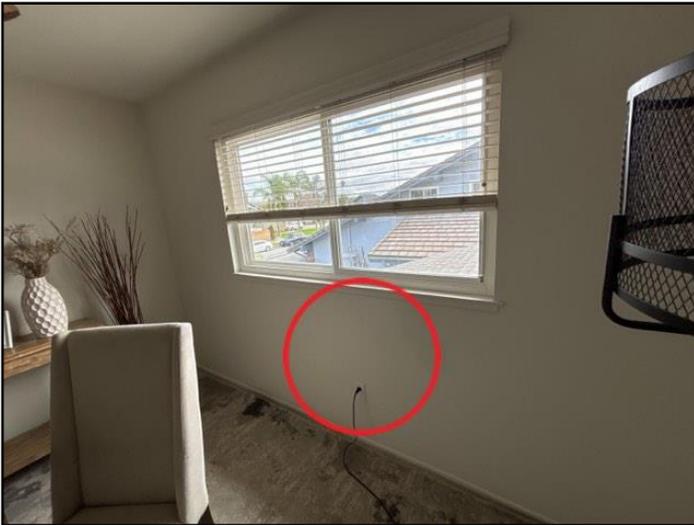
131. Moisture detected with moisture meter

**Condition:** • Moisture detected with moisture meter

**Task:** Repair , further evaluation

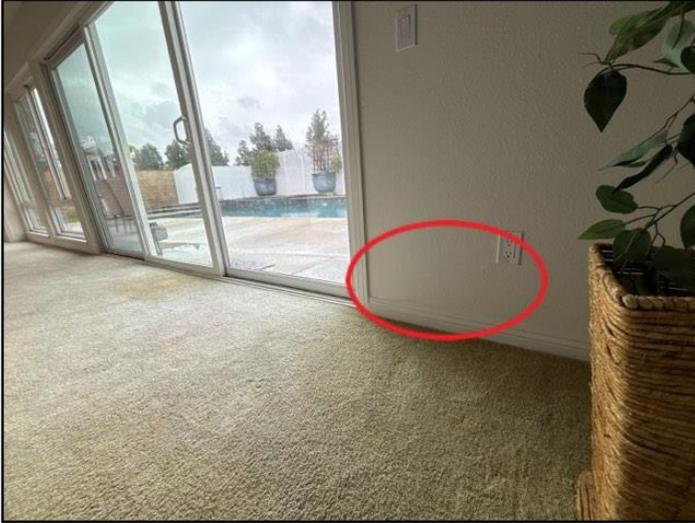
134. Moisture detected with moisture meter

**Condition:** • Moisture detected with moisture meter

It is recommended to waterproof the exterior walls and have area further evaluated by a qualified specialist
