INSPECTION REPORT

For the Property at:
A STREET
SOME CITY, CO 80138

Prepared for: A HOME BUYER
Inspection Date: Saturday, September 23, 2017
Prepared by: David Kidston

RE: Report No. 1115, v.5
A Street
Some City, CO
80138

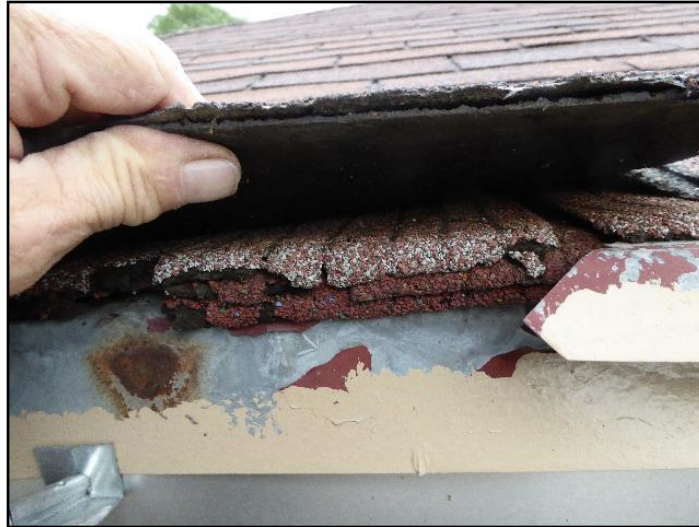
Condition: • Roof is beyond it's life expectancy, weather damaged

General: • 3 Layers

1. 3 layers, Old worn out

Task: Remove and replace entire roof

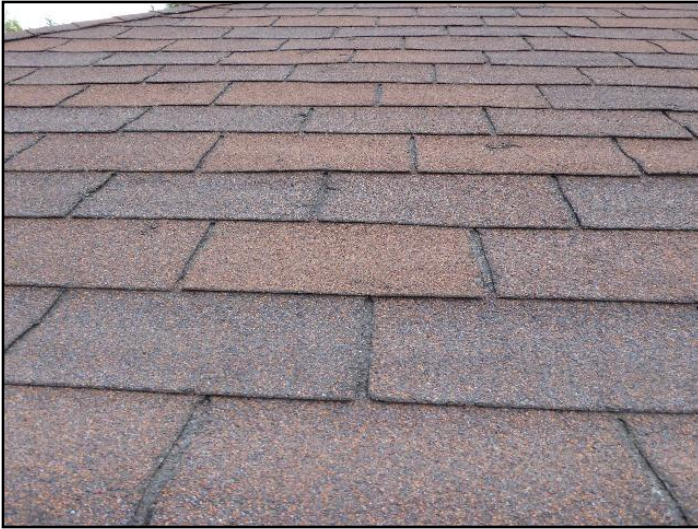
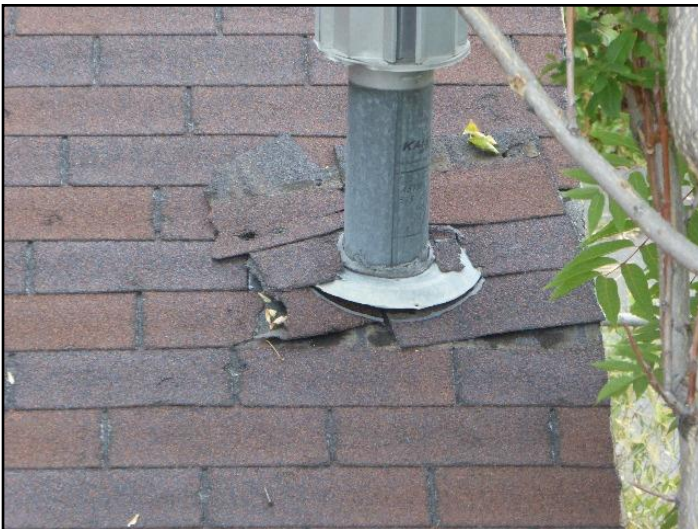
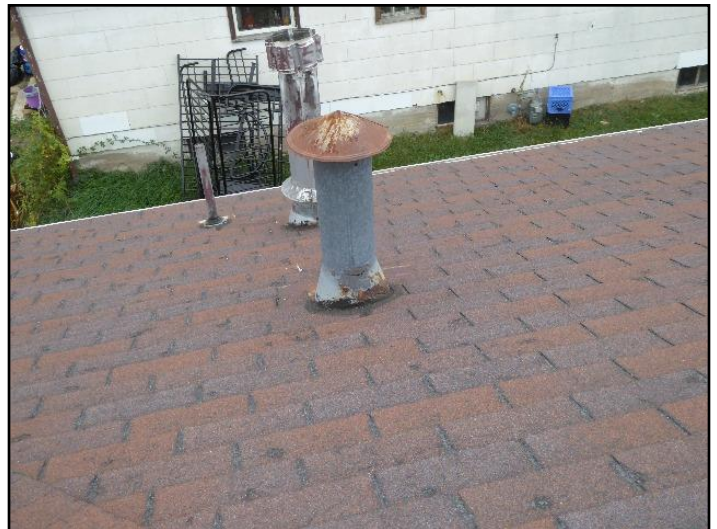
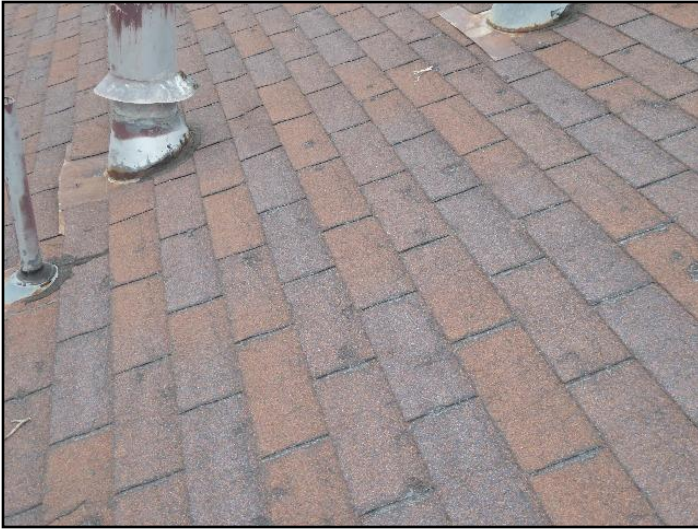
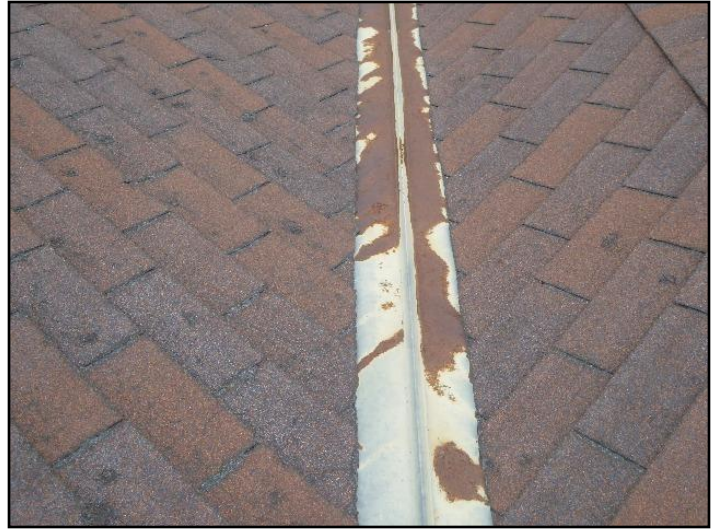
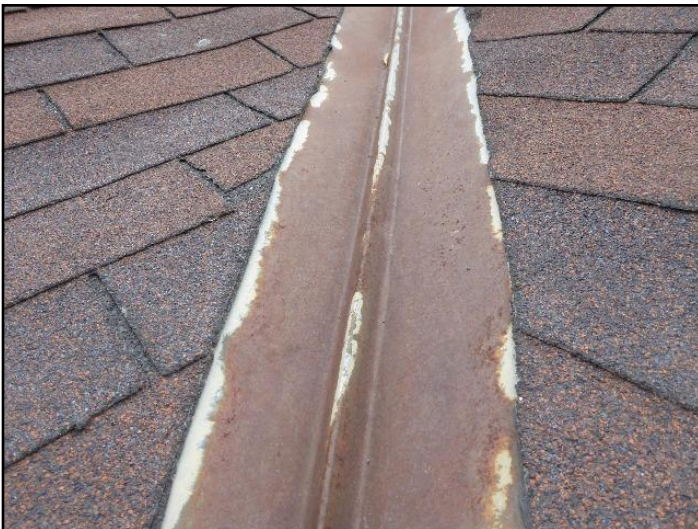
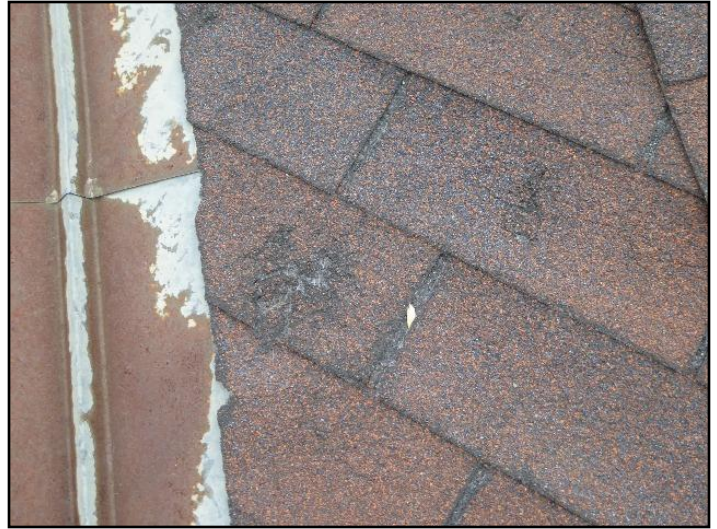
3. **Condition:** • [Old, worn out](#)

2. Old, worn out

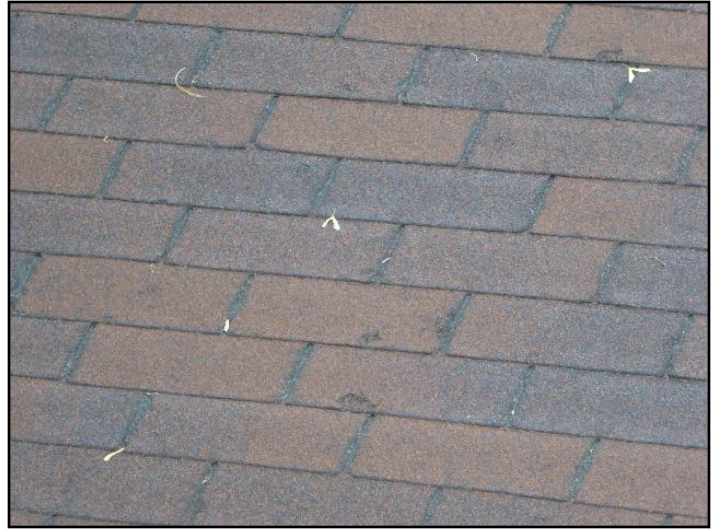
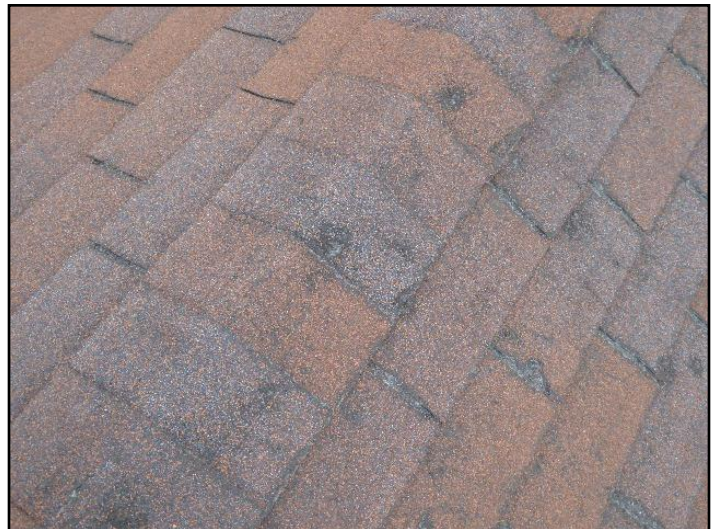
2. **Condition:** • Roof is beyond it's life expectancy, weather damaged

3. Old, worn out, weather damaged

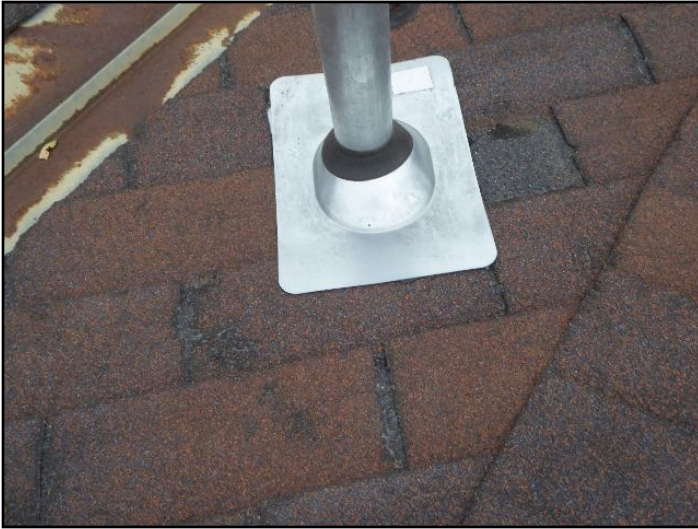
10. Improper flashing installation

4. Condition: • Replace when reroofing

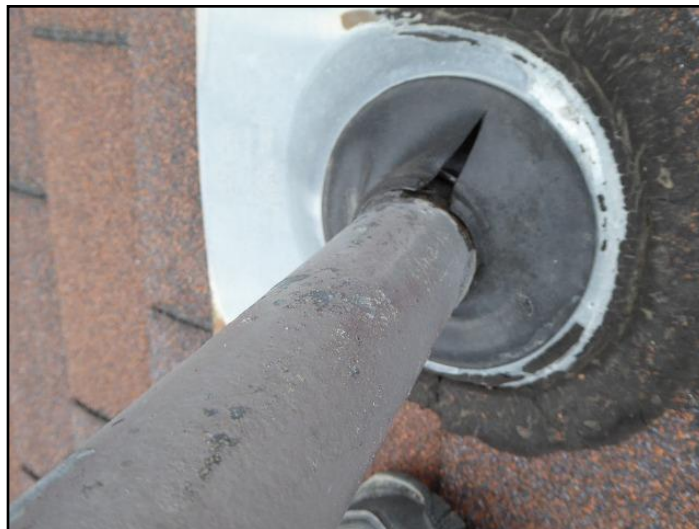
5. Condition: • Gap in rubber seal

12. Cracked boot seal

Task: Replace/seal rubber boot

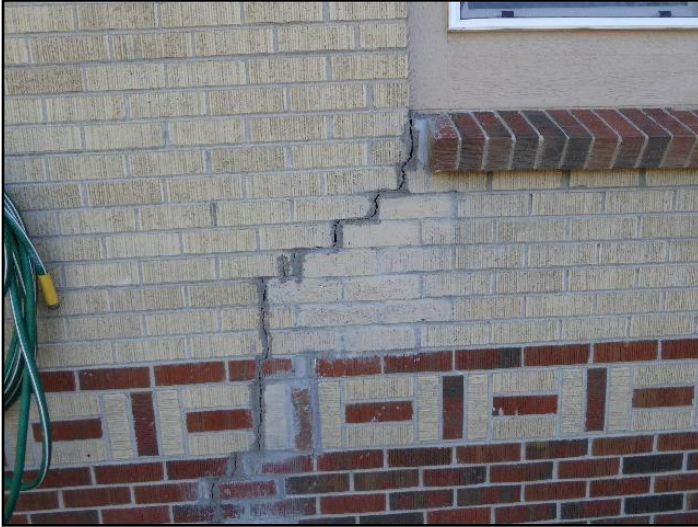
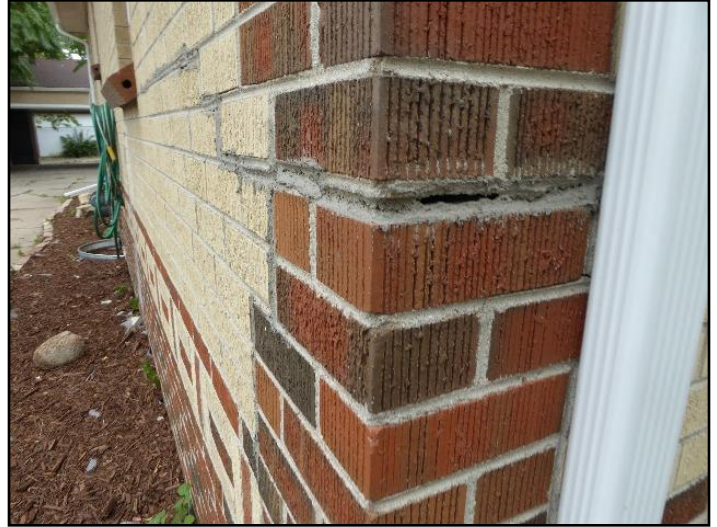
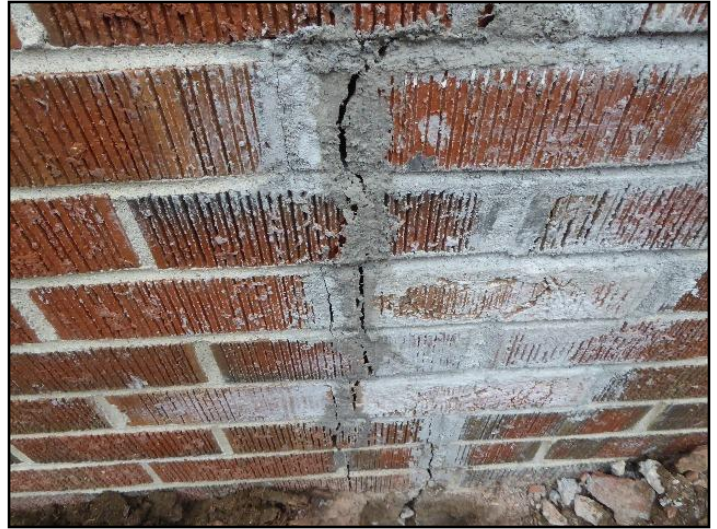
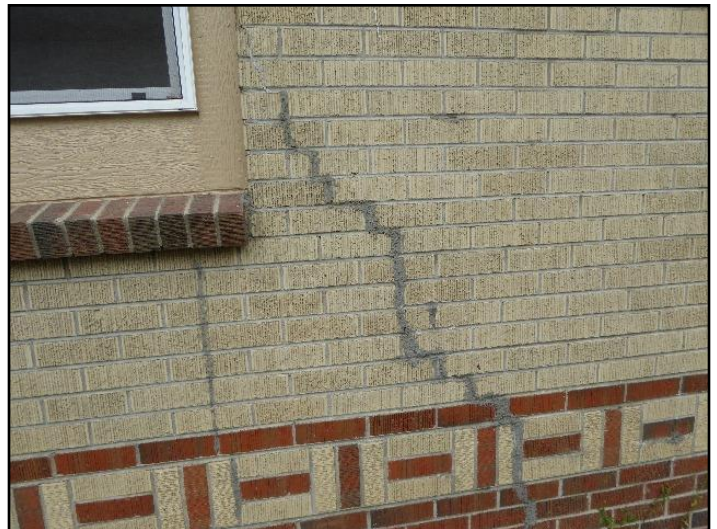
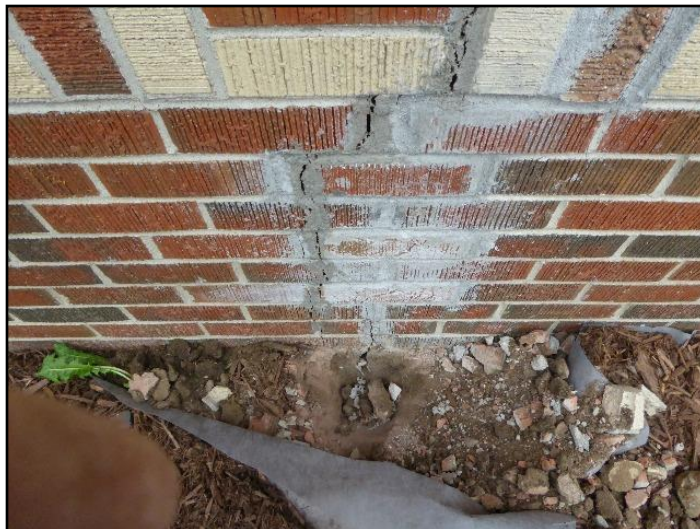
Step cracking from settling

17. Settling cracks

Task: Tuck point as needed

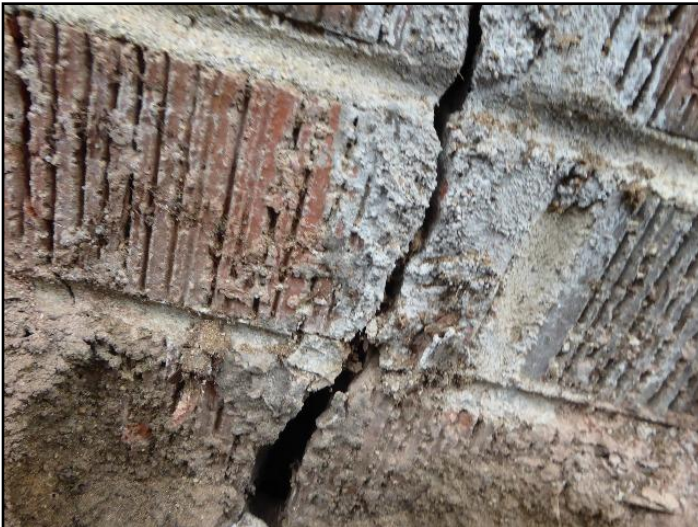
19. Cracks below grade

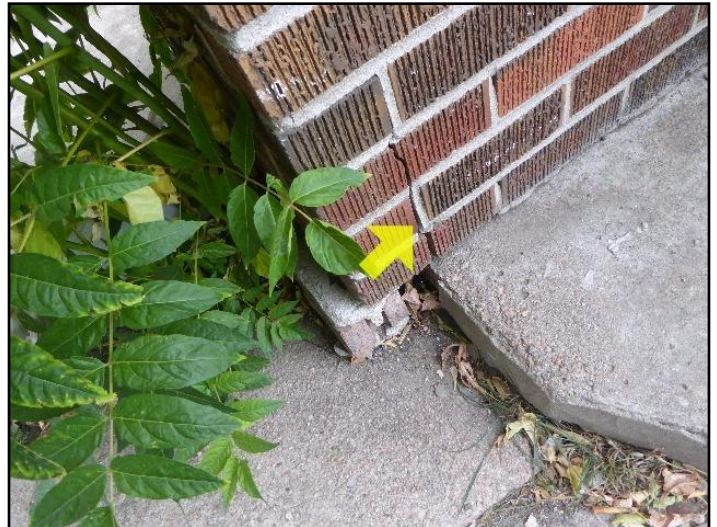
20. Cracks

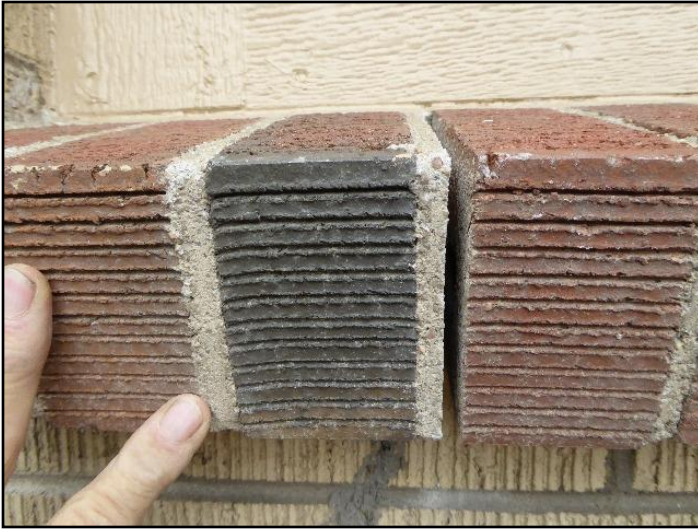
21. Movement

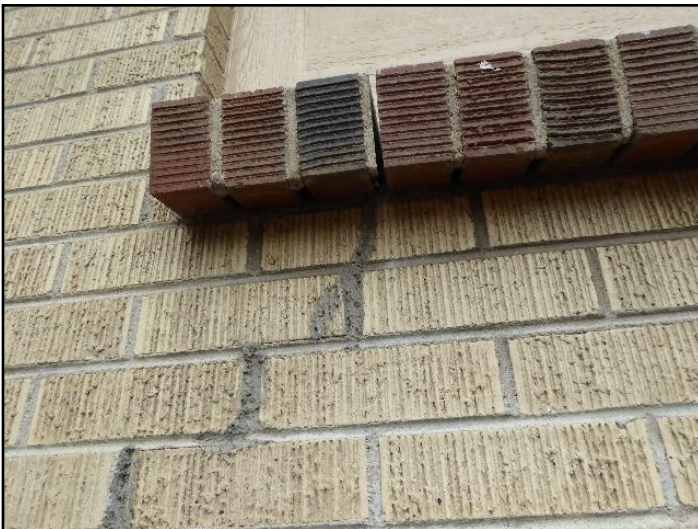
6. Condition: • [Masonry deterioration](#)

23. Masonry deterioration

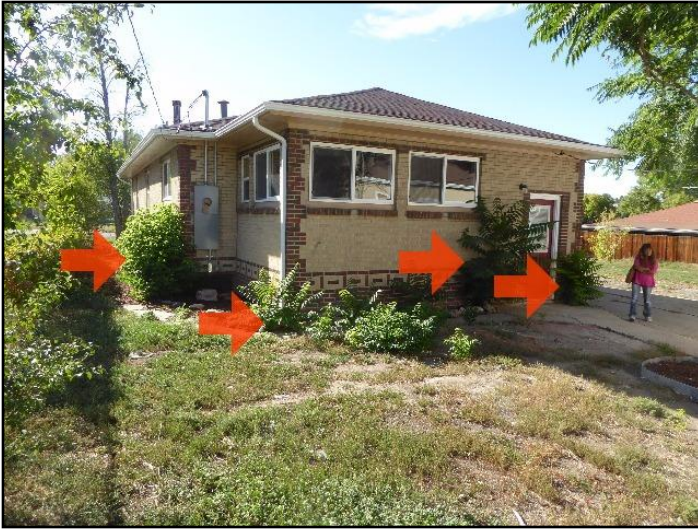
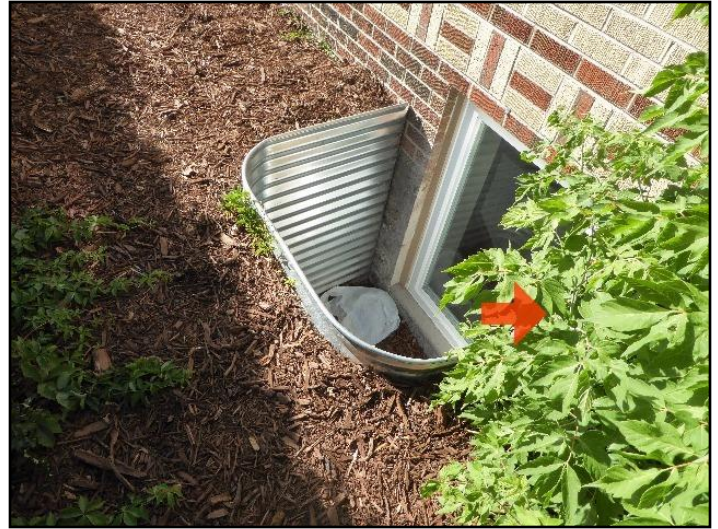
7. Condition: • [Trees or shrubs too close to building](#)

Implication(s): Chance of water damage to contents, finishes and/or structure | Chance of pests entering building | Material deterioration

26. Trees or shrubs too close to building

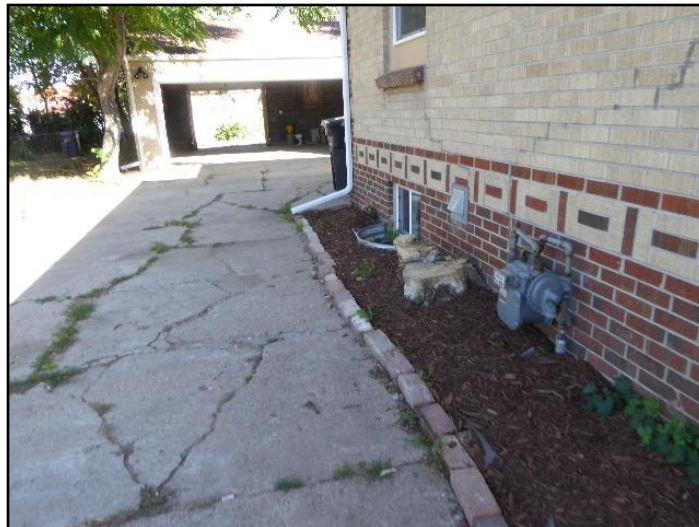
Old driveway

28. Cracked or damaged surfaces

Task: Replace as desired

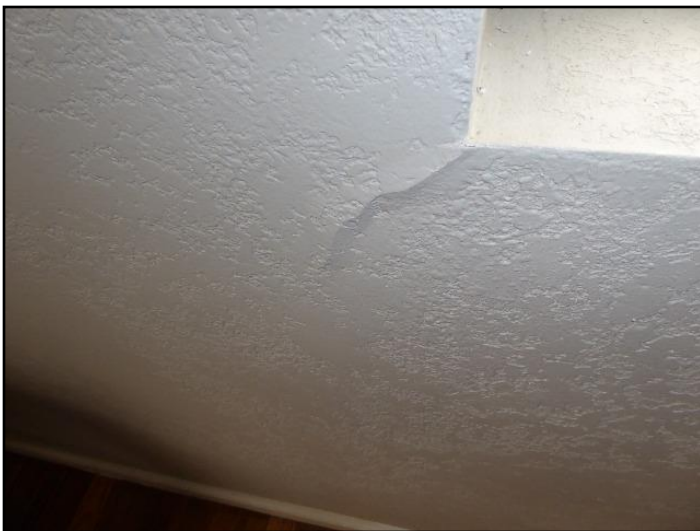
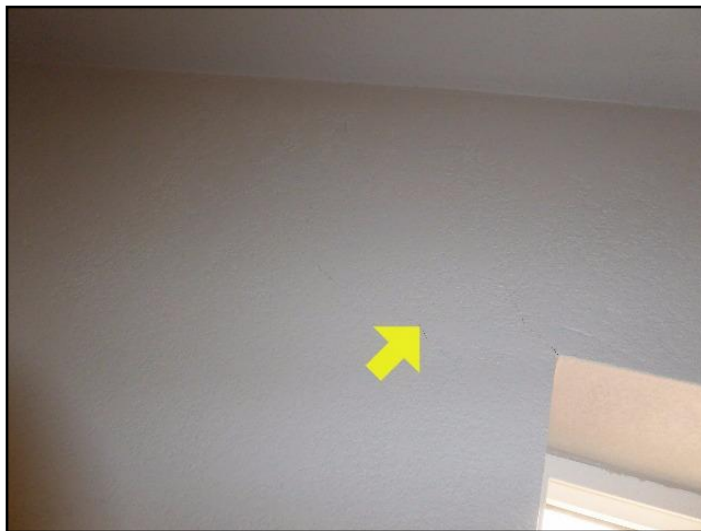
Old home typical settling. Step cracks in exterior brick. Drywall cracks in N/W bedroom. Recent settling cracks in interior drywall N/W bedroom

29. Settled

30. Settling cracks in drywall

Task: Monitor and repair as needed

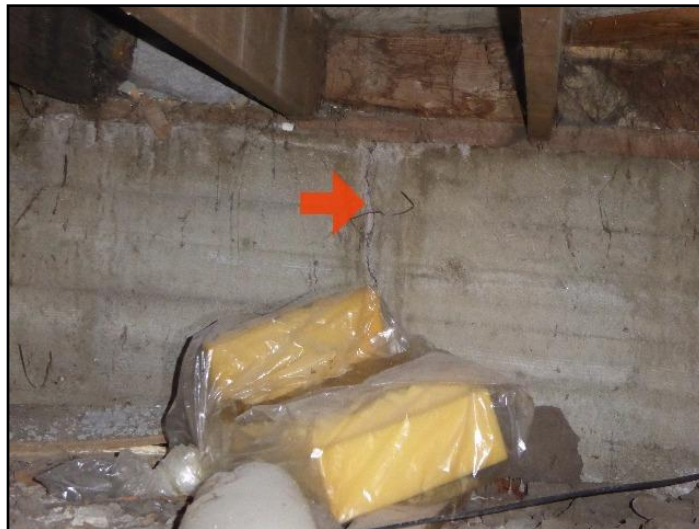
12. Condition: • [Cracked](#)

31. Cracked

Patching and repairs were accomplished but gaps and cracks in mortar have continued

Task: Repair

Task: Have a structural engineer inspect the foundation and make recommendations.

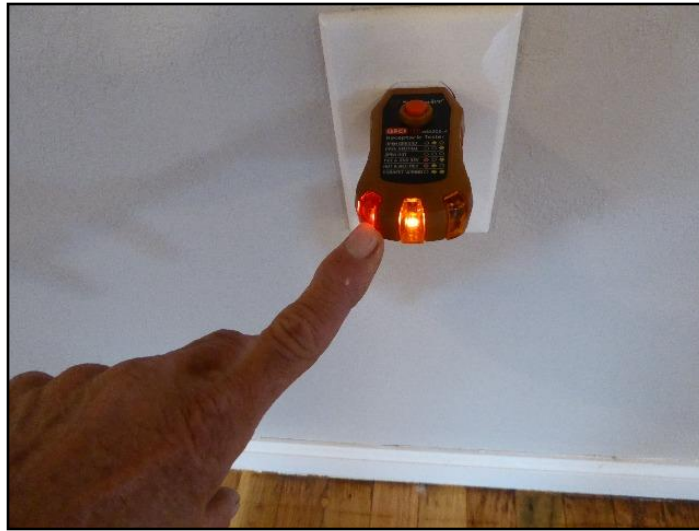
15. Condition: • [Reversed polarity](#)

33. Reversed polarity

Task: Have a licensed electrician correct as needed

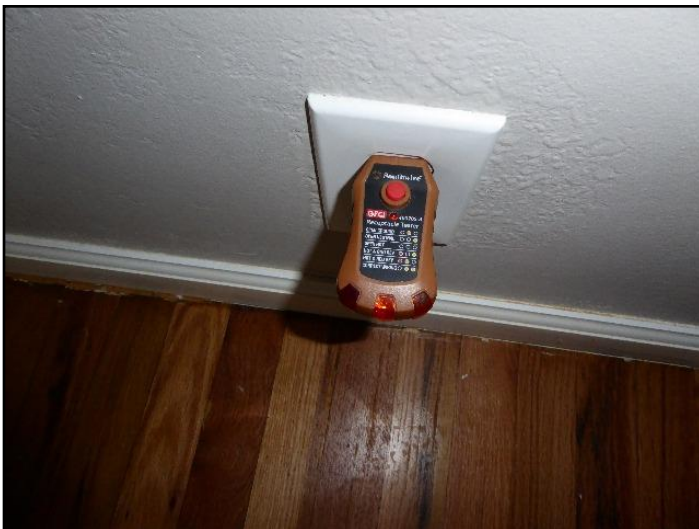
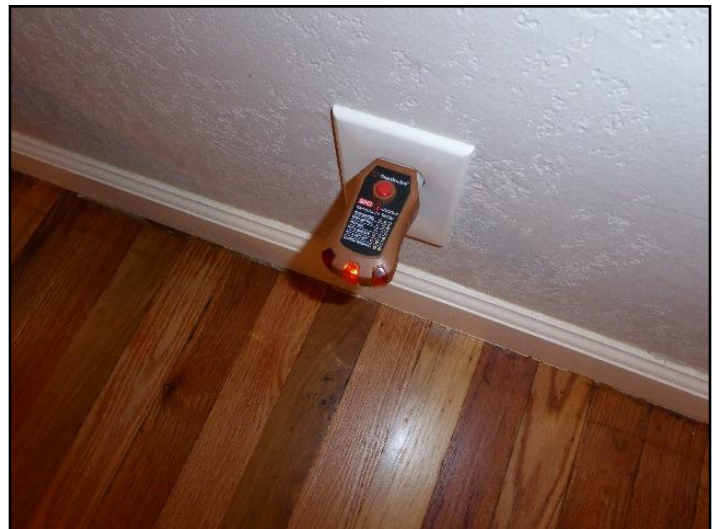
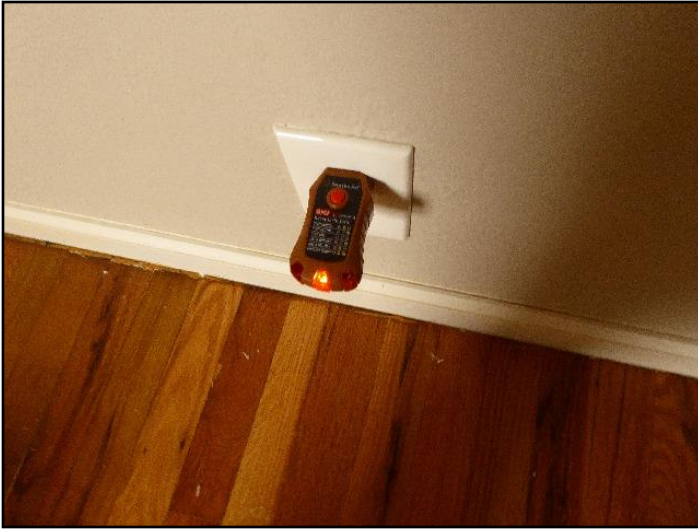
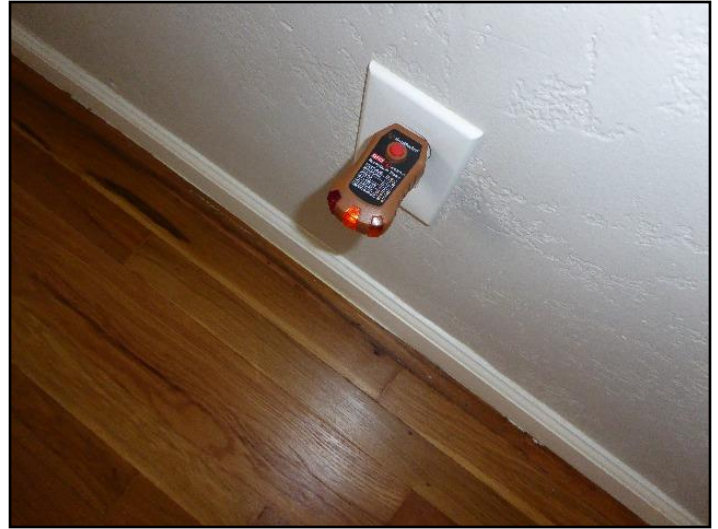
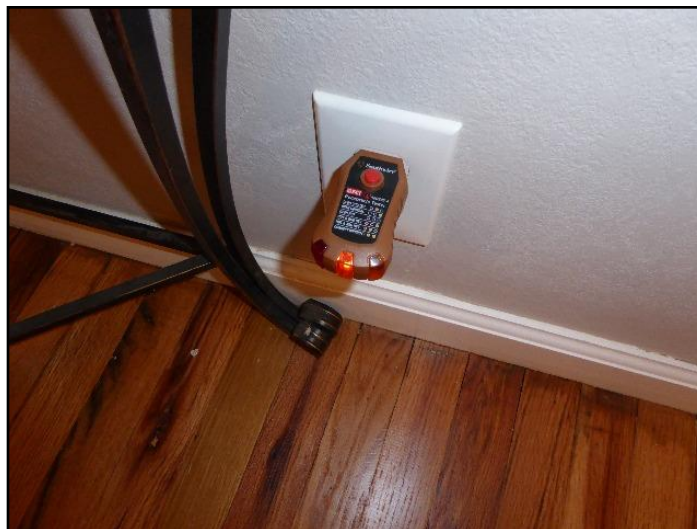
16. Condition: • [Ground needed for 3-slot outlet](#)

34. Ground needed for 3-slot outlet

Task: Have an electrician correct as needed

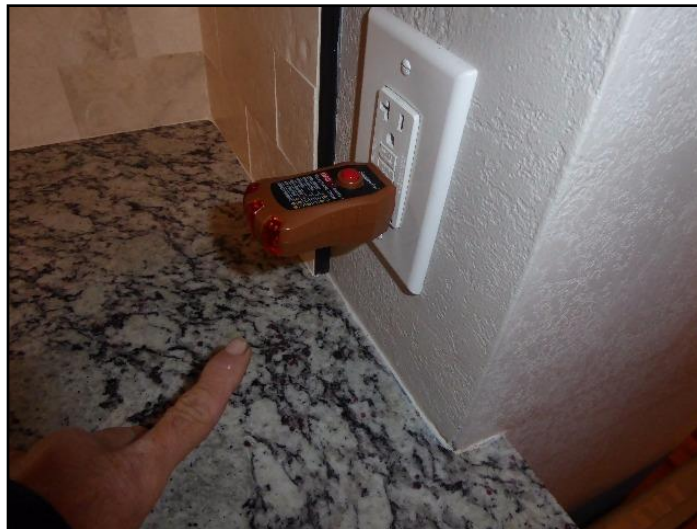
17. Condition: • [Test faulty on GFCI/GFI \(Ground Fault Circuit Interrupter\)](#)

39. No operating

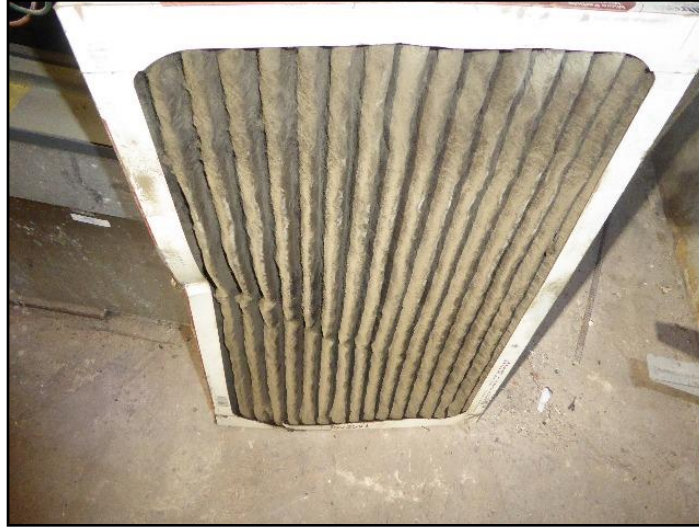
18. • Furnace filter is clogged

41. Furnace filter is clogged

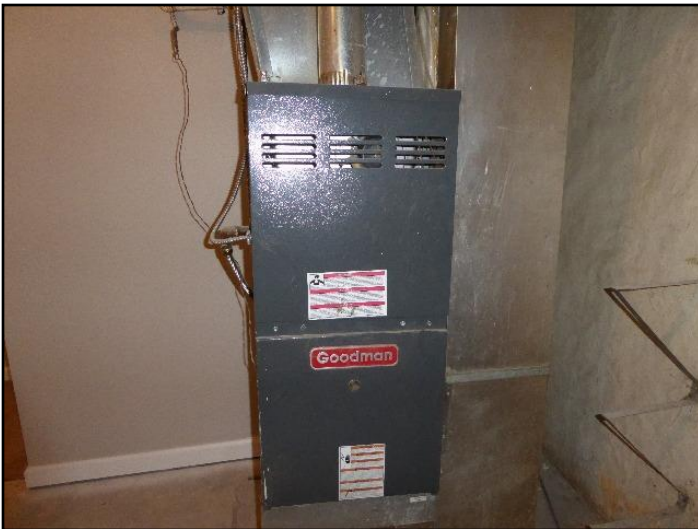
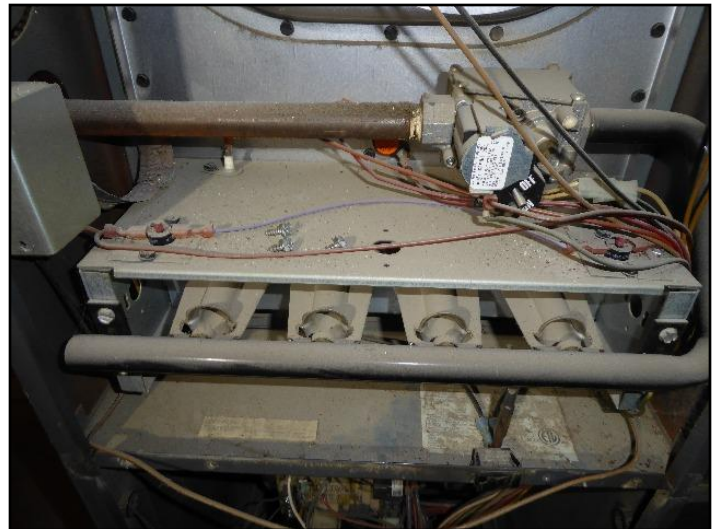
19. • Furnace was not operating at time of inspection

42. Furnace was not operating at time of...

Task: Have an HVAC tech repair as needed

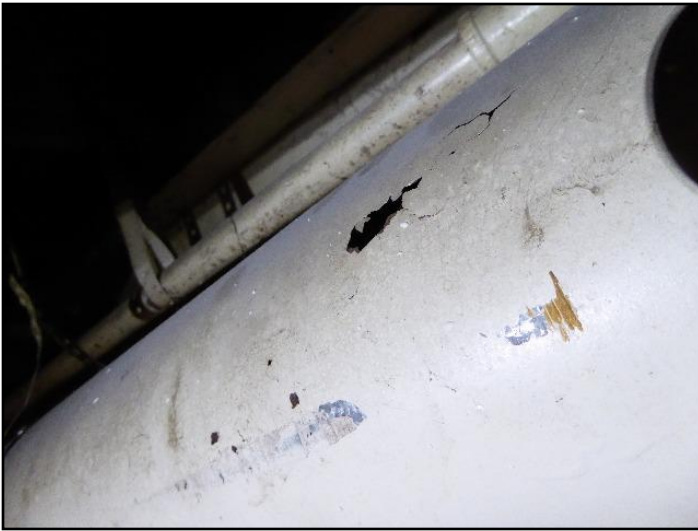
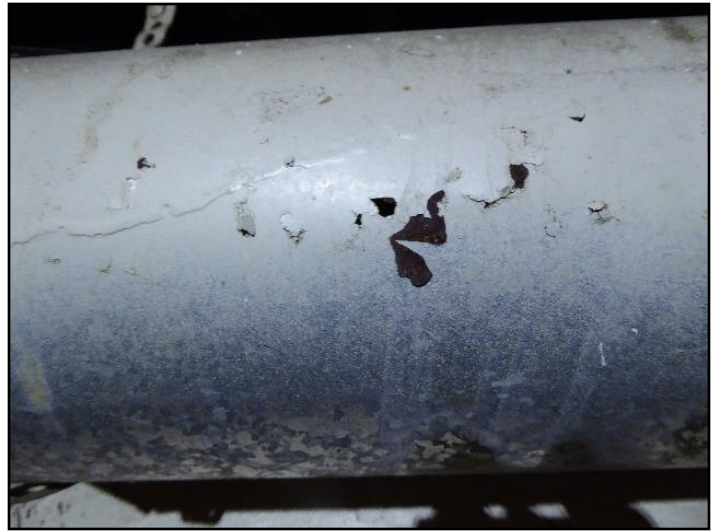
Rust holes in furnace vent pipe, safety issue

44. Safety issue. Rust holes in furnace vent pipe

Task: Replace rust damaged vent pipe

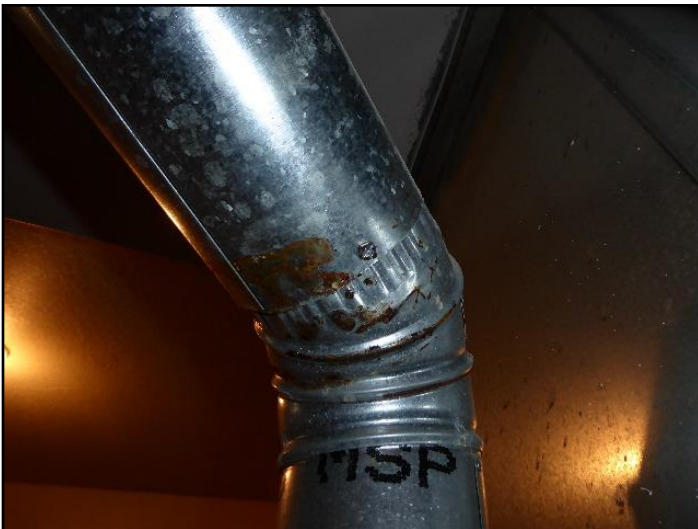
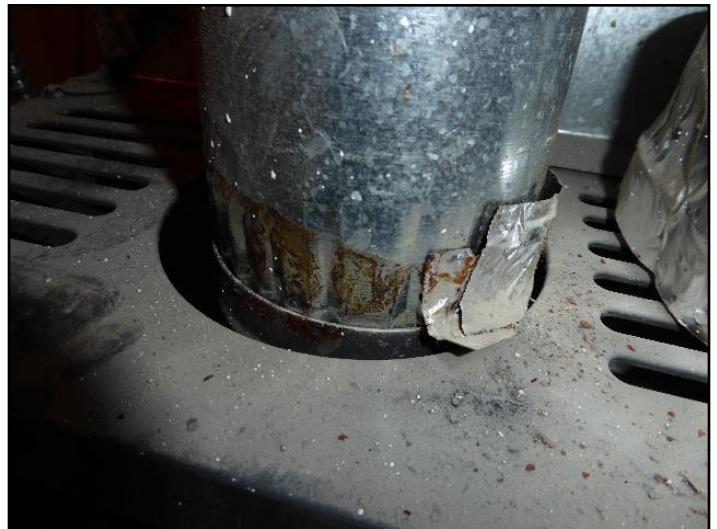
46. Poor connections

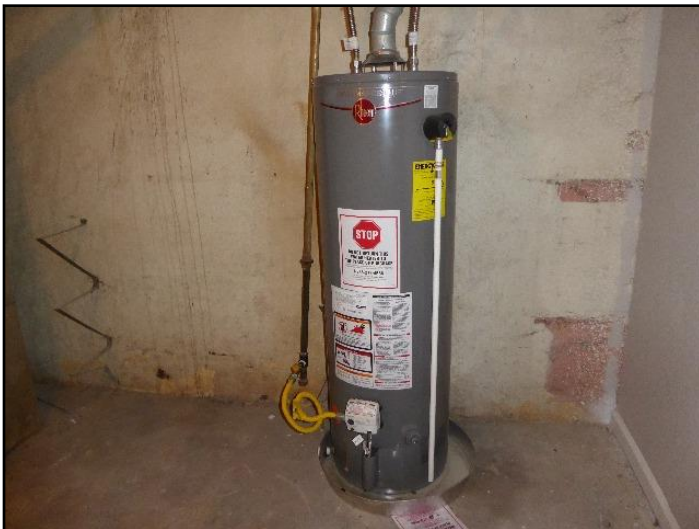
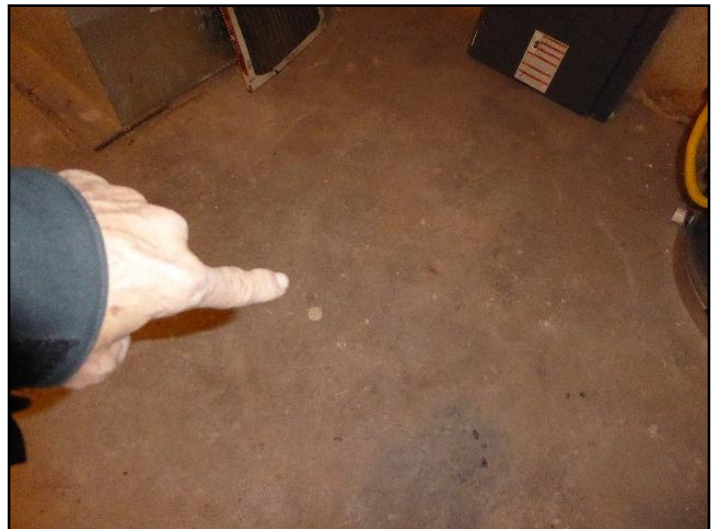
Floor drain location: • No floor drain for water heater

50. No floor drain for water heater

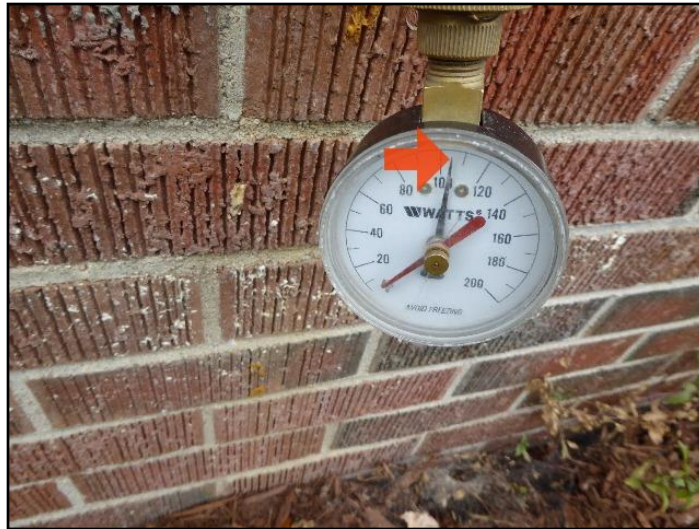
28. Condition: • Recommended due to high supply water pressure

52. Water pressure is 105 PSI

Task: Have a plumber install a pressure regulator
