YOUR INSPECTION REPORT

160 Stanley Street, Suite 28
Simcoe, ON N3Y5E6

Tuesday, February 6, 2024

Report No. 2042, v.2

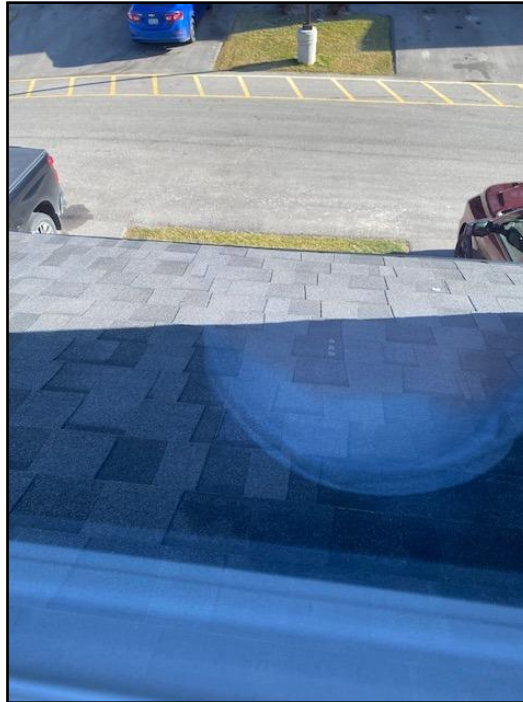
1. Composition shingles

From the ground they looked like just an asphalt shingle, but they are a fiberglass composite which is an upgrade from asphalt shingles. They are rated as a 40-year shingle. Shingles are 3 years old. No Concerns.

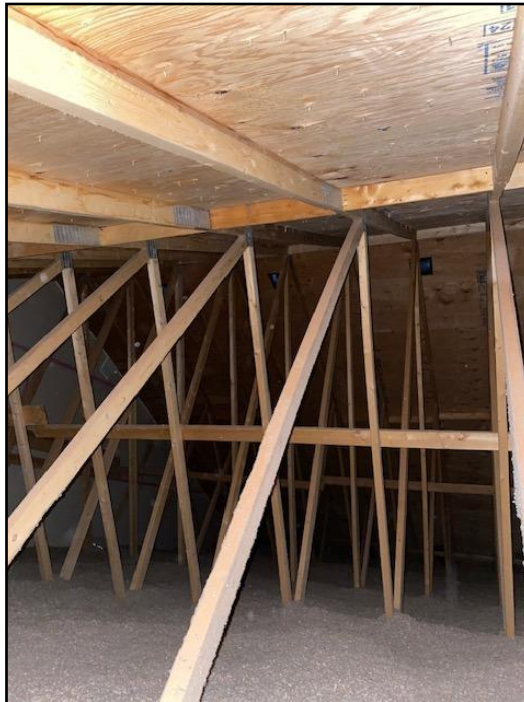
5. Plywood sheathing

Roof structure is trusses and plywood sheathing. Looks new. No Concerns.

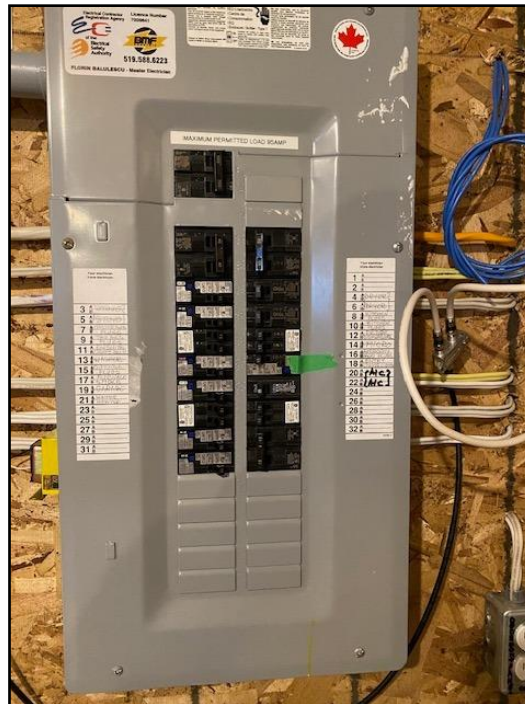
7. Breakers - basement

- Breakers - basement
- Panel is labelled. No Concerns.

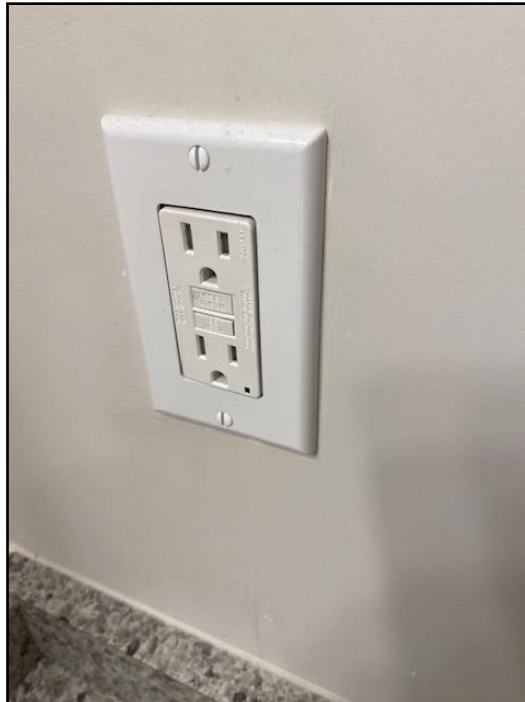
8. GFCI - bathroom and exterior

There are GFCI outlets at exterior, bathroom, washroom and kitchen. If you lose power at back exterior outlet, go to front and press reset on GFCI outlet. In main bathroom if you lose power, go to Ensuite and press reset on that outlet.

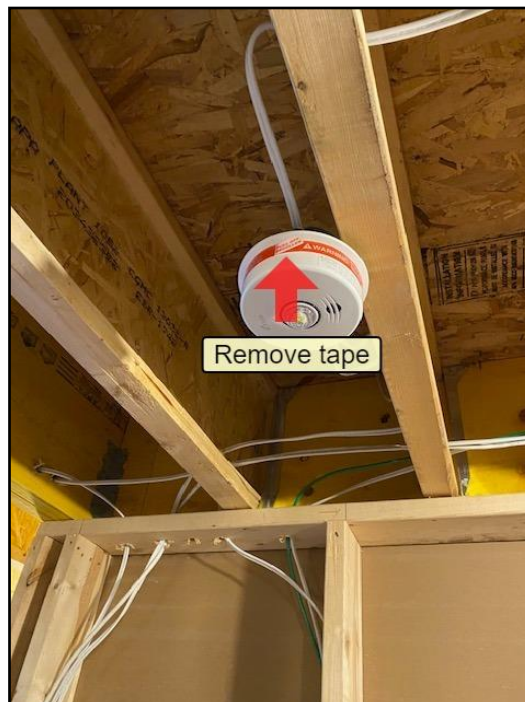
9. Combination type (photoelectric and...

Basement detector needs tape removed so if it went off you could hear it.

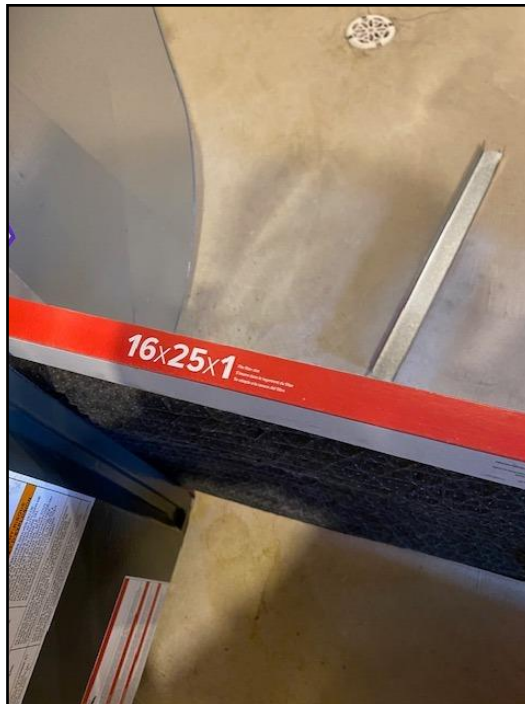
10. Furnace filter

General: • Needs to be changed and arrow on filter needs to point towards furnace.

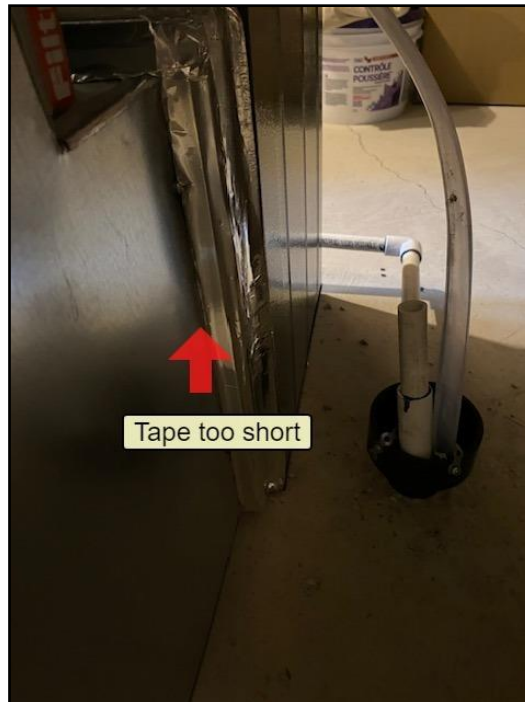
11. Ducts and registers

When furnace is running it has a slight noise from air going around the tape. Need another piece of metal tape. Roll of tape is under \$20.00

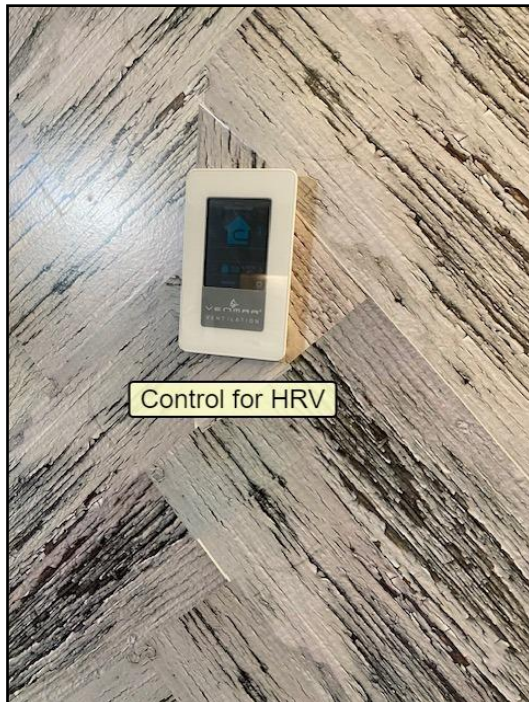
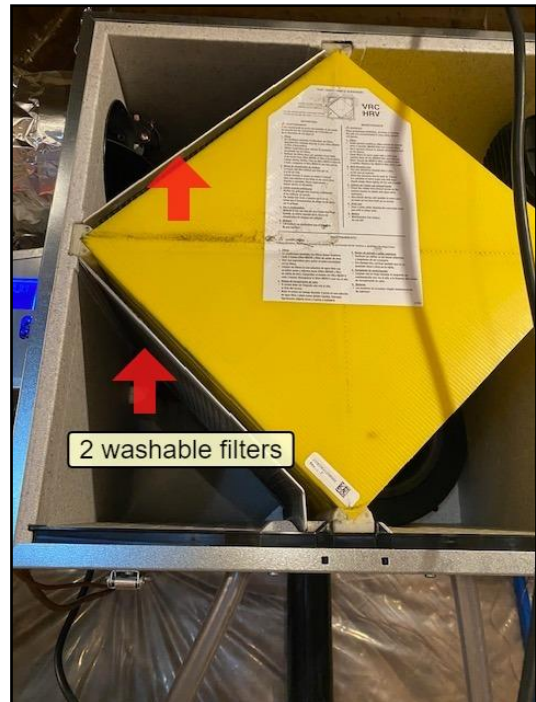
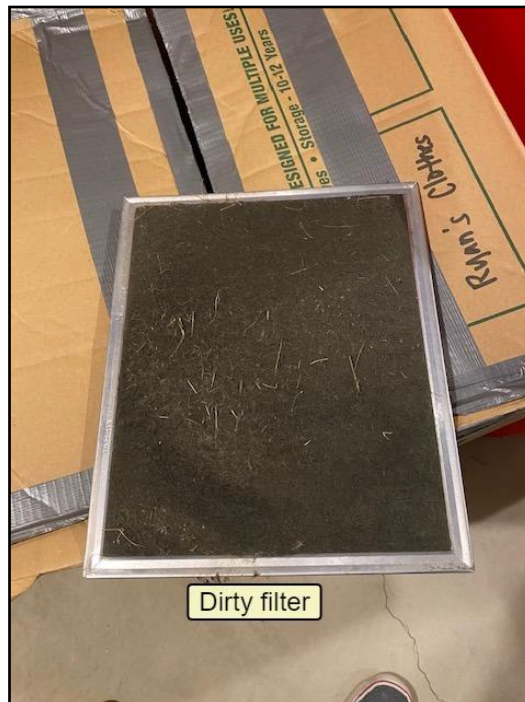
The intake filter is dirty, both should be rinsed clean. Thiis should be done every change of seasons when you change the furnace filter. Operator instructions can be found on Internet for Venmar HRV unit.

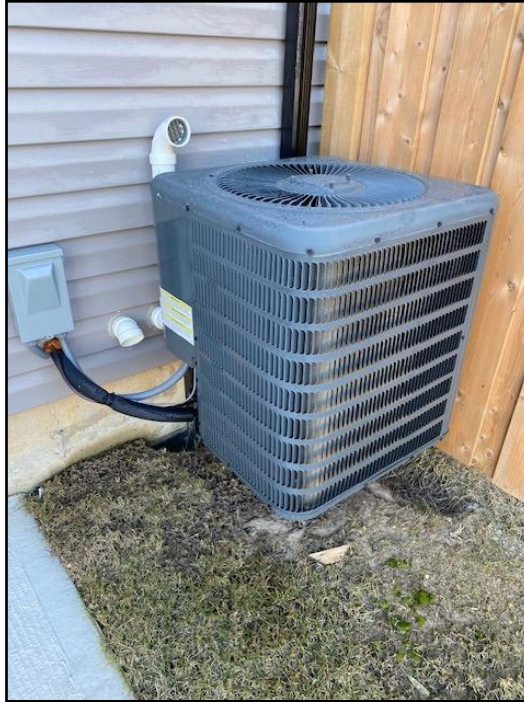
17. 3 years

Do not use cover during off season. No tall trees close by so let it breath to avoid rust forming on the top of unit.

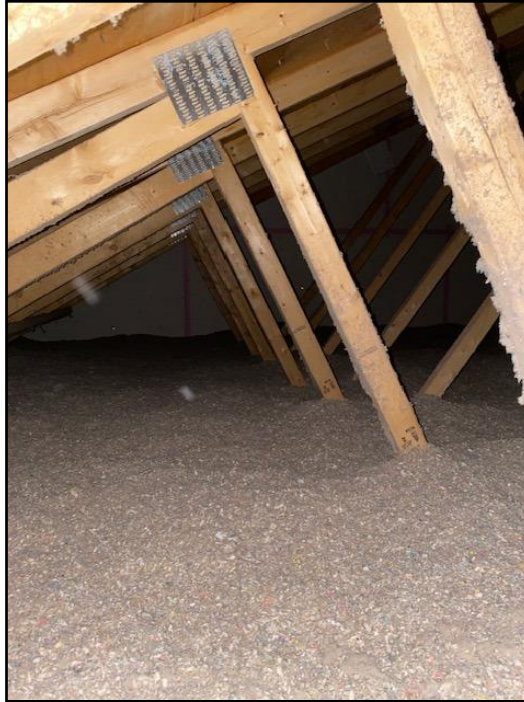
18. R-60

Meets new code. Lots of insulation. No Concerns.

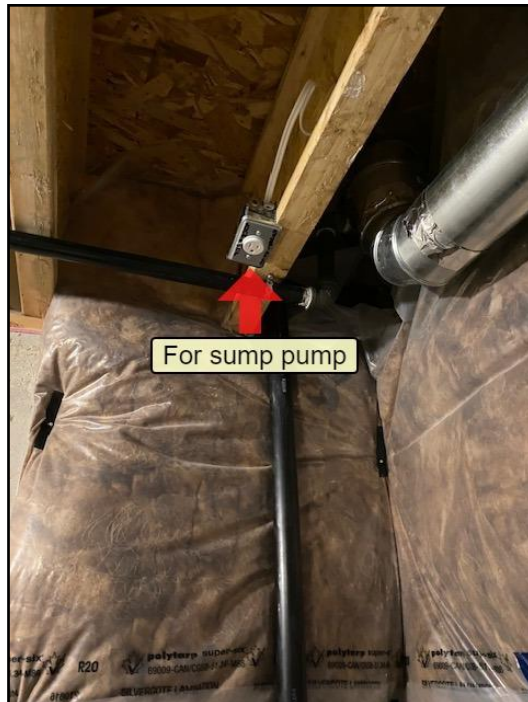
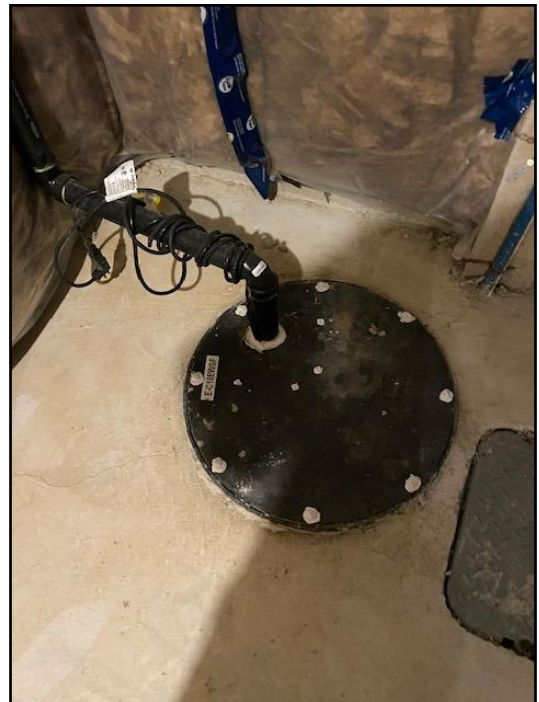
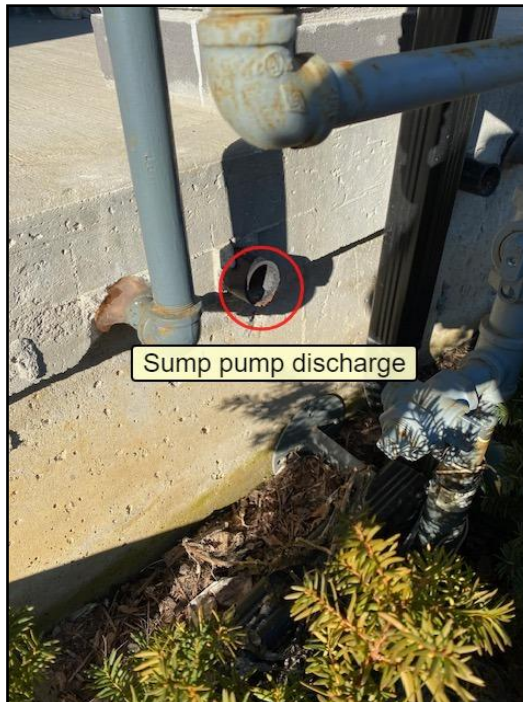
Guess sump pump has never been needed because the electrical cord for pump and float is too short to reach outlet.

This needs to be corrected. About a \$300.00 fix.

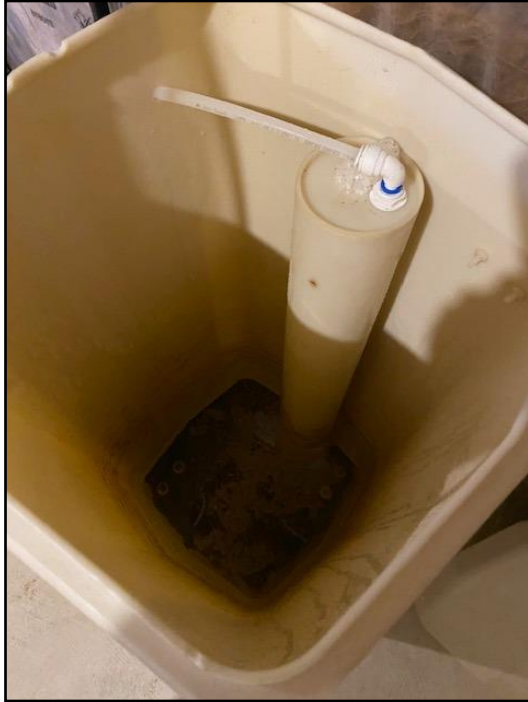
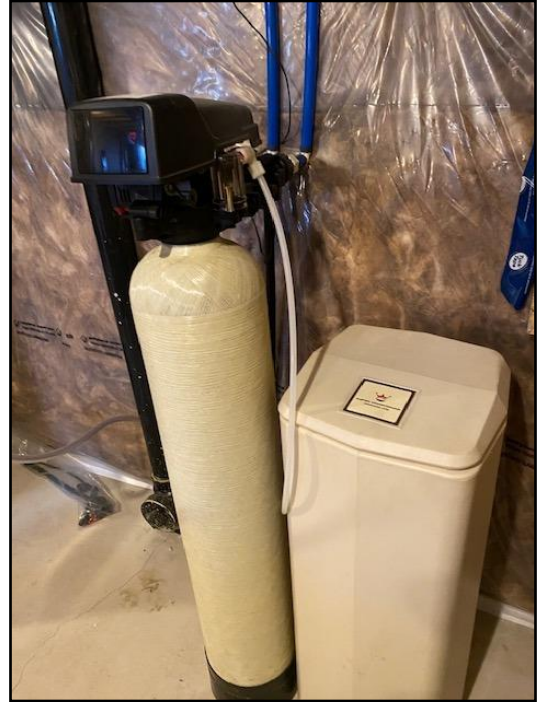
This is a rental and not being using because there is no salt in the tank, but they are still paying rental fee. Needs salt.

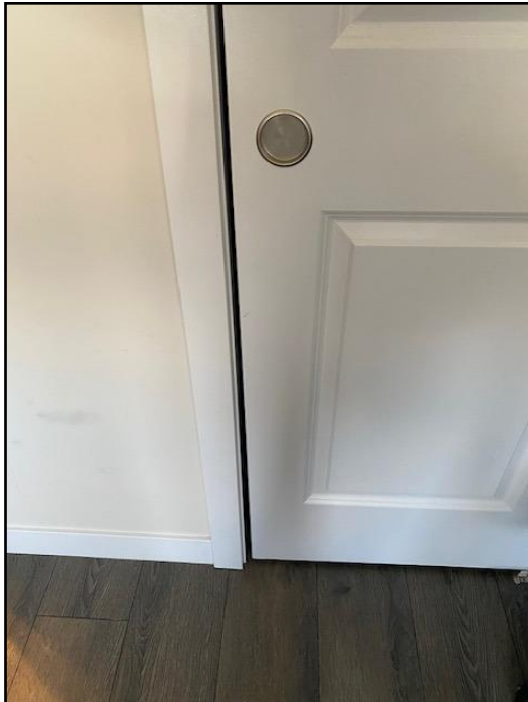
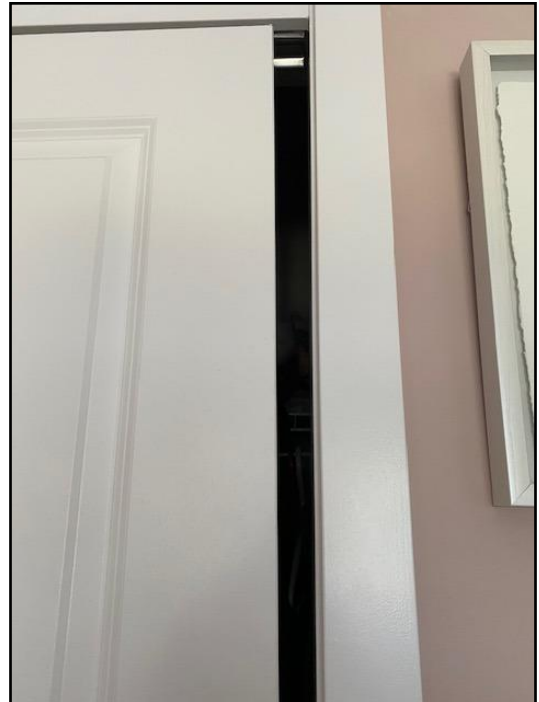
General: • Both front bedrooms the closet doors need to be adjusted. About \$200.00

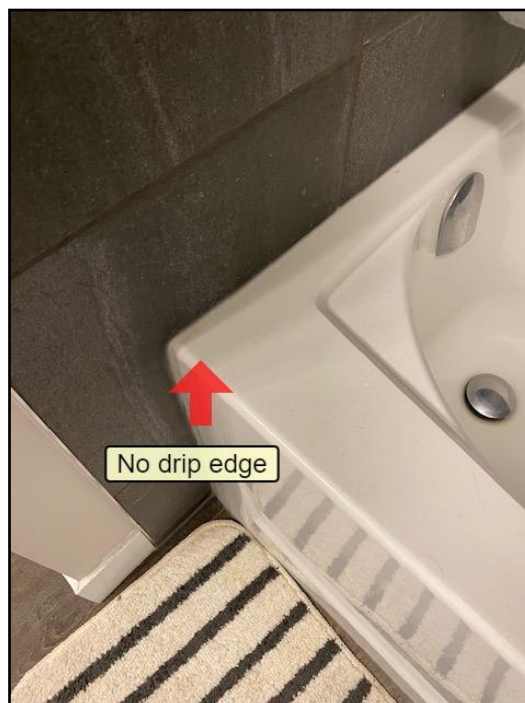
33. Bath tubs

General: • They have no drip edge so try not to set wet bottles or toys on outer edge because water will run over edge. Sides of walls are tile so if it does happen it won't damage drywall.

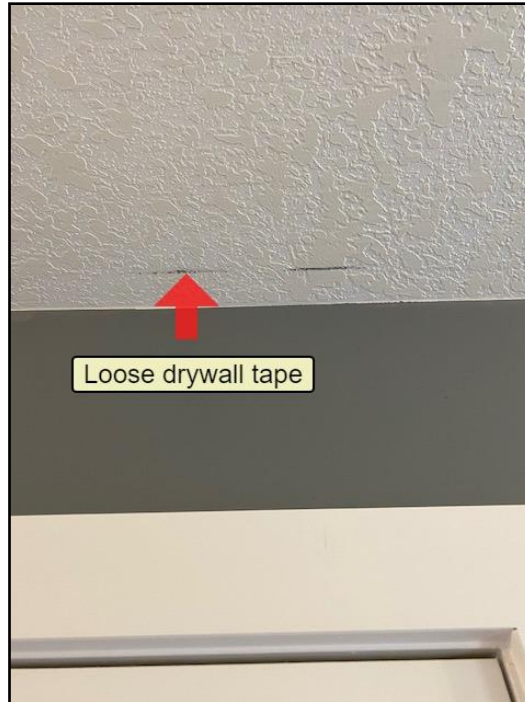
34. Plaster/drywall

Above front entry closet looks like drywall tape is coming loose. About \$400 repair.

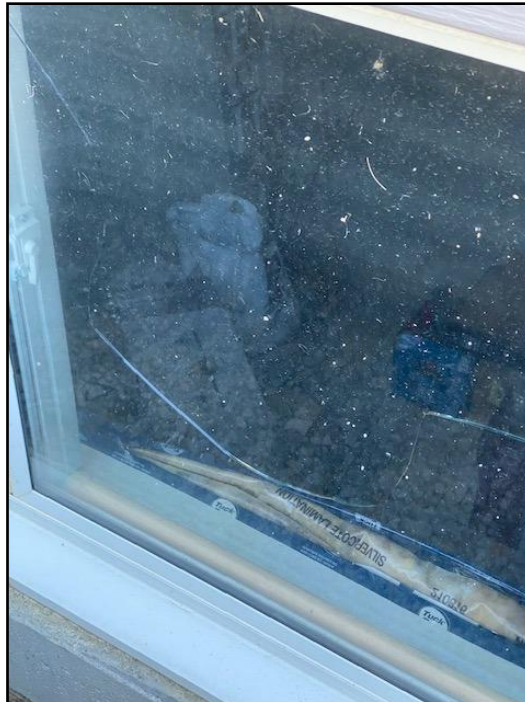
35. Sliders

Basement window is cracked. They can have a window company come and just replace that section of slider. Cost about \$250.00
