INSPECTION REPORT

For the Property at:
1234 SAMPLE LANE
POTTSTOWN, PA 19465

Prepared for: SAM PLE BOOKING
Inspection Date: Monday, July 24, 2017
Prepared by: Ed Gibson

RE: Report No. 1006, v.4
1234 Sample Lane
Pottstown, PA
19465

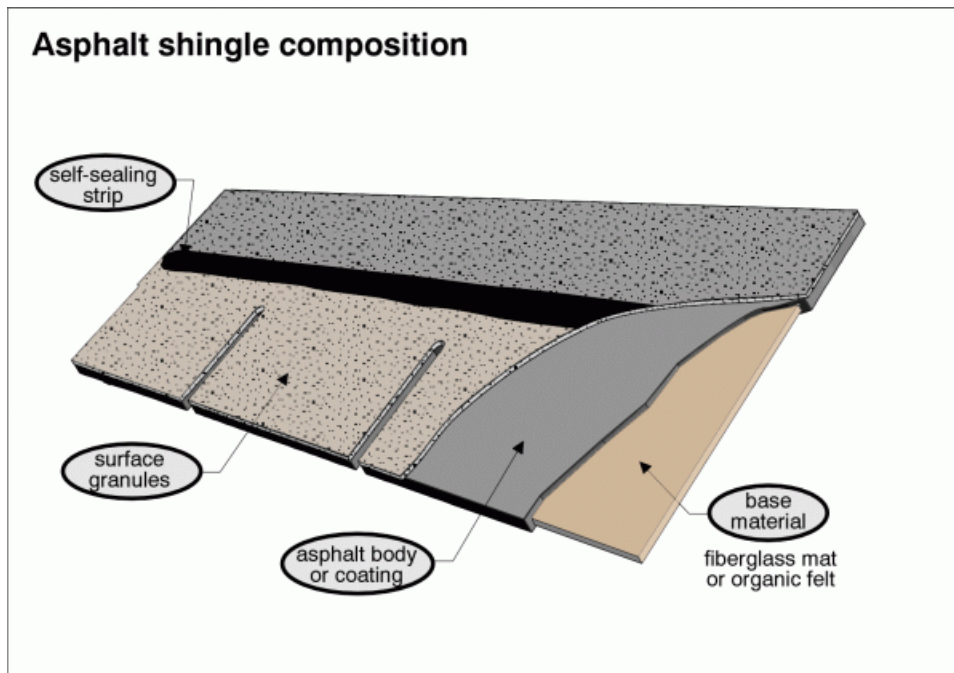
1. Condition: • [Granule loss](#)

Implication(s): Chance of water damage to contents, finishes and/or structure

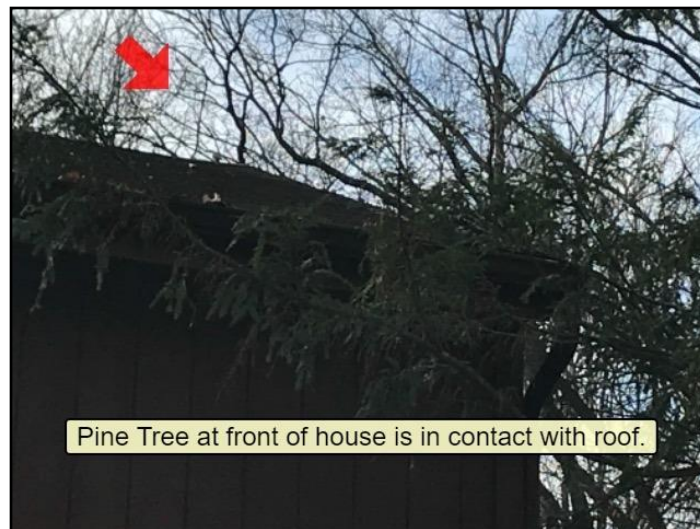
1. West

4. Condition: • Tree branches touching roof

Implication(s): Shortened life expectancy of material

Task: Remove

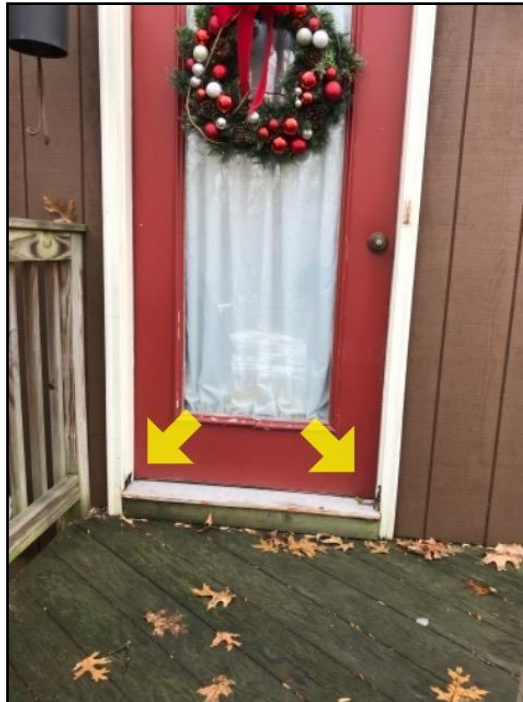
2. Rot

5. Condition: • [Rot](#)

Implication(s): Chance of damage to finishes and structure

Task: Replace

Time: Immediate

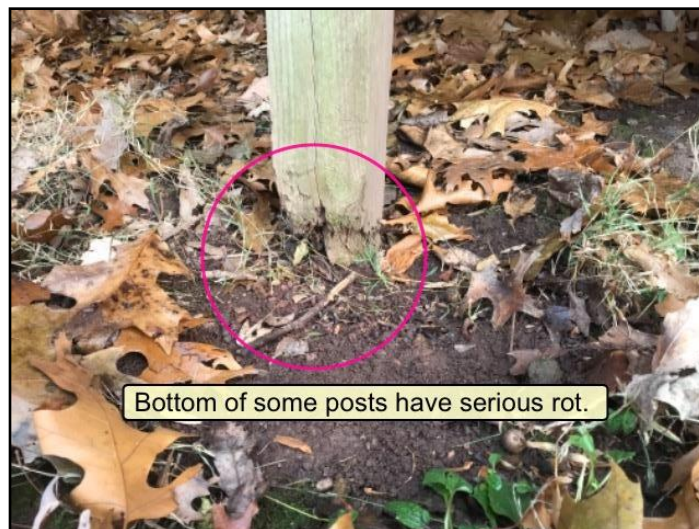
3. Wood/soil contact

7. Condition: • [Wood/soil contact](#)

Implication(s): Weakened structure | Chance of movement | Rot | Insect damage

Task: Correct

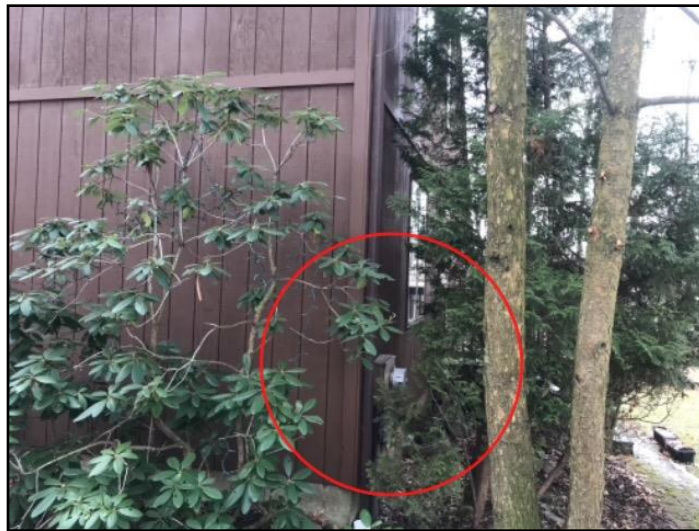
4. *Trees or shrubs too close to building*

9. Condition: • [Trees or shrubs too close to building](#)

Implication(s): Chance of water damage to contents, finishes and/or structure | Chance of pests entering building | Material deterioration

Task: Correct

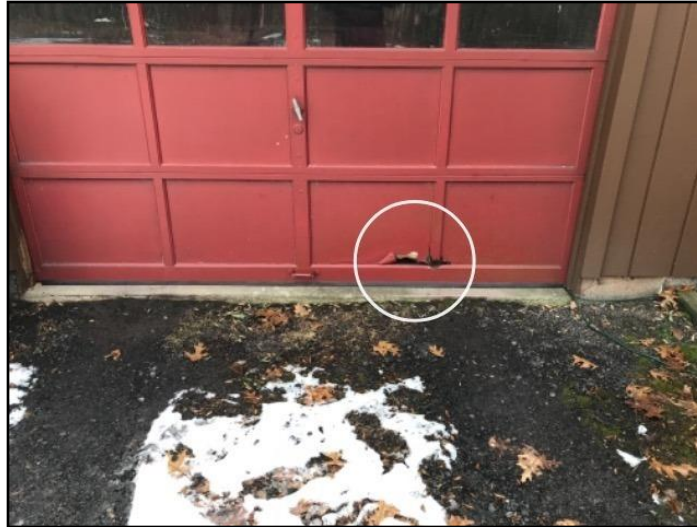
5. Rot

13. Condition: • Rot

Implication(s): Material deterioration

Location: Right Side Exterior Garage

Task: Correct

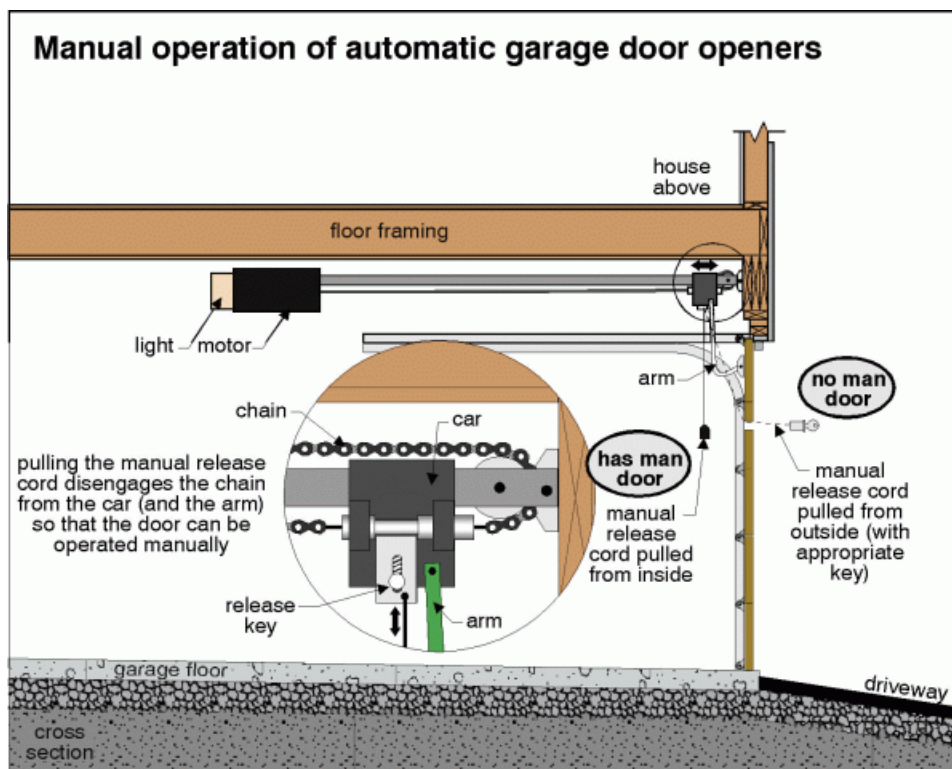
14. Condition: • [Inoperative](#)

Implication(s): System inoperative

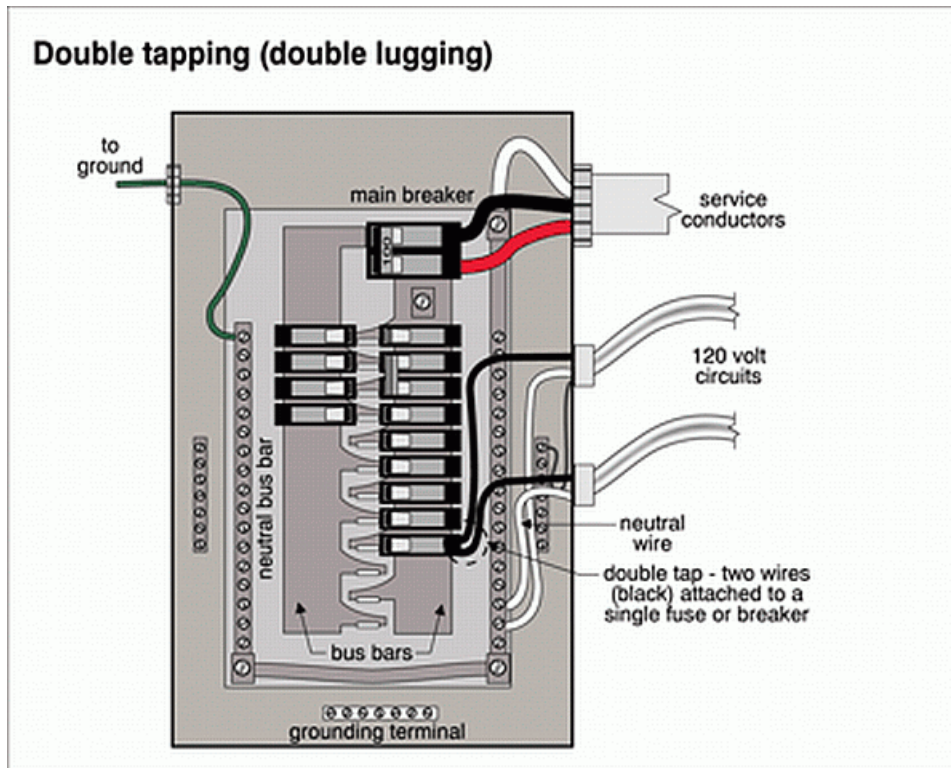
16. Condition: • [Double taps](#)

Sub-panel in garage

Implication(s): Fire hazard

Task: Further evaluation

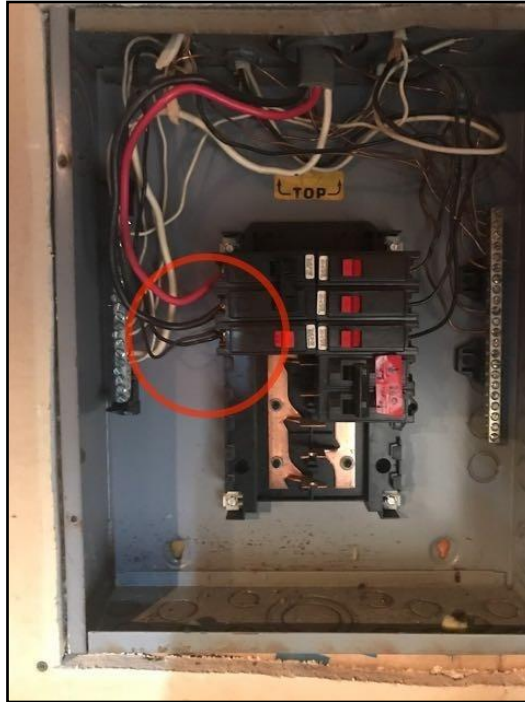
6. 100 Amps

• [100 Amps](#)

Double tap. Amateur installation

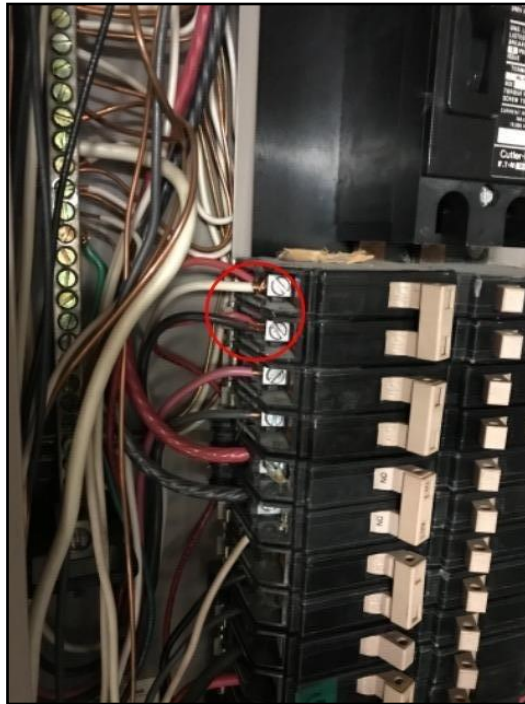
7. Breakers - basement

17. Condition: • [Double taps](#)

Main Panel in Basement

Implication(s): Fire hazard

Task: Correct

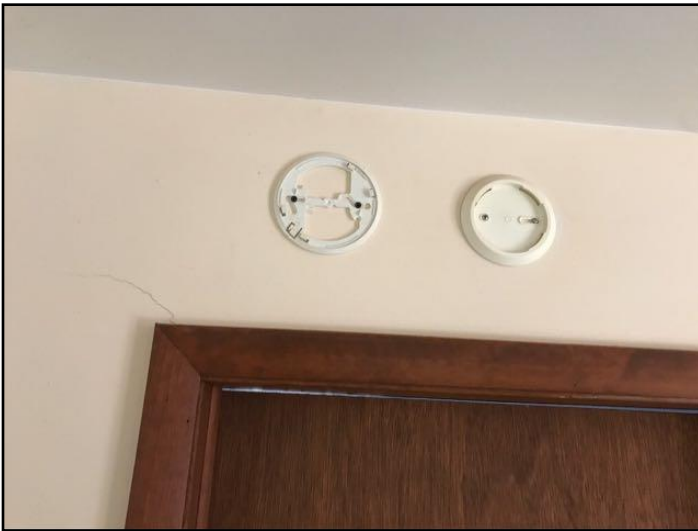
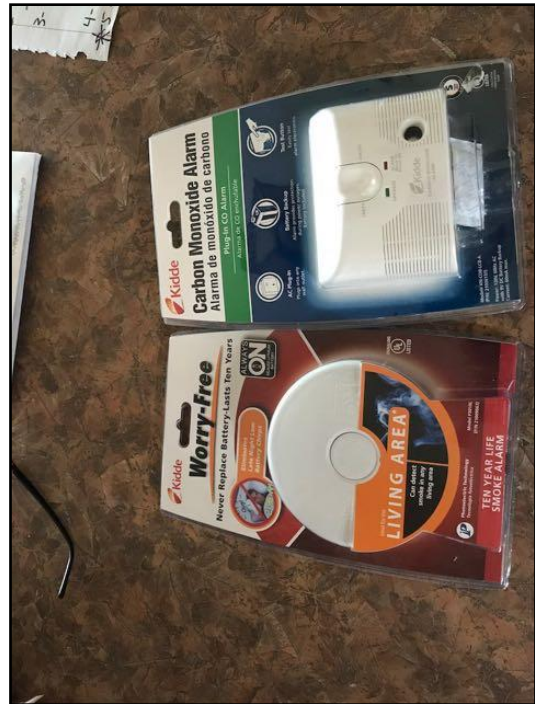
8. Present

Detectors seemed to have removed. I noted seeing a couple new detectors still in packaging on kitchen counter.

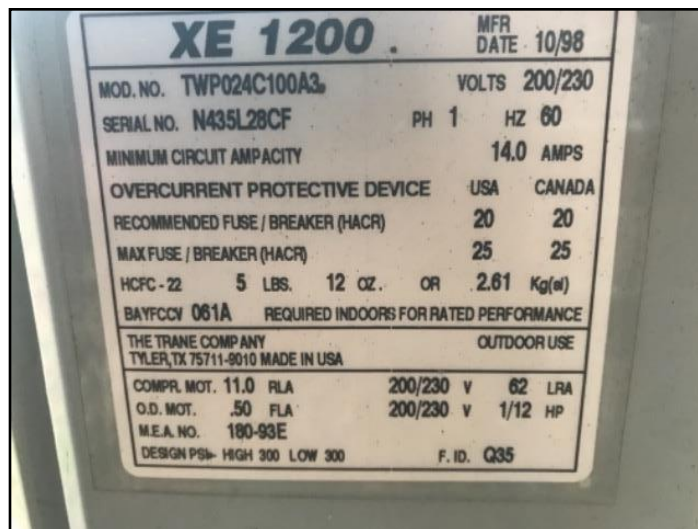
12. High

Compressor approximate age: • 19 years

• [High](#)

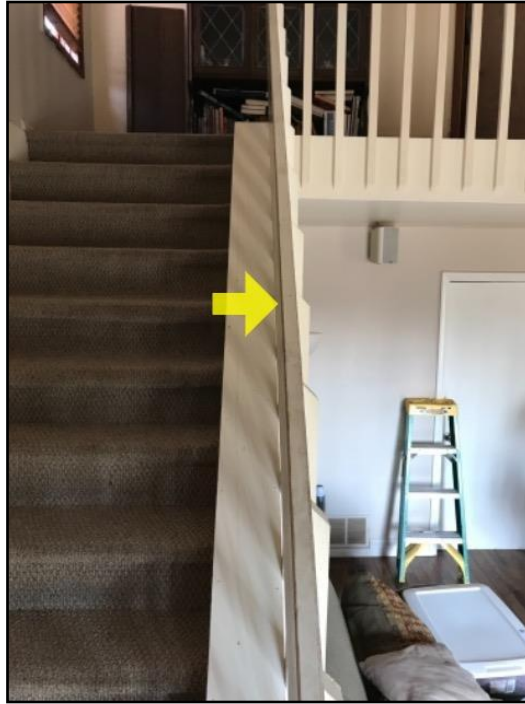
13. Hard to hold

20. Condition: • [Hard to hold](#)

Implication(s): Fall hazard

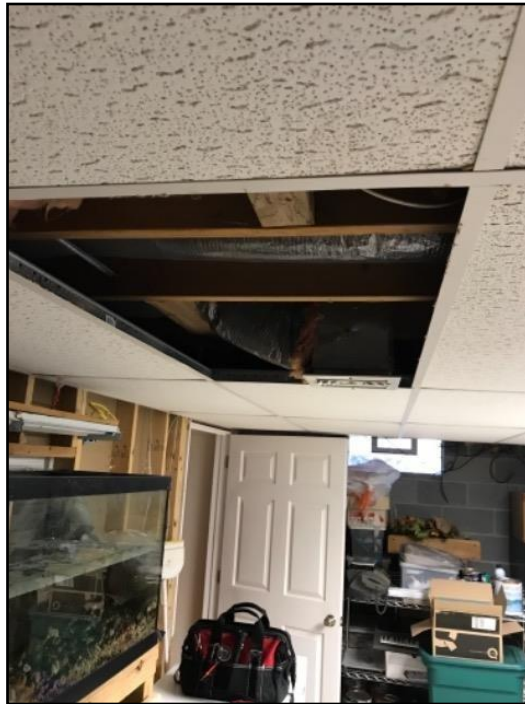
14. Water marks

21. Condition: • [Water marks](#)

Implication(s): Chance of water damage to contents, finishes and/or structure

Task: Monitor
