YOUR INSPECTION REPORT

89 Major Lake Road
Madawaska, ON K0J 2E0

Dunbar
Home Inspections

RE: Report No. 10333
89 Major Lake Road
Madawaska, ON
K0J 2E0

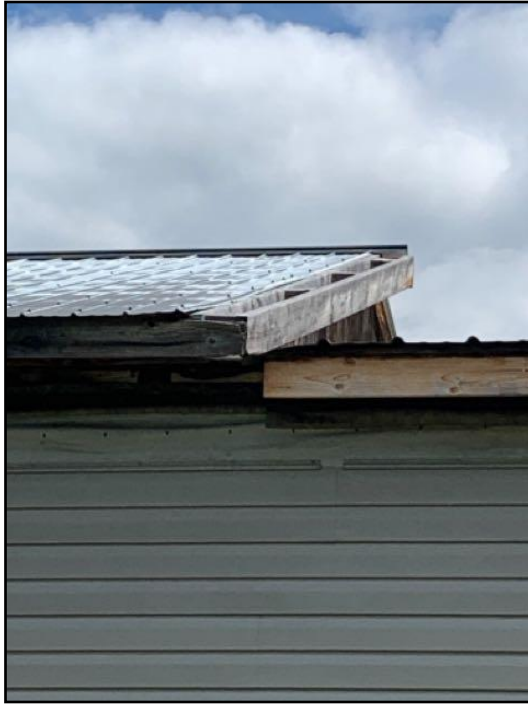
10. Missing, loose or broken pieces

1. Condition: • [Missing, loose or broken pieces](#)

Missing piece of metal roofing, this wood will rot if not covered, repair needed

Implication(s): Chance of water damage to structure, finishes and contents

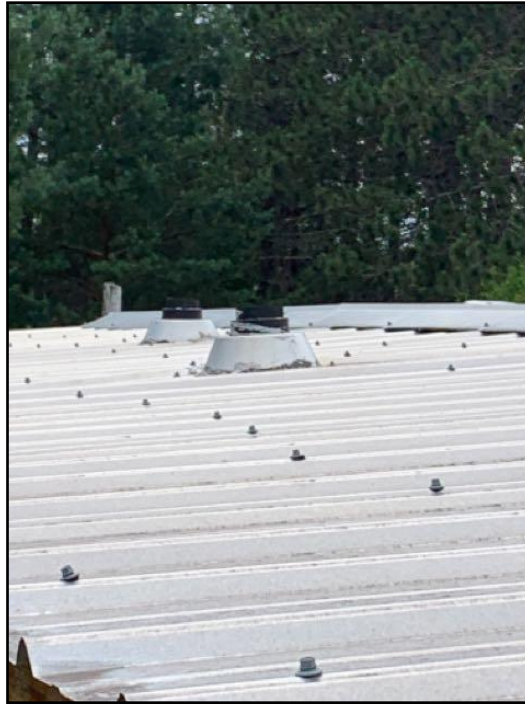
13.

3. Condition: • Stacks need to be extended, to low.

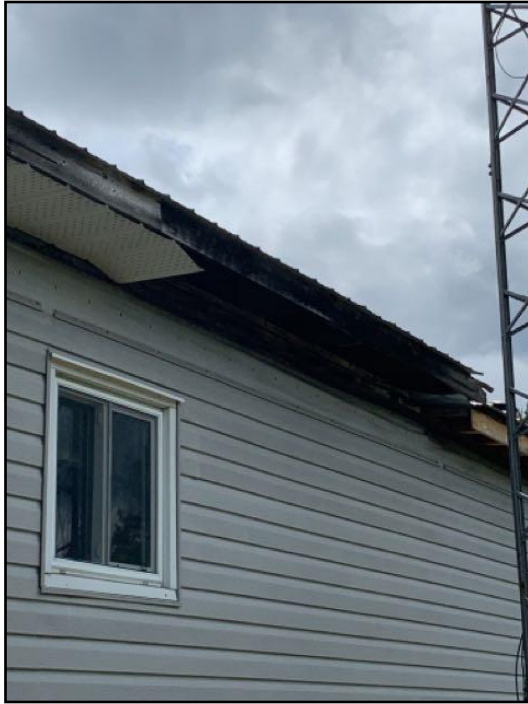
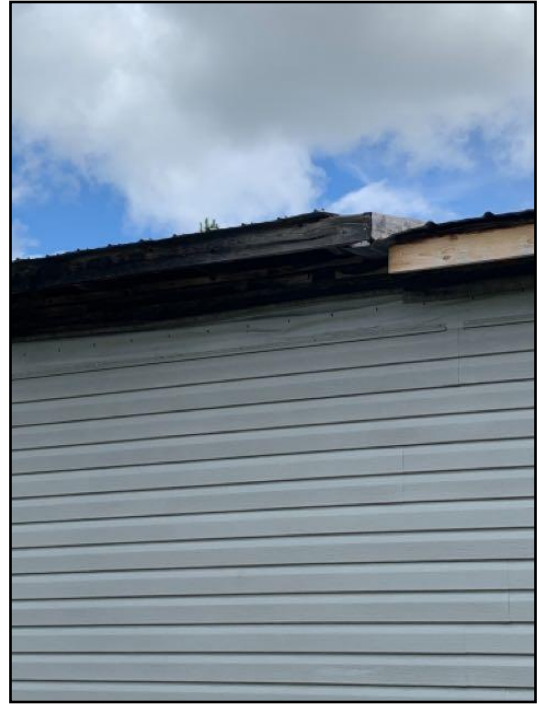
4. Condition: • [Loose or missing pieces](#)

Missing soffit and fascia, fascia needs to be covered with aluminum to prevent rot. Repair needed around whole house.

Implication(s): Chance of pests entering building | Chance of water damage to structure, finishes and contents

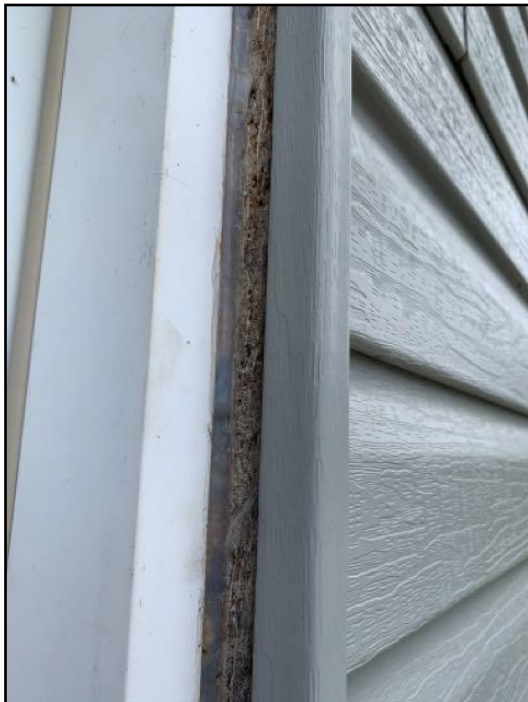
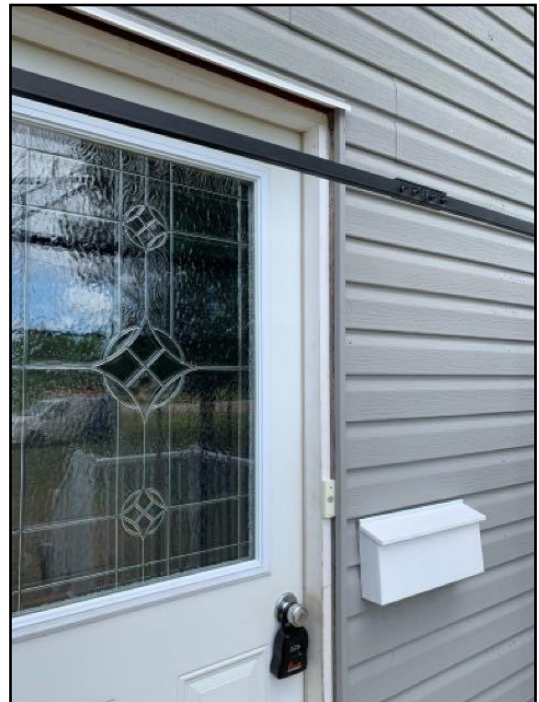
5. Condition: • [Flashings missing](#)

Implication(s): Chance of water damage to structure, finishes and contents

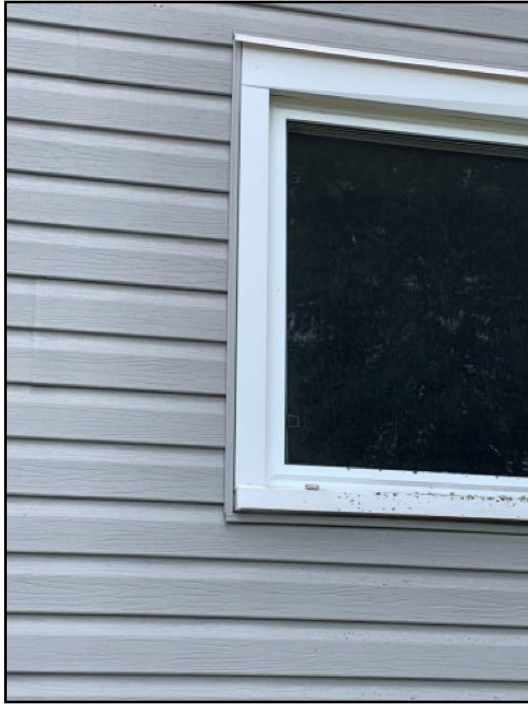
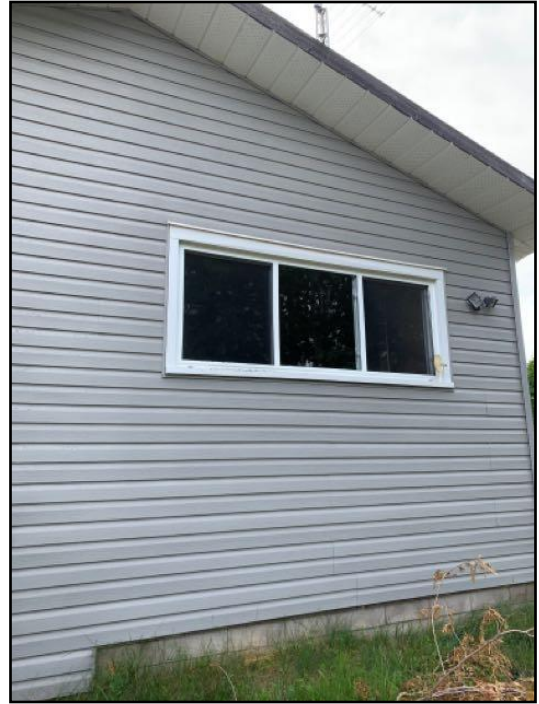
7. Condition: • [Caulking missing or ineffective](#)

Implication(s): Chance of water damage to structure, finishes and contents

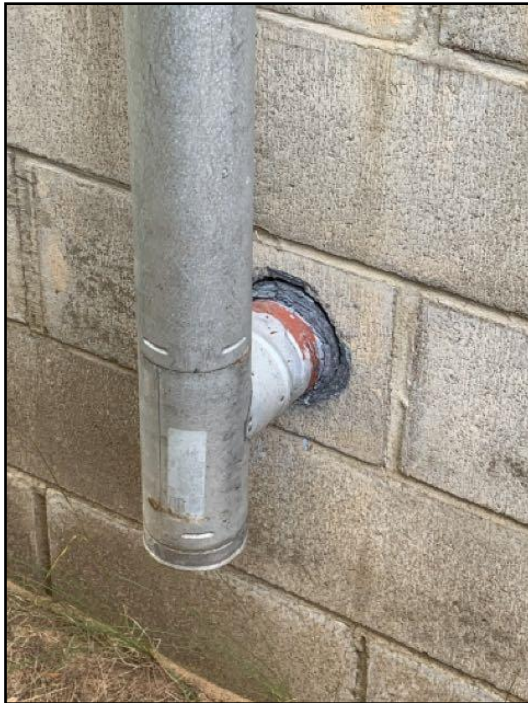
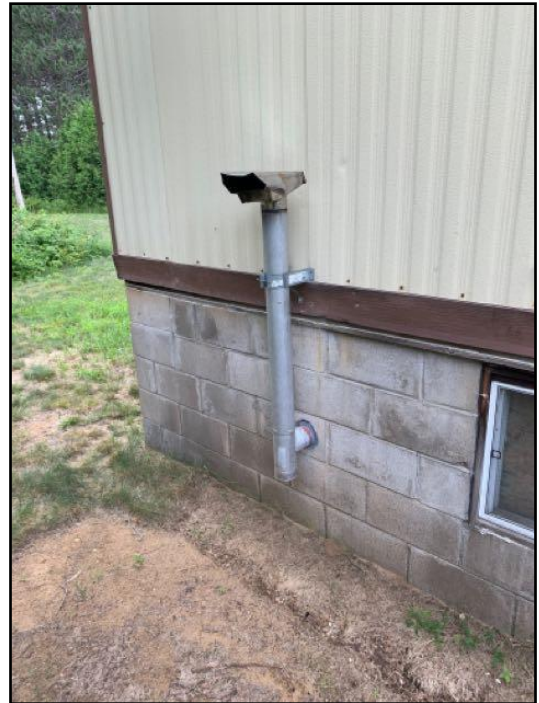
8. Condition: • [Caulking missing or ineffective](#)

Implication(s): Chance of water damage to structure, finishes and contents

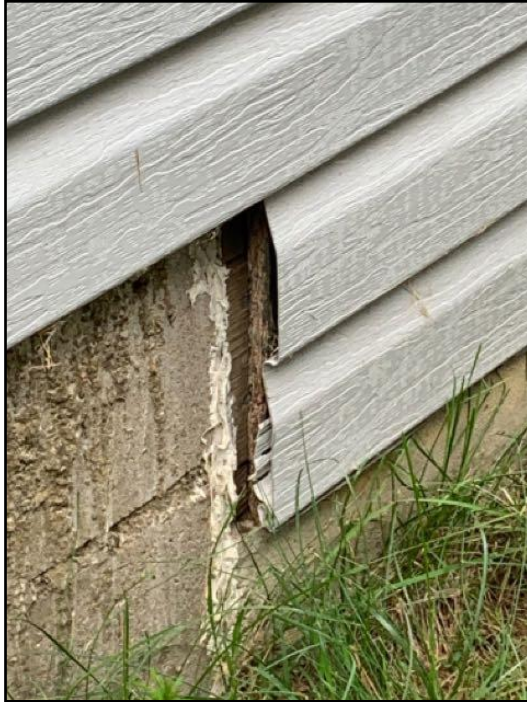
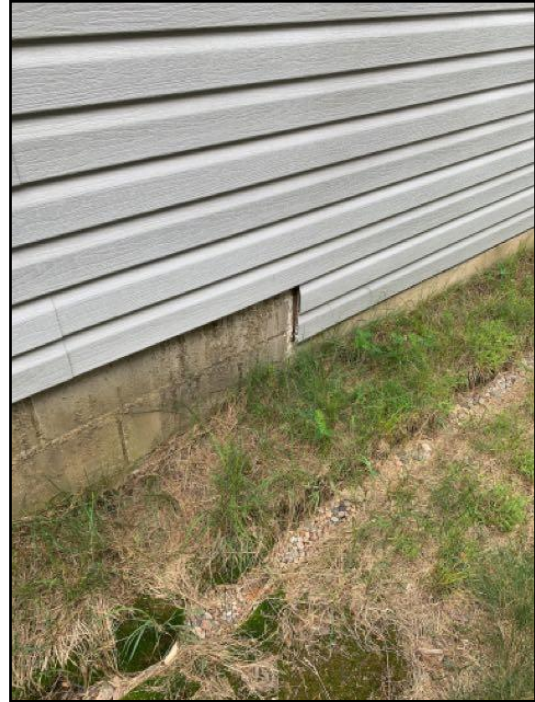
9. Condition: • [Swelling](#)

Exposed OSB starting to swell, this area should be covered.

Implication(s): Material deterioration | Chance of water damage to structure, finishes and contents

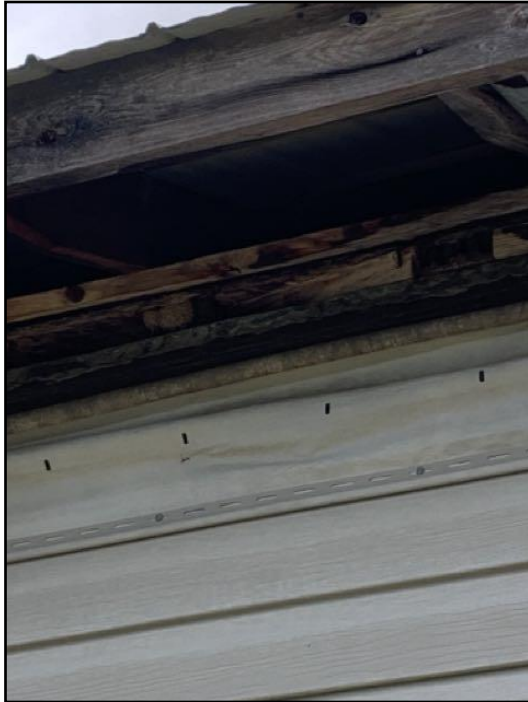
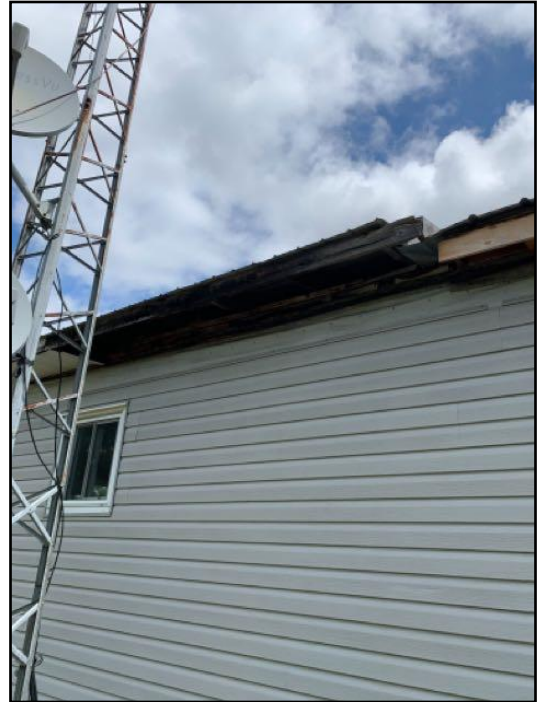
10. Condition: • Rot

Exposed parts of wall that are wood are starting to rot, repair needed.

Implication(s): Material deterioration | Chance of water damage to structure, finishes and contents

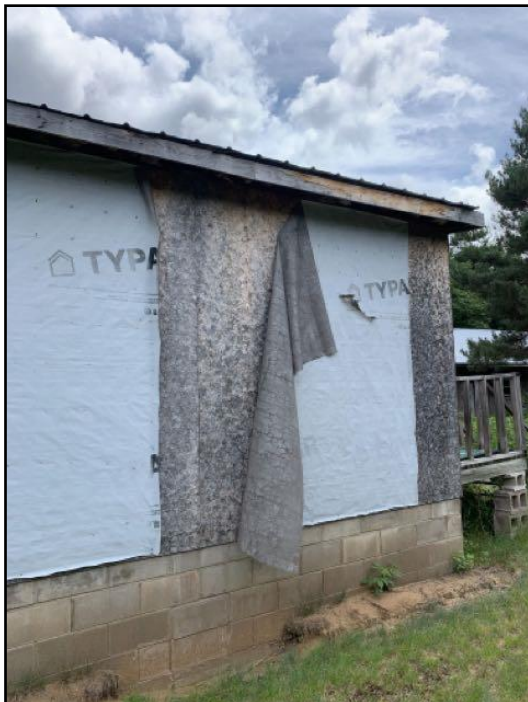
49.

11. Condition: • Exposed OSB starting to deteriorate from the weather, this area needs to be covered with weatherproof material. These sheets may need to be replaced.

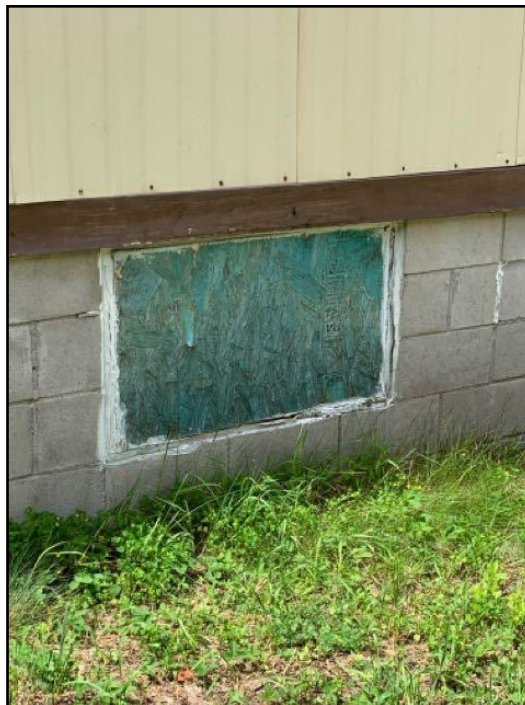
52.

12. **Condition:** • OSB panel poorly sealed, recommend aluminum flashing here.

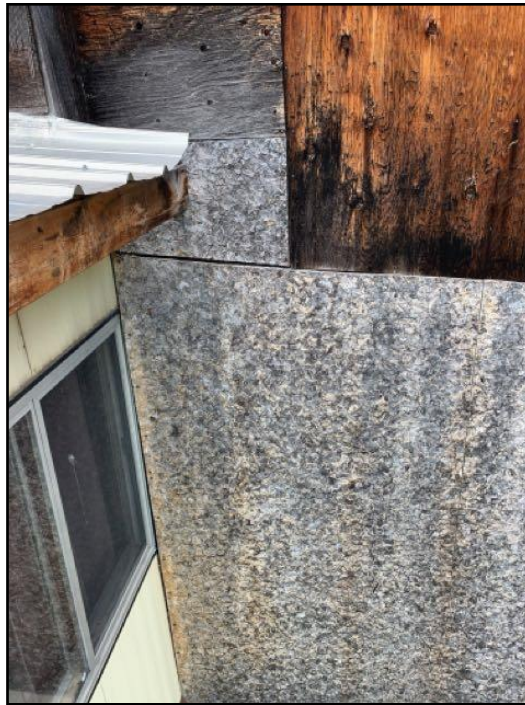
53.

13. Condition: • Gap in OSB will let water in, repair needed.

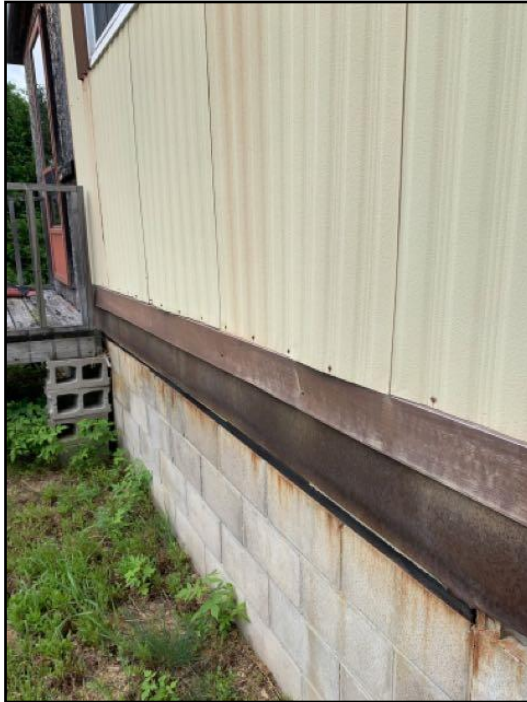
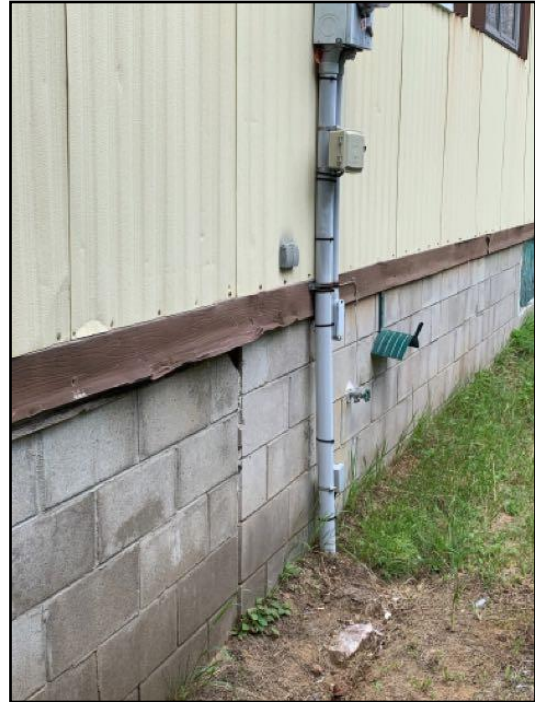
16. Condition: • [Loose or missing pieces](#)

Implication(s): Chance of water damage to structure, finishes and contents

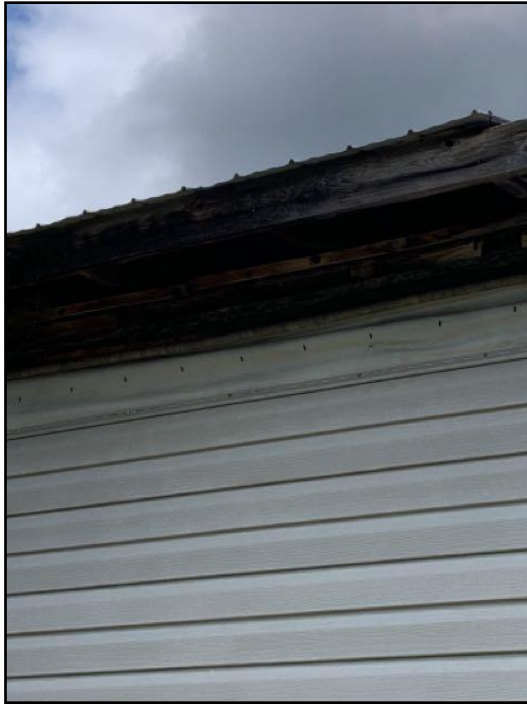
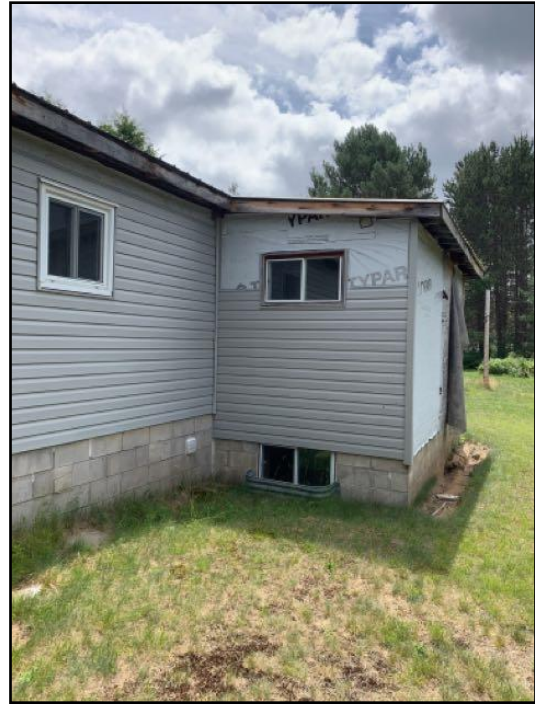
18. Condition: • [Loose or missing pieces](#)

Implication(s): Chance of water damage to structure, finishes and contents

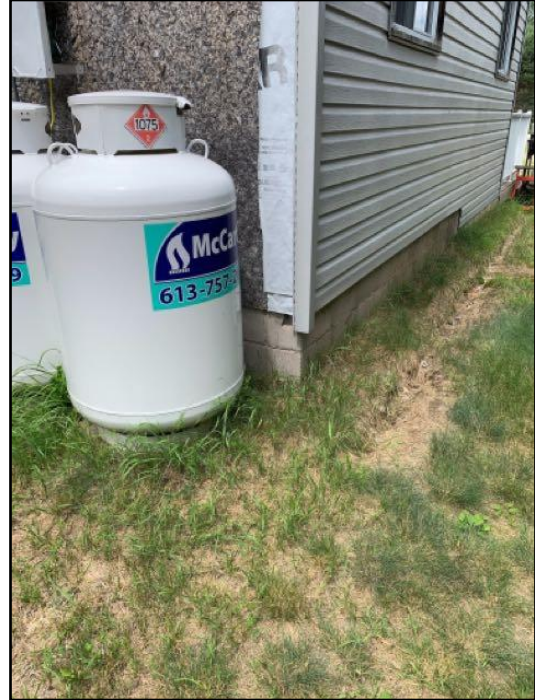
64. Masonry deterioration

20. Condition: • [Masonry deterioration](#)

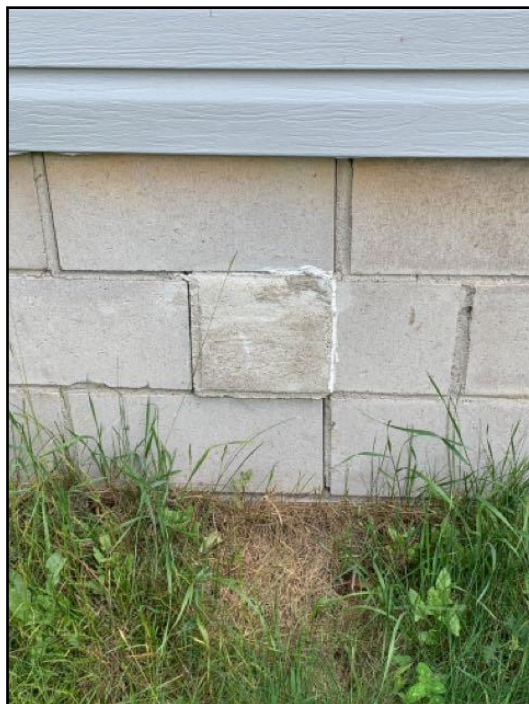
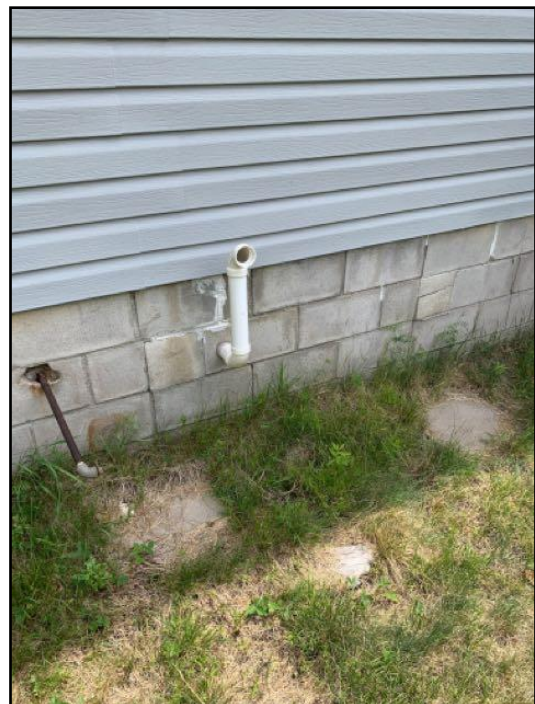
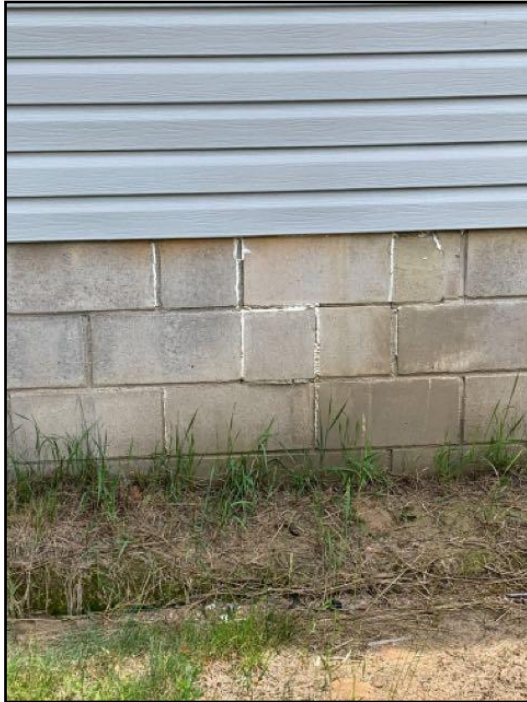
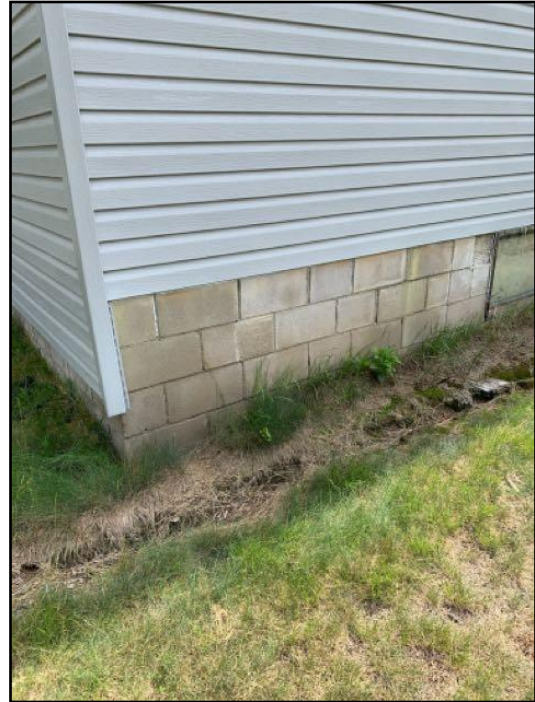
21. Condition: • [Mortar deterioration](#)

Masonry block should be re painted. Cracks and deteriorated mortar joints .

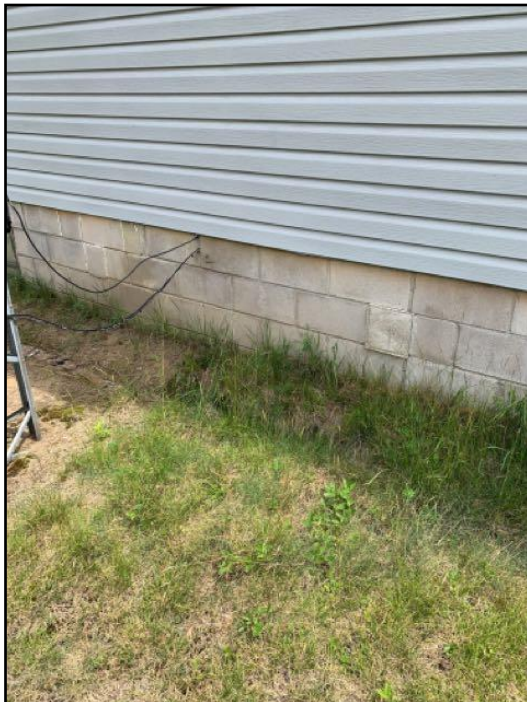
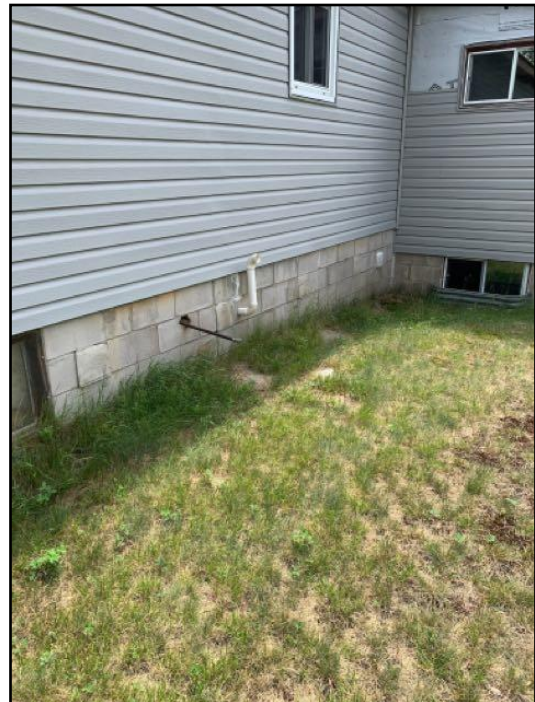
22. Condition: • [Parging damaged or missing](#)

Implication(s): Shortened life expectancy of material | Chance of damage to structure

Recommend masonry block be parged.

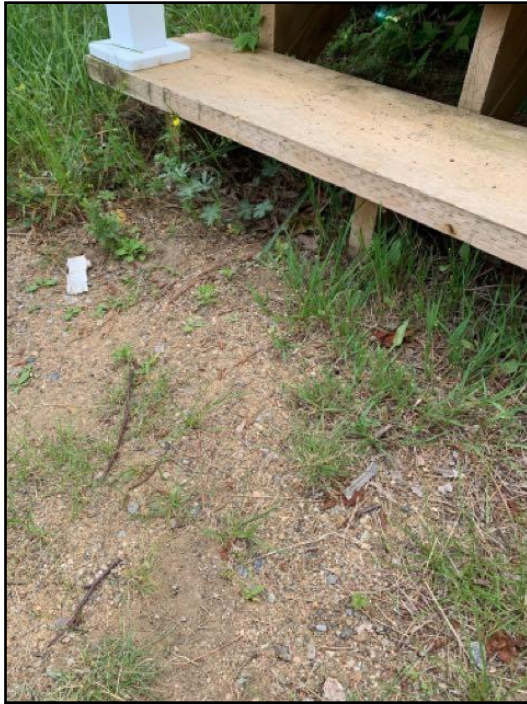
76. Wood/soil contact

26. Condition: • [Wood/soil contact](#)

Implication(s): Rot | Insect damage

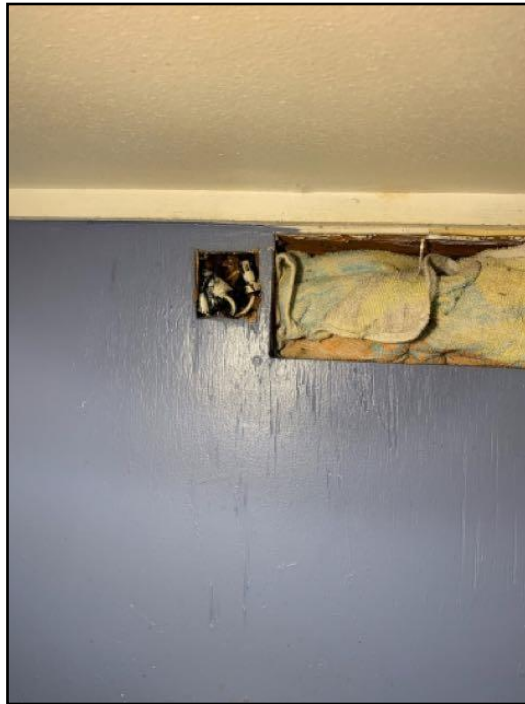
86. Open splices

29. Condition: • [Open splices](#)

Implication(s): Fire hazard | Electric shock

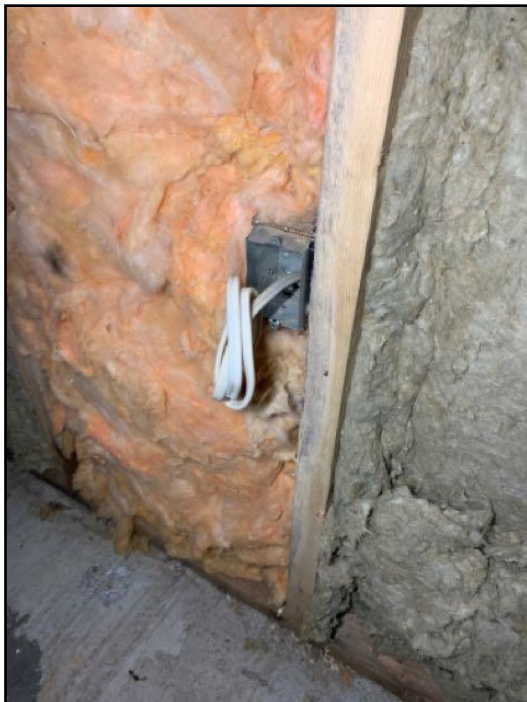
87.

30. Condition: • Info and loose wiring in rear of basement, these wires should be looked at by an electrician to ensure it was done properly.

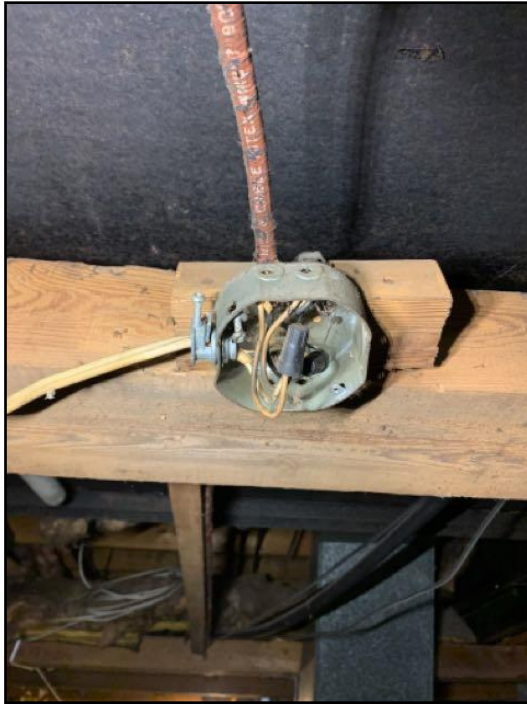
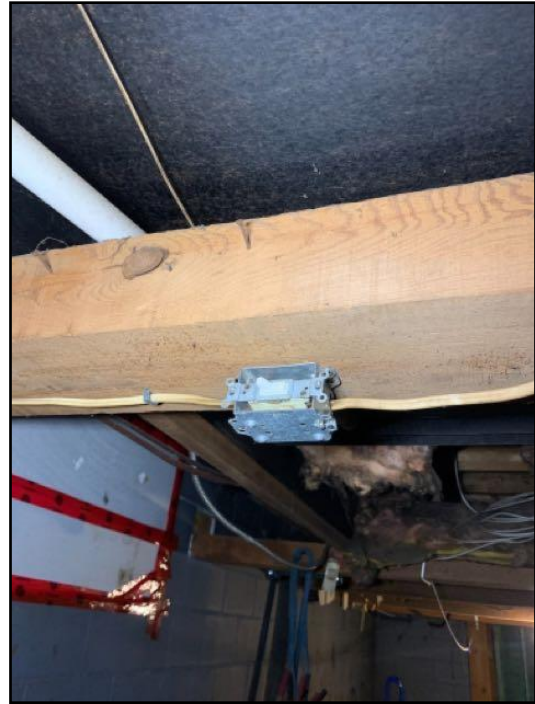
32. Condition: • [Cover loose or missing](#)

Cover plates missing

Implication(s): Fire hazard | Electric shock

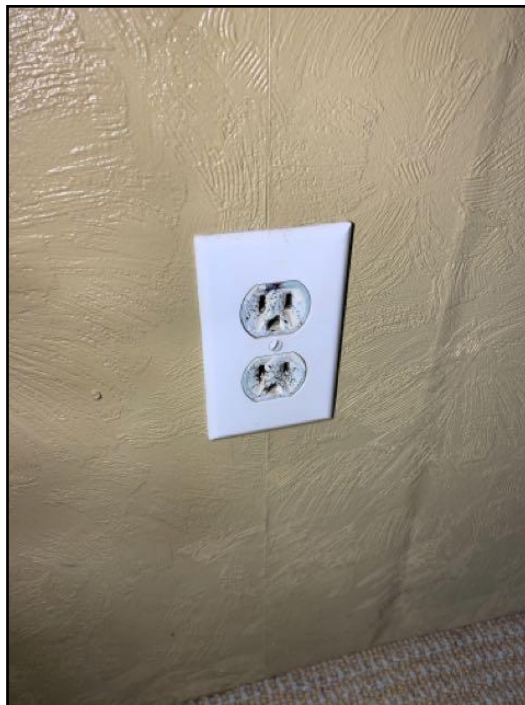
98.

37. **Condition:** • Painted outlets should be replaced.

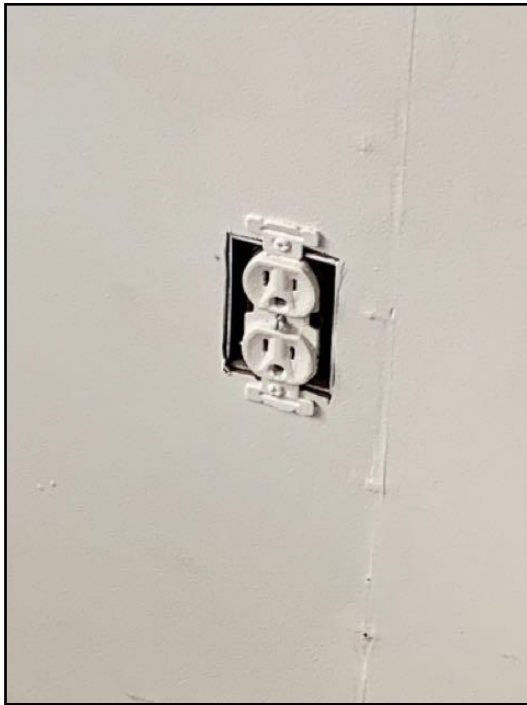
99.

38. Condition: • Painted outlet should be replaced, needs cover plate.

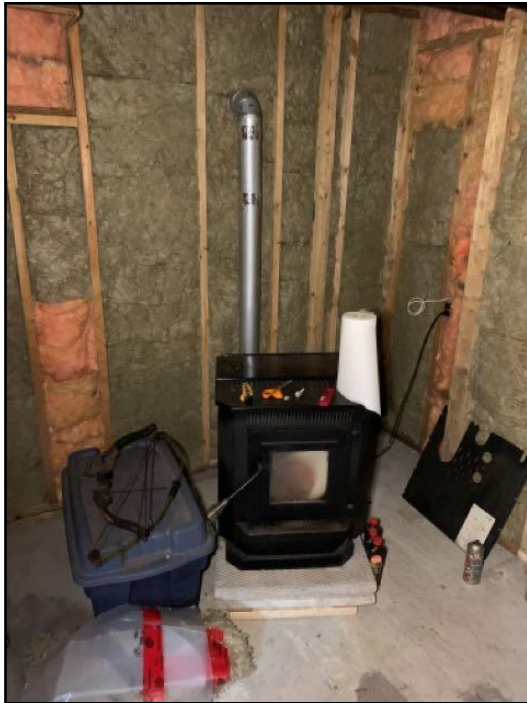
106.

Auxiliary heat: • Pellet stove in basement. Did not test, appears to be under repair.

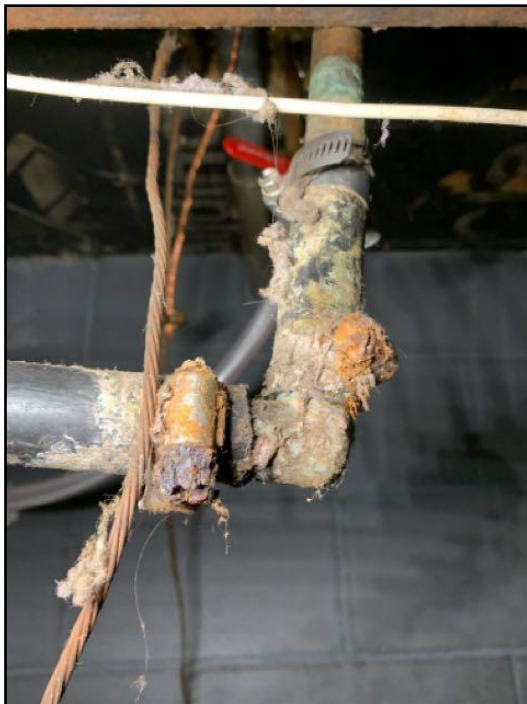
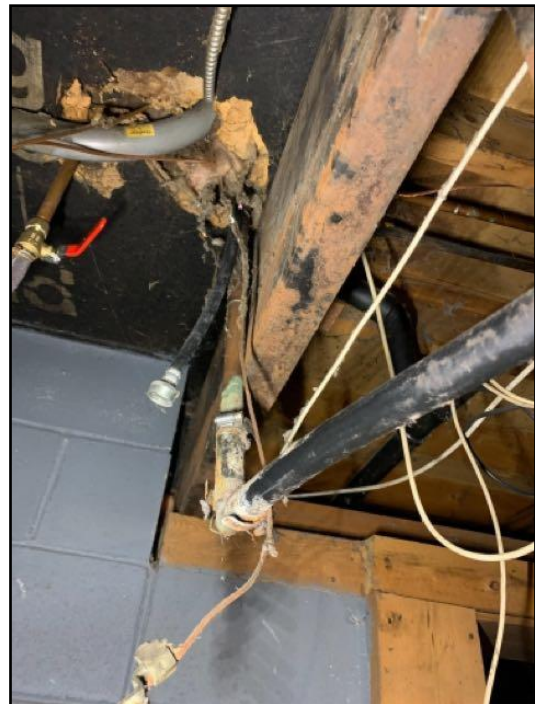
43. Condition: • [Rust](#)

Water supply for bathroom has rusted clamps and is a plastic line with very little support, recommend replacement of water line to bathroom

Implication(s): Chance of water damage to structure, finishes and contents | Leakage | Reduced system life expectancy | Equipment failure

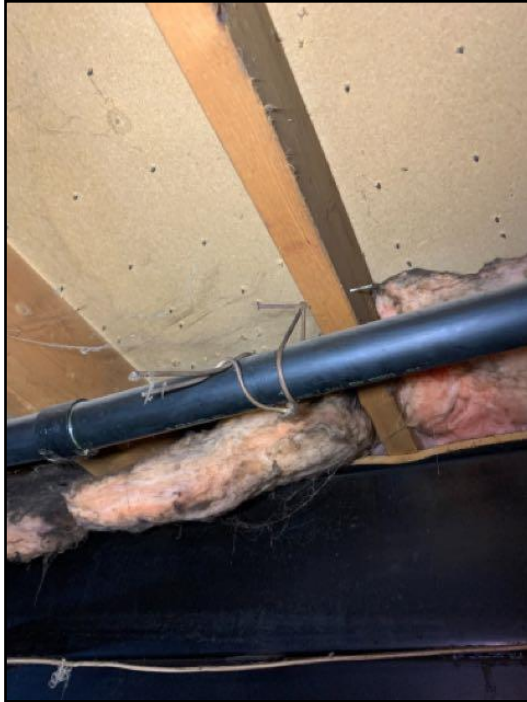
119. Poor support

45. Condition: • [Poor support](#)

Plumbing lines from kitchen are not properly supported, repair needed

Implication(s): Sewage entering the building | Chance of water damage to structure, finishes and contents

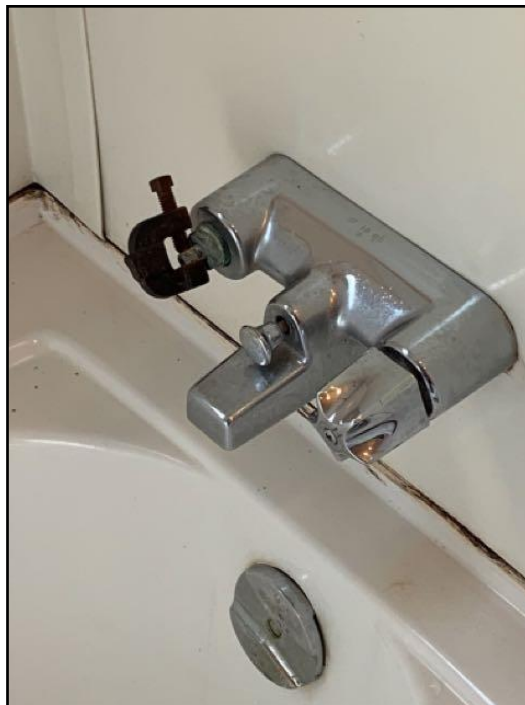
122.

47. **Condition:** • Missing knob for shower faucet, replacement needed.

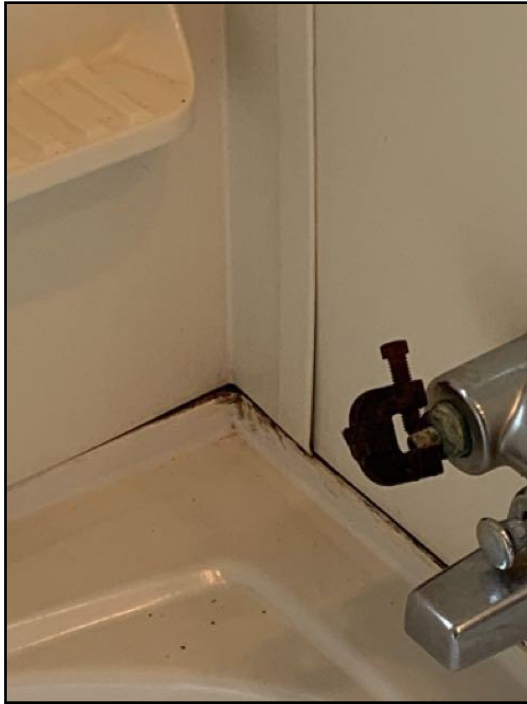
123.

48. Condition: • Shower stall enclosure is falling off and not properly caulked, recommend repair or replacement.

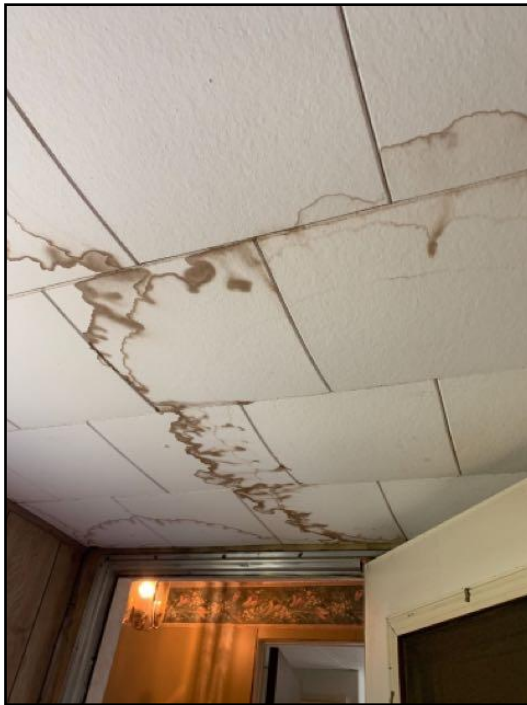
157.

51. Condition: • Extensive signs of water damage in back room, recommend removal of paneling and insulation to investigate further.

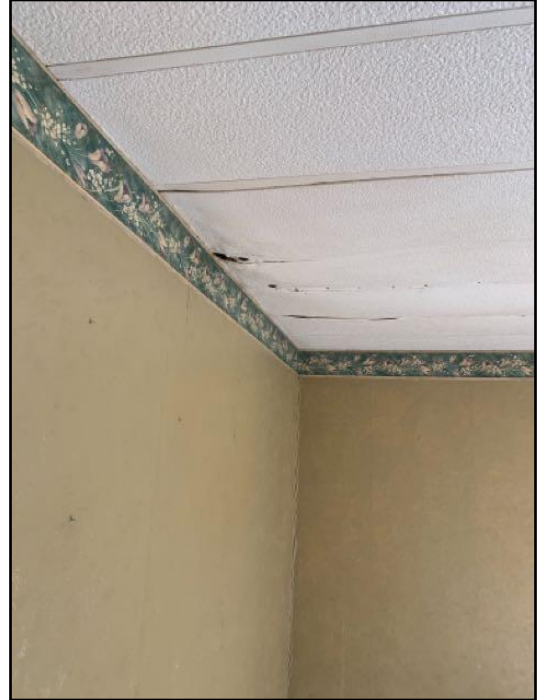
163. Water damage

53. Condition: • [Water damage](#)

Implication(s): Rot | Leakage | Chance of movement

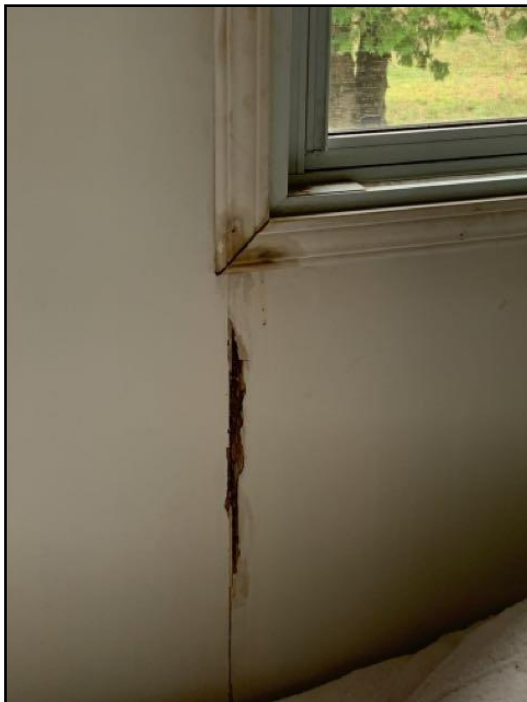
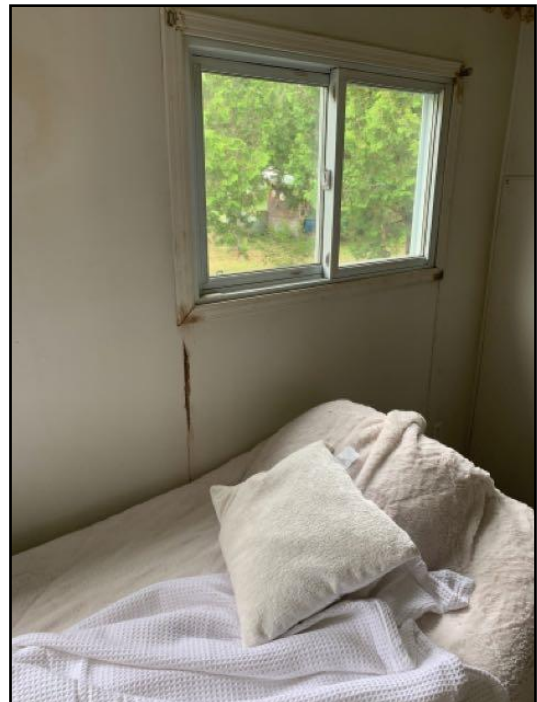
55. Condition: • Water damage

Implication(s): Chance of water damage to structure, finishes and contents

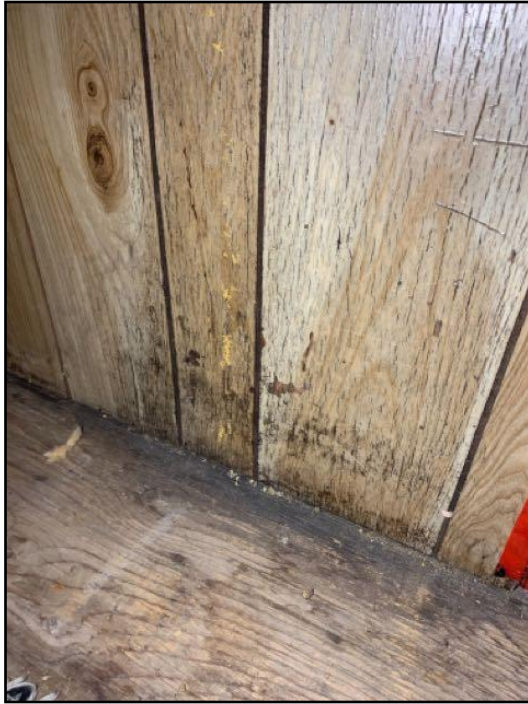
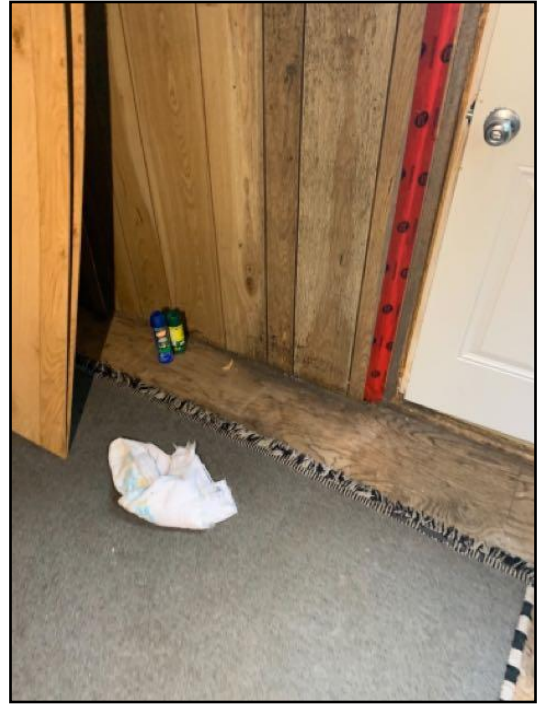
57. Condition: • Water damage

Implication(s): Chance of water damage to structure, finishes and contents

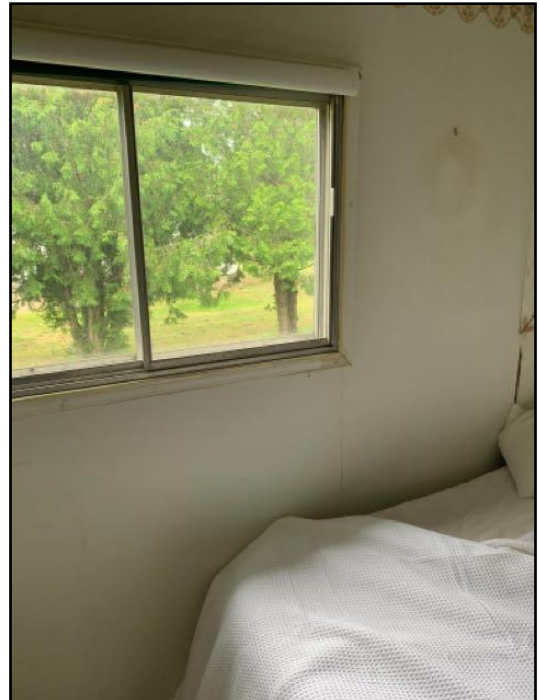
171. Water stains

58. Condition: • Water stains

Implication(s): Chance of water damage to structure, finishes and contents

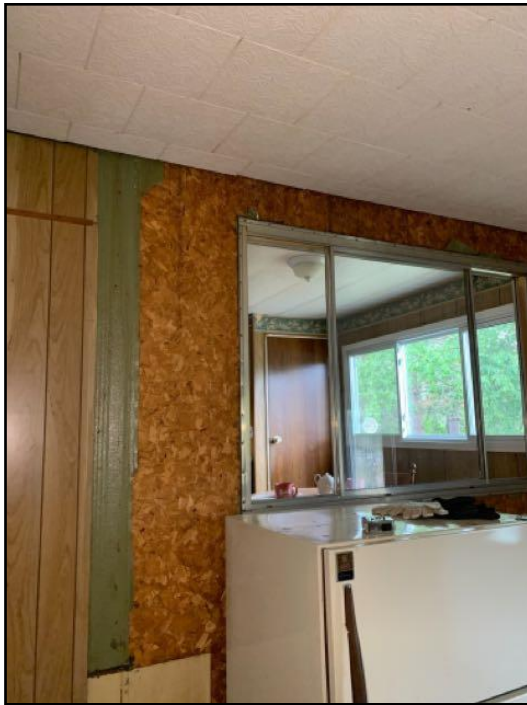
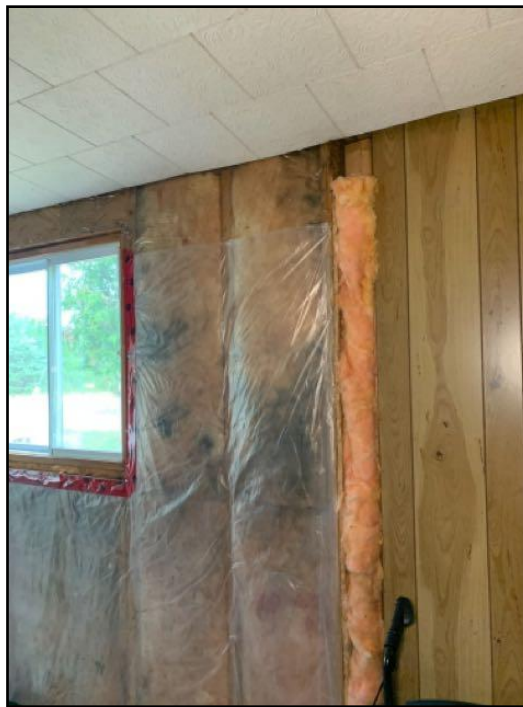
59. Condition: • Unfinished walls, discoloured insulation should be replaced.

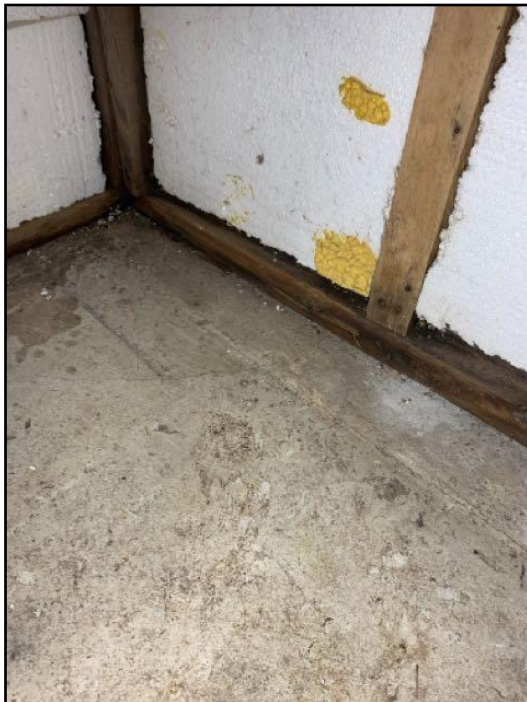
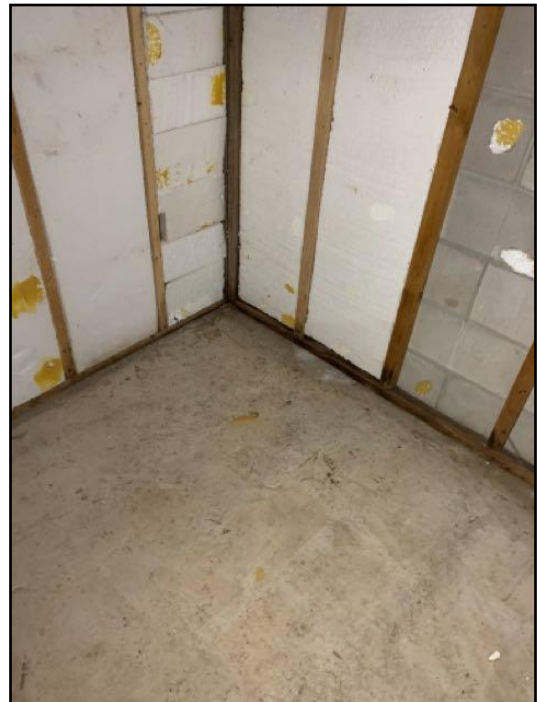
61. Condition: • [Rot](#)

Implication(s): Material deterioration

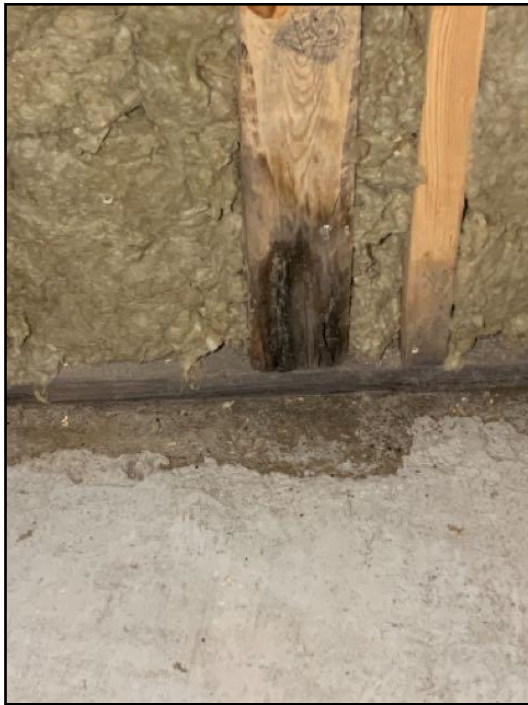
178.

62. Condition: • Water stains and rot on wall plates in basement .

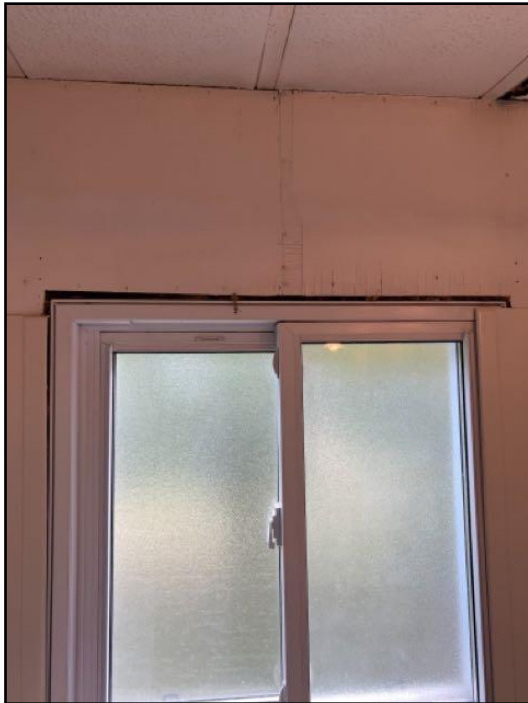
185.

65. Condition: • Window in shower is poorly sealed, this will let water in behind walls and cause rot, repair needed.

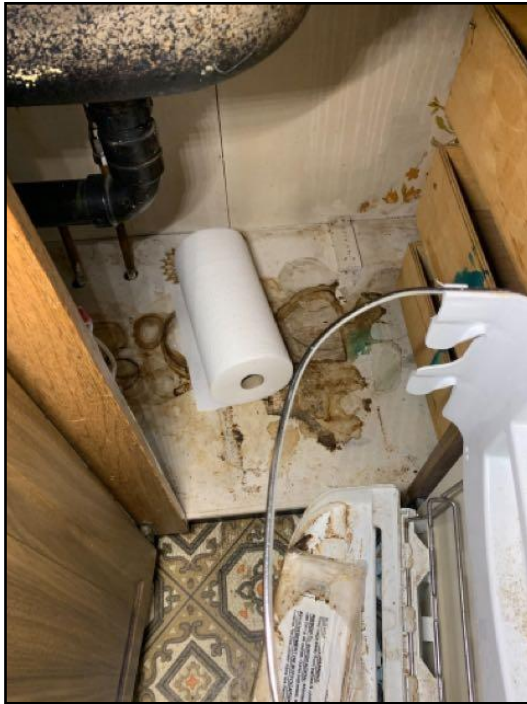
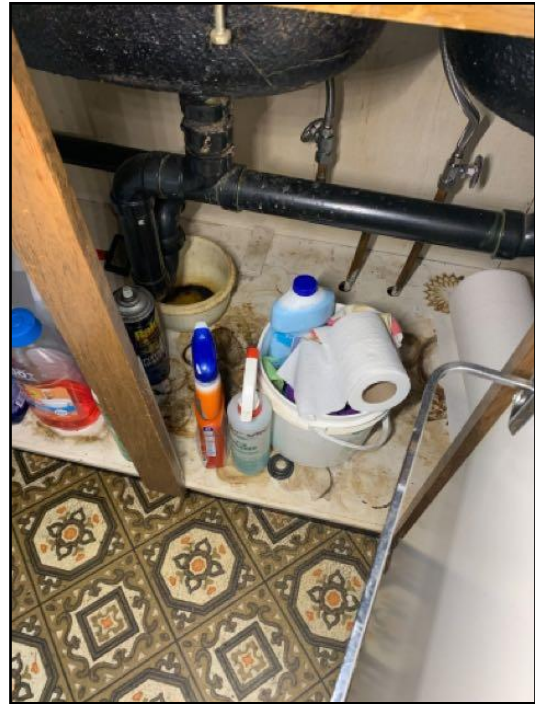
66. Condition: • [Water damage](#)

Under kitchen sink

Implication(s): Material deterioration

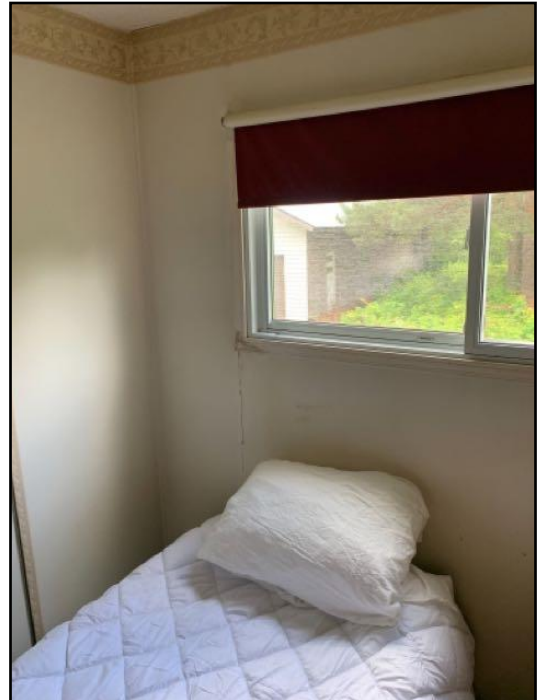
191. Water damage

68. Condition: • [Water damage](#)

Implication(s): Material deterioration

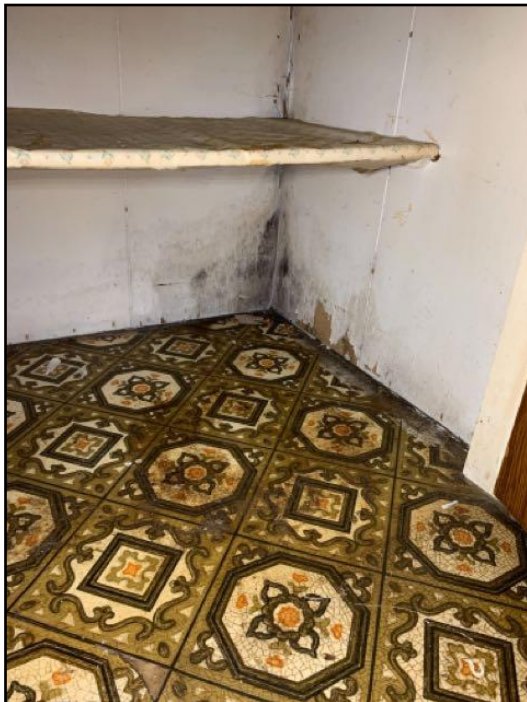
194. Mold

71. Condition: • Mold

Implication(s): Health hazard
