# YOUR Inspection Report

97 Main st  
Example Report, ON

MOULD STAIN REMOVAL - ATTIC

Thursday, January 1, 2015

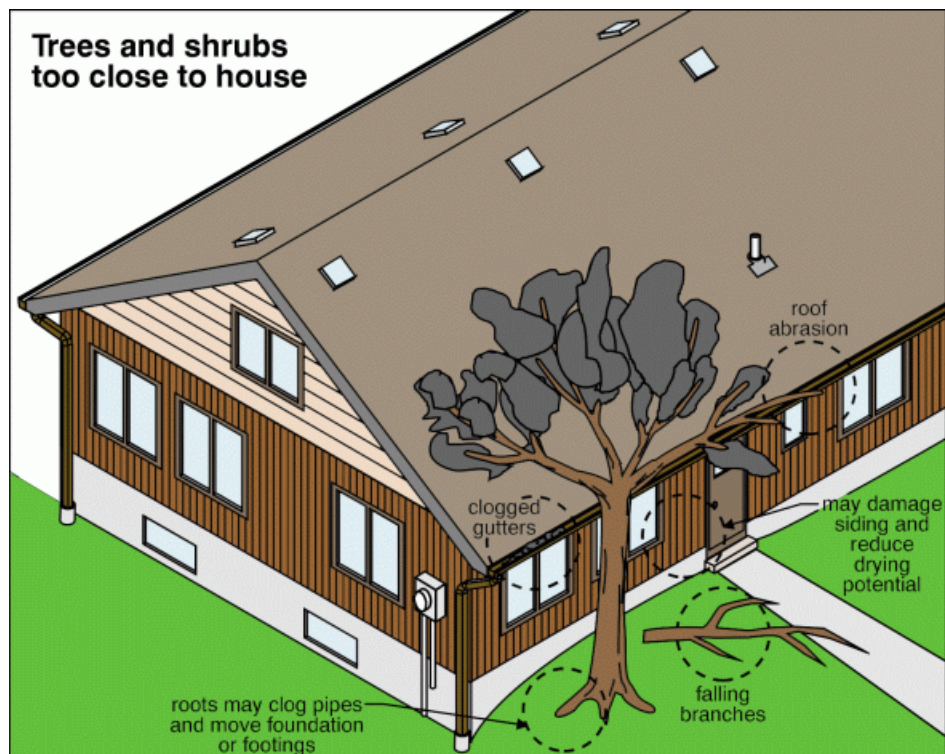
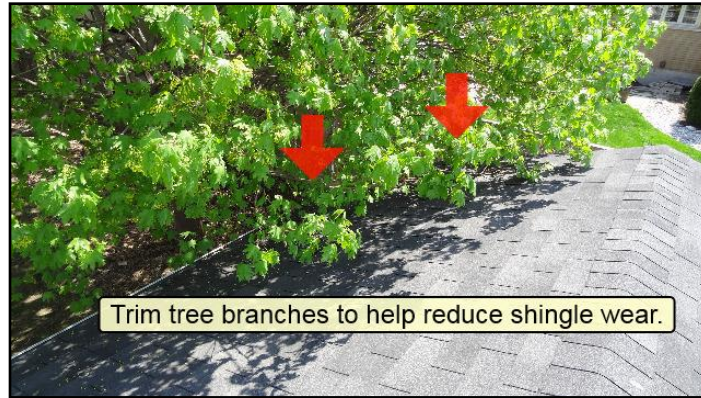
**Condition:** • [Vulnerable areas](#)

Remove tree branches from roof area.

**Implication(s):** Chance of water damage to contents, finishes and/or structure

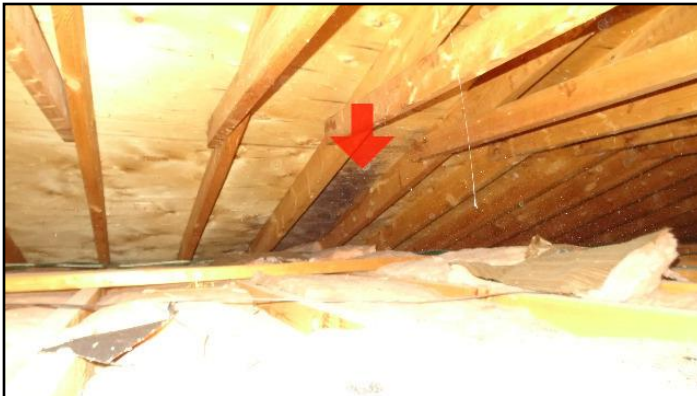
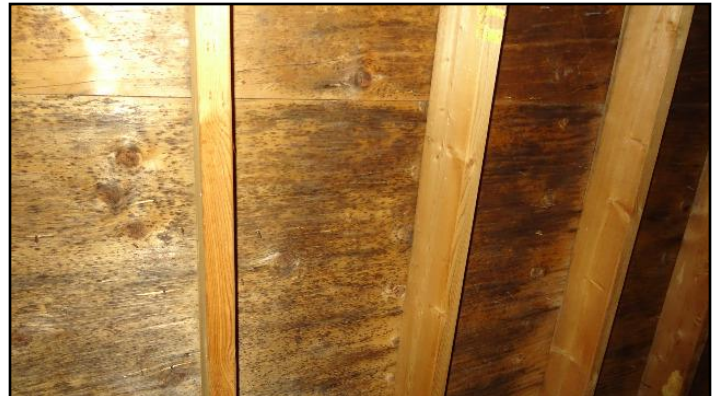
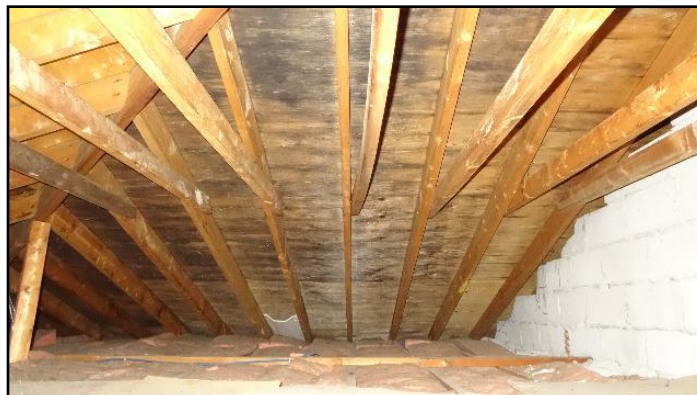
**Condition:** • [Mold](#)

Mould like substance noted in attic space.

**Implication(s):** Weakened structure | Chance of structural movement

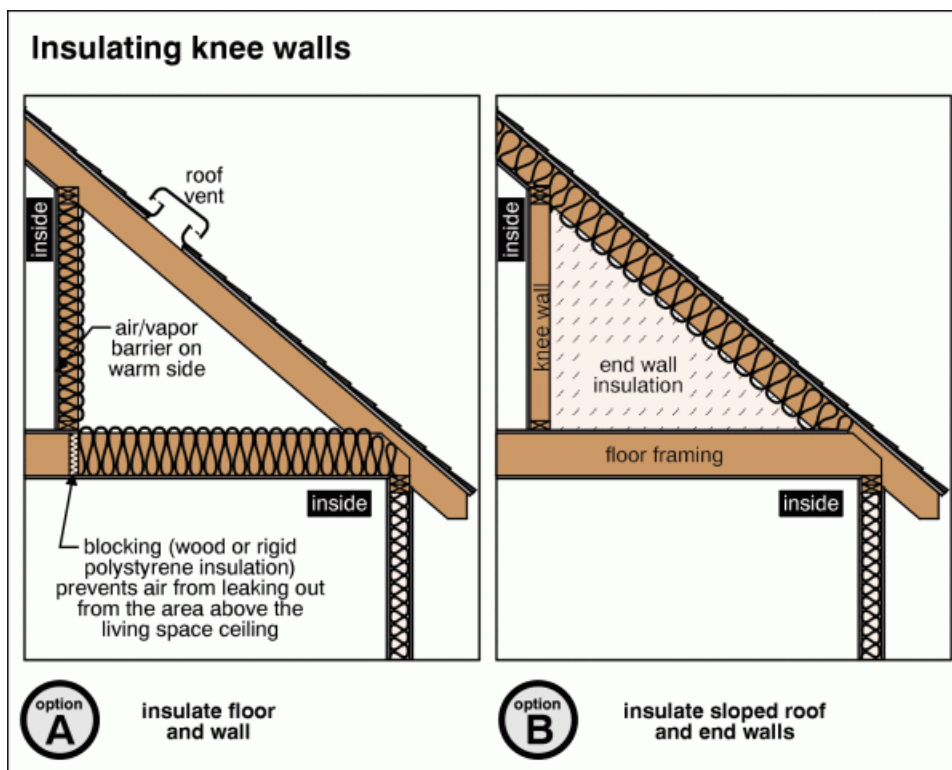
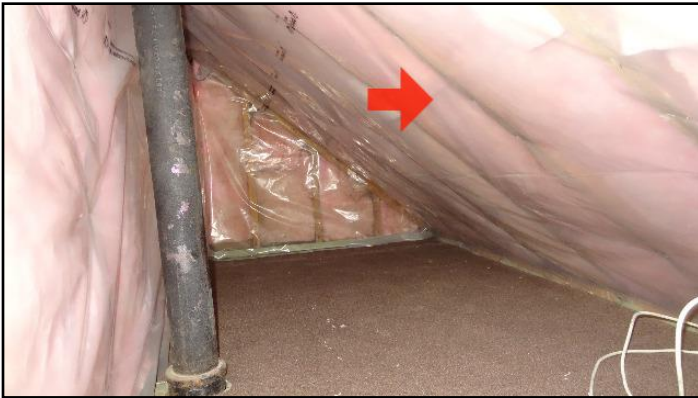
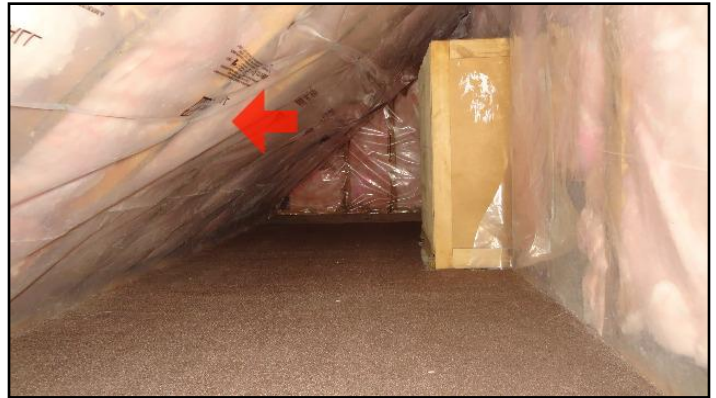
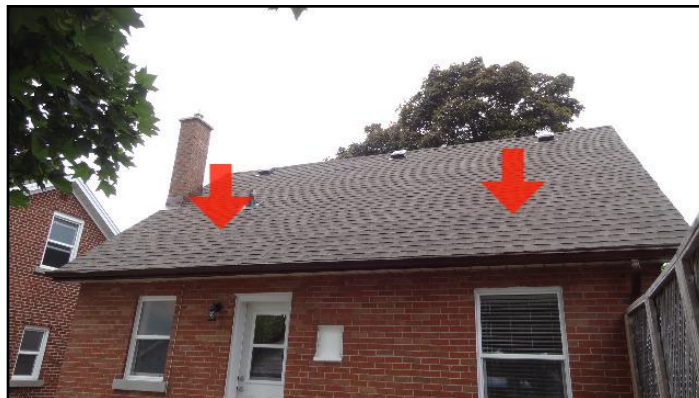
Condition: • [Missing](#)

Provide roof vents for knee wall ventilation and remove insulation on ceiling to prolong shingle life and help prevent mould growth.

**Implication(s):** Chance of condensation damage to finishes and/or structure

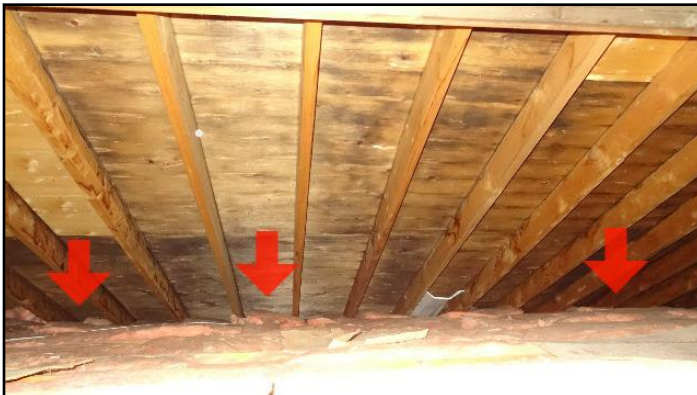
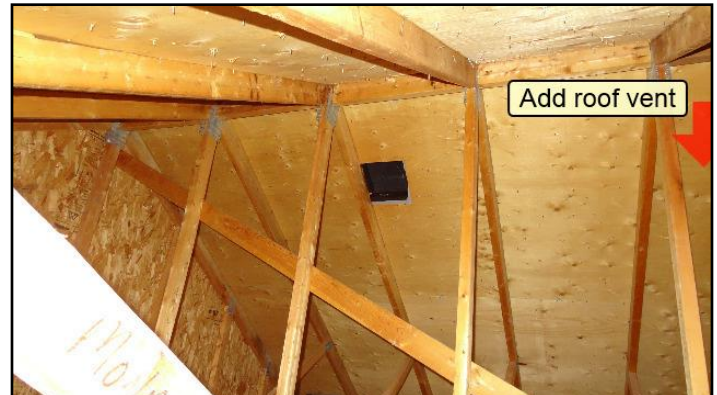
**Condition:** • [Missing](#)

Provide soffit venting and roof vents to increase air movement. Mould stains present in attic space.

**Implication(s):** Chance of condensation damage to finishes and/or structure

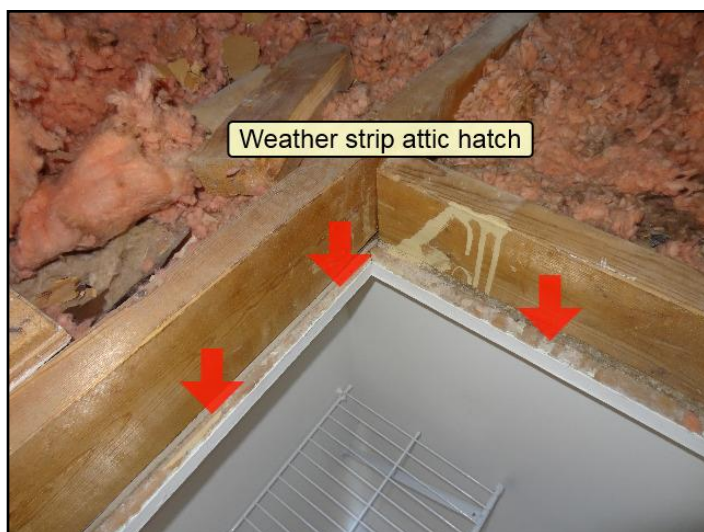
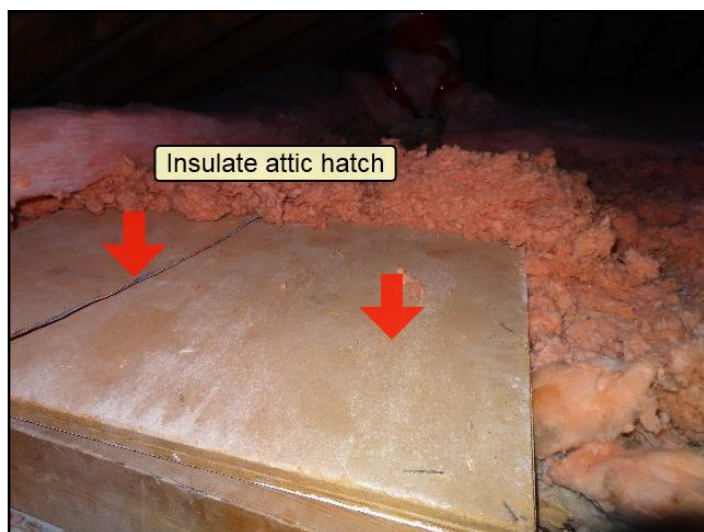
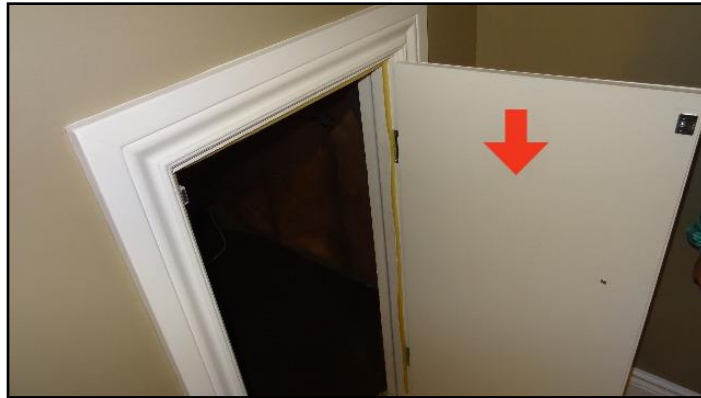
**Condition:** • [Not insulated and not weatherstripped](#)

Weather strip and insulate the attic hatch and knee wall door.

**Implication(s):** Chance of condensation damage to finishes and/or structure | Increased heating and cooling costs | Reduced comfort

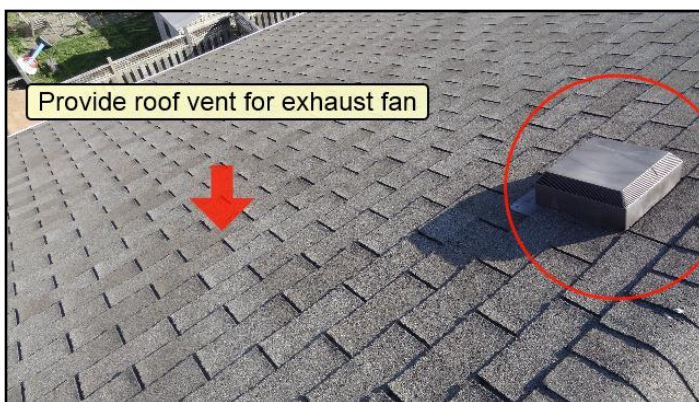
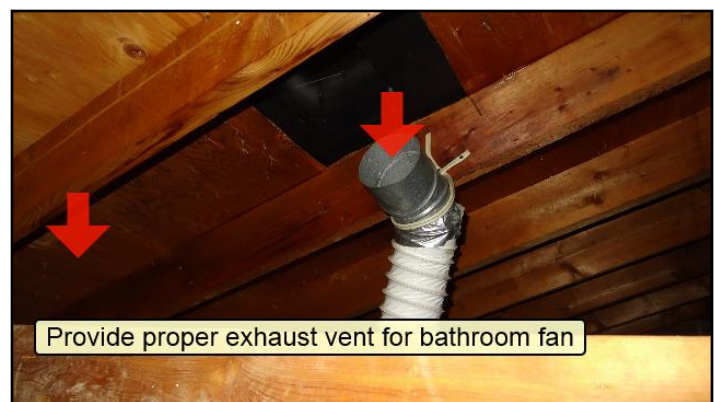
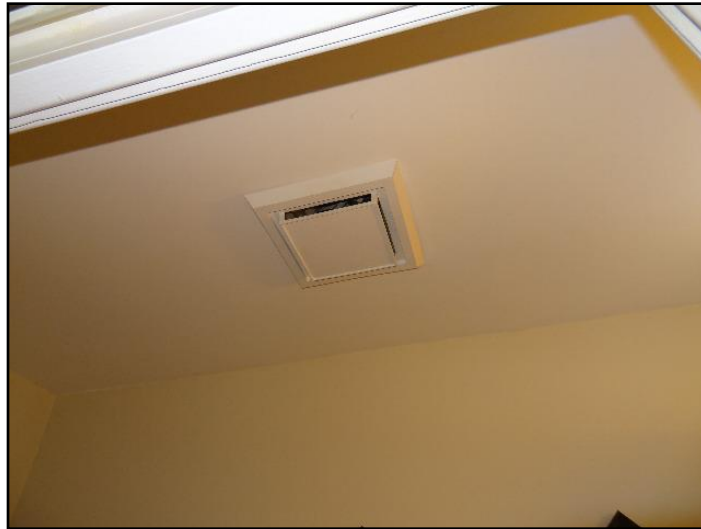
**Condition:** • [Not vented to exterior](#)

Provide exhaust termination point to exterior of home for bathroom vent.

**Implication(s):** Chance of condensation damage to finishes and/or structure
