# Your Inspection Report

Sea View Dr  
Mill Bay, BC

**INSPECTION DATE:**  
Wednesday, October 6, 2021

RE: Report No. 2857  
Sea View Dr  
Mill Bay, BC

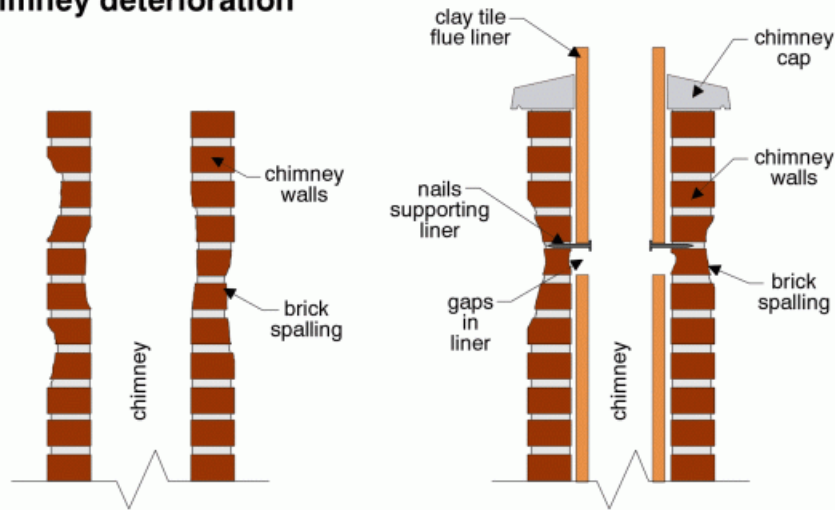
unlined chimneys are particularly prone to damage caused by condensation of flue gases - the damage tends to be worse near the top of the chimney

even lined chimneys can suffer from condensation related brick damage

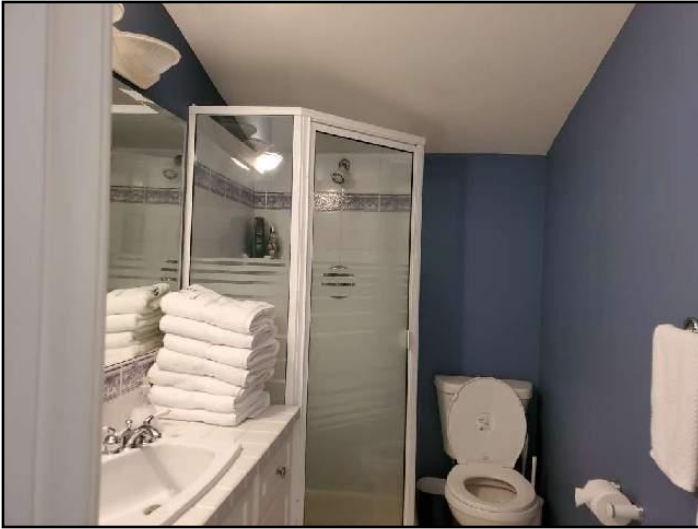
56.

- Finished basement pictures
