INSPECTION REPORT

For the Property at:
1234 SAMPLE LANE
POTTSTOWN, PA 19465

Prepared for: SAM PLE BOOKING
Inspection Date: Monday, July 24, 2017
Prepared by: Ed Gibson

RE: Report No. 1006, v.4
1234 Sample Lane
Pottstown, PA
19465

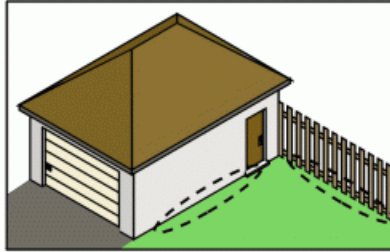
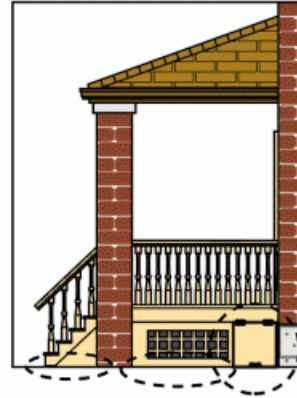
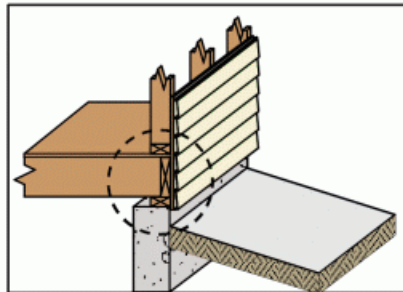
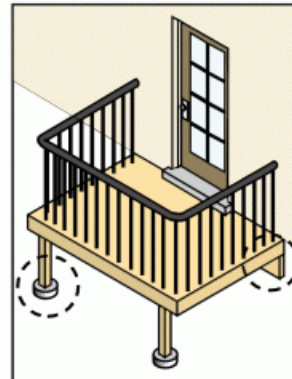
3. Wood/soil contact

7. Condition: • [Wood/soil contact](#)

Implication(s): Weakened structure | Chance of movement | Rot | Insect damage

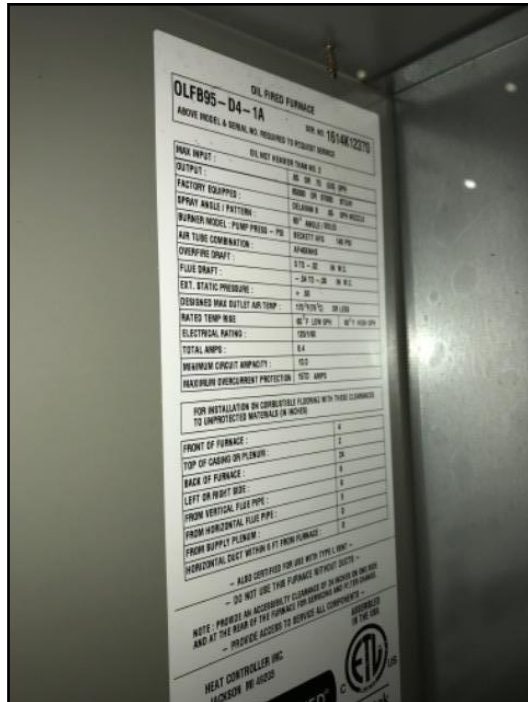
10. Oil

• [Oil](#)
