YOUR INSPECTION REPORT

89 Major Lake Road
Madawaska, ON K0J 2E0

Dunbar
Home Inspections

RE: Report No. 10333
89 Major Lake Road
Madawaska, ON
K0J 2E0

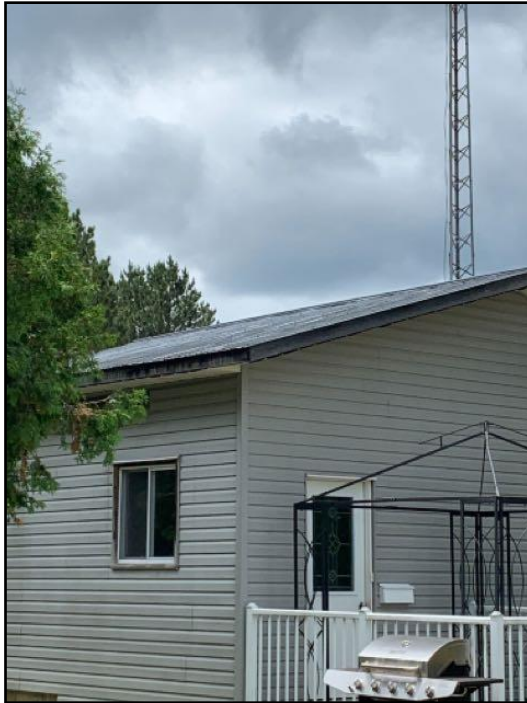
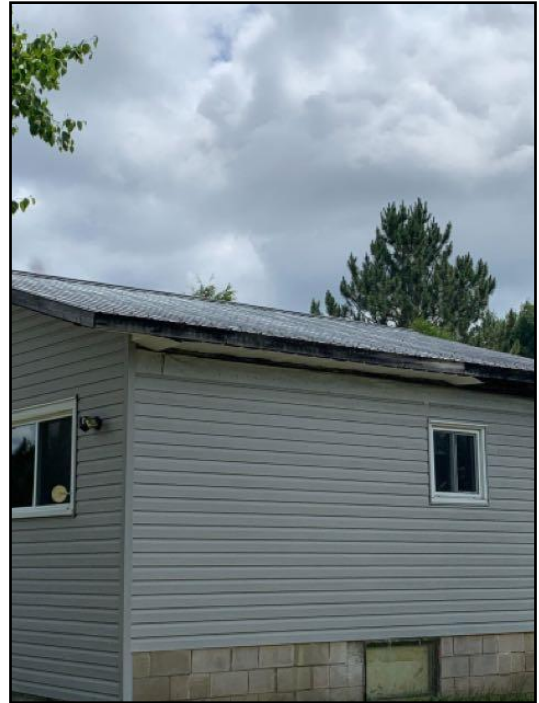
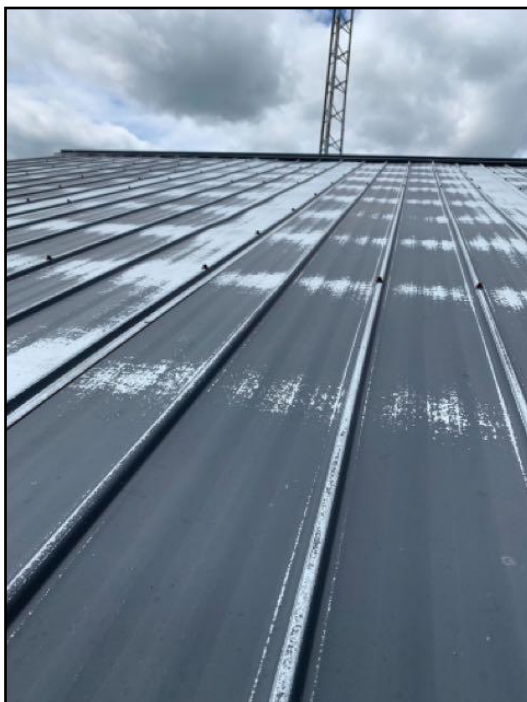
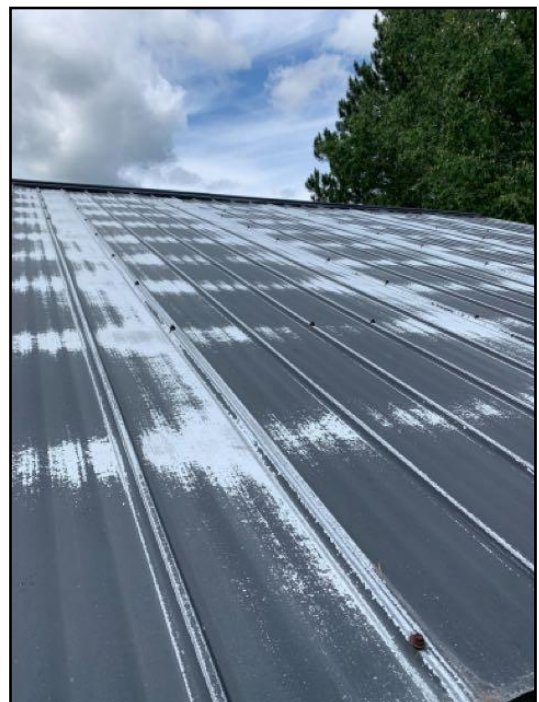
Metal roof on front part of house is much older than rear part of house.

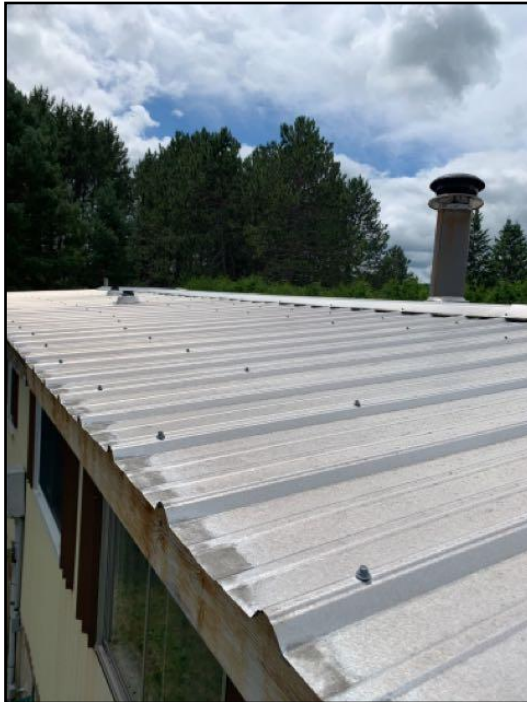
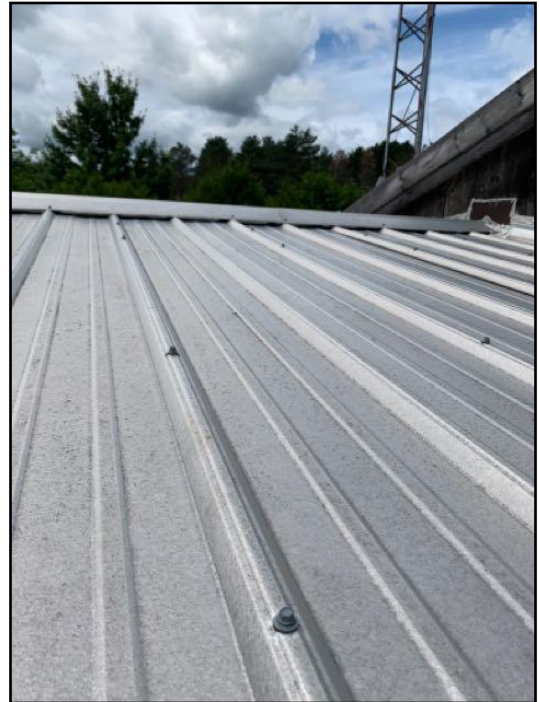
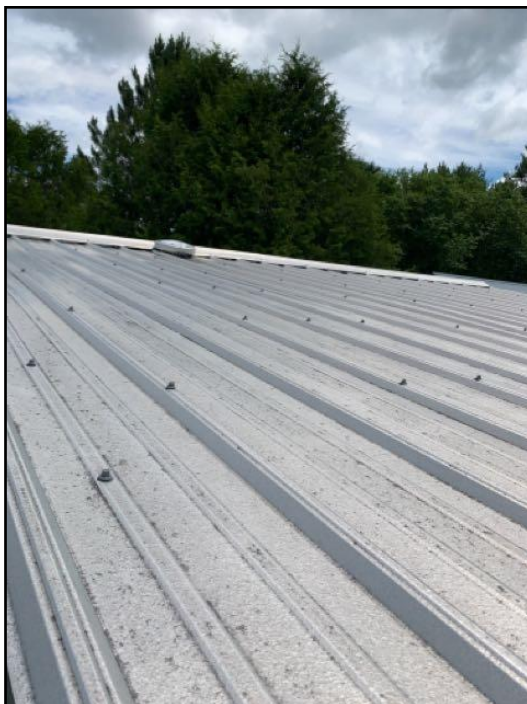
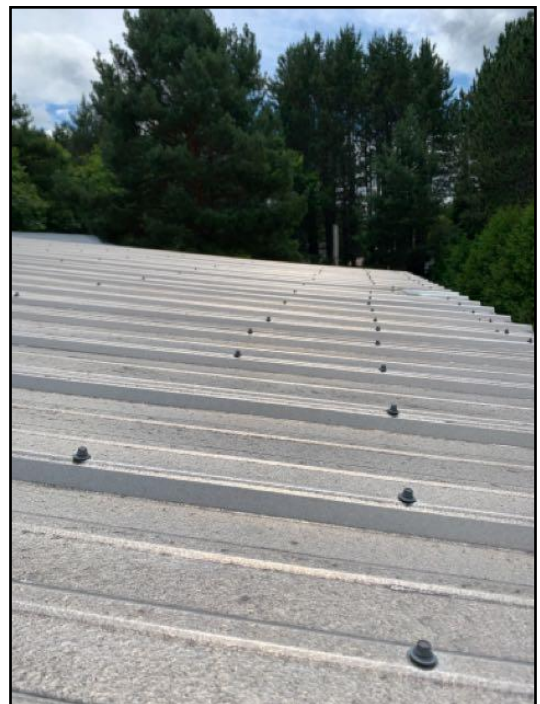
Metal roof on rear part of house is newer and in good condition

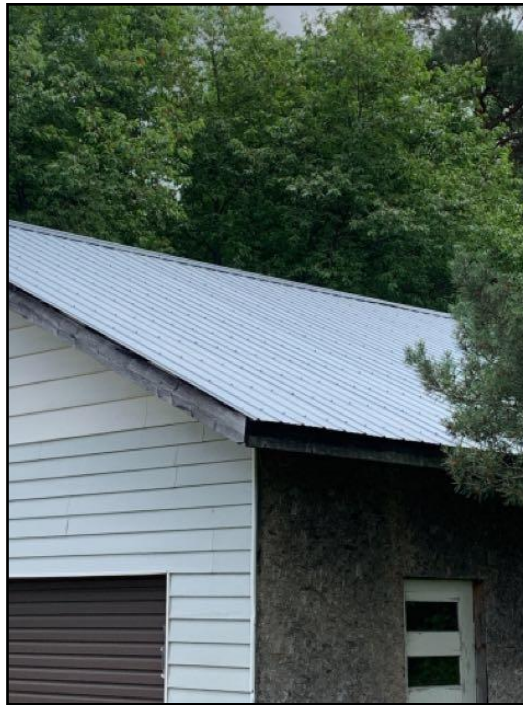
9. Metal

Metal roof on garage is in good condition

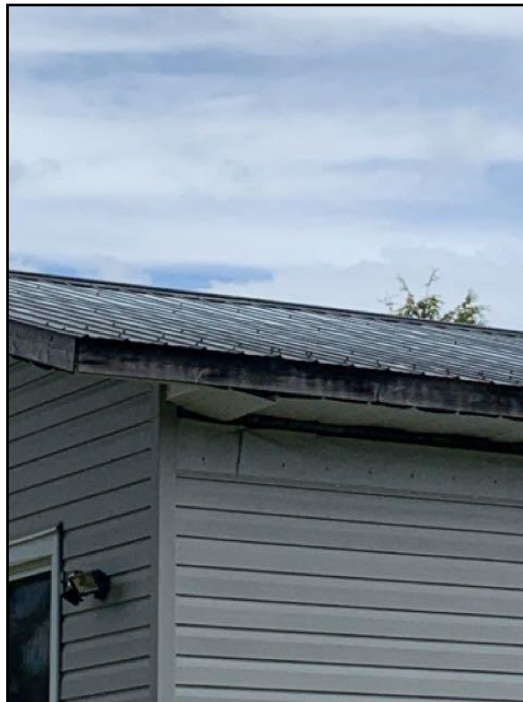
12. Rust

2. Condition: • [Rust](#)

Rusted screws and some are loose, repair needed.

Implication(s): Chance of water damage to structure, finishes and contents

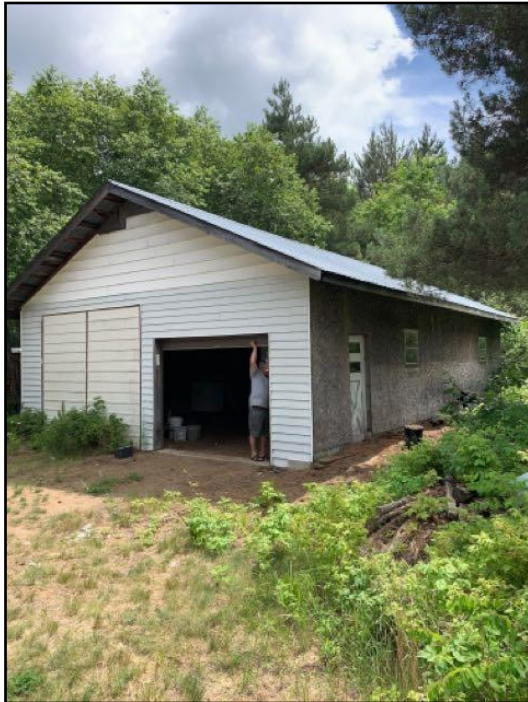
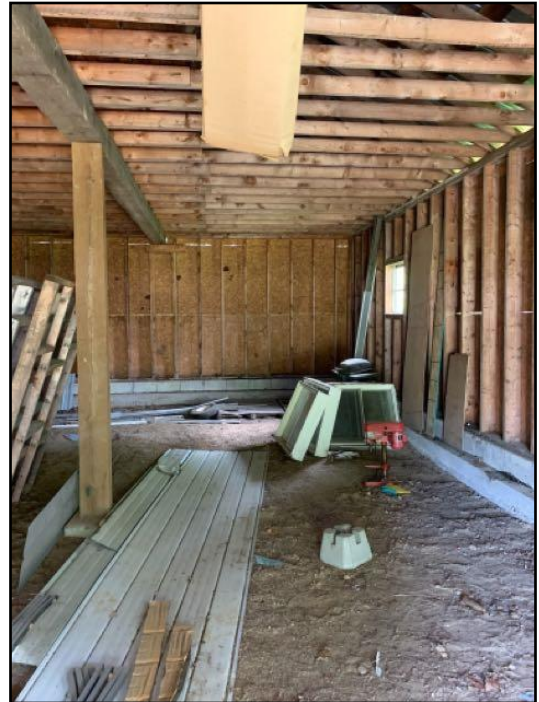
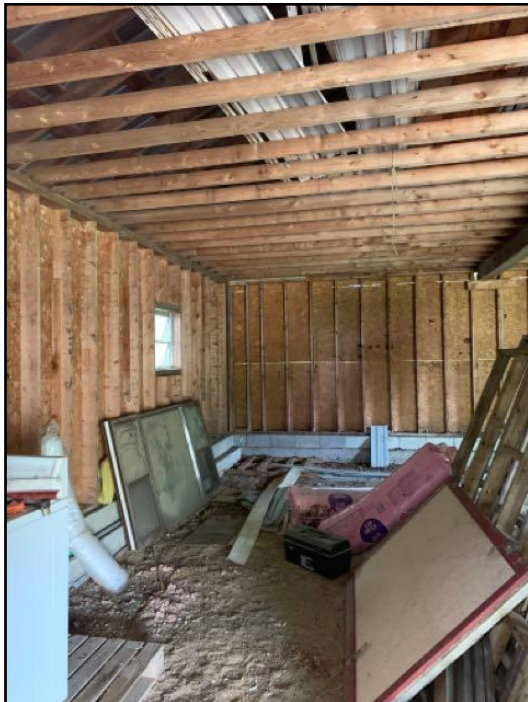
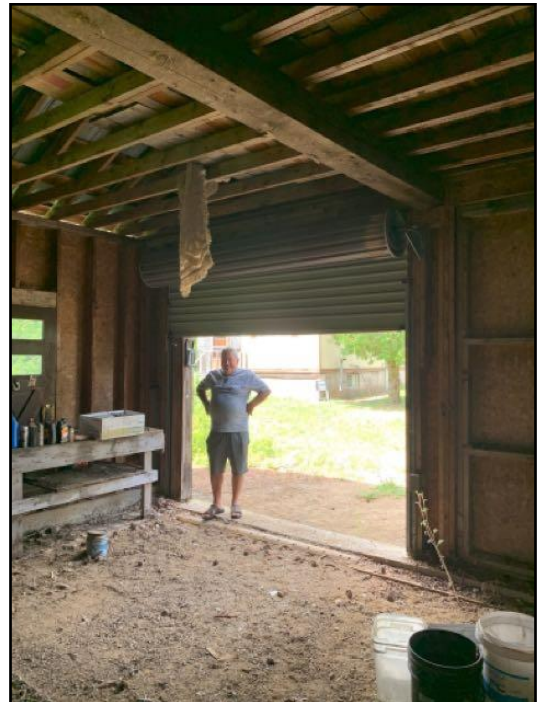
Garage door opens manually but does not stay open. No electricity in garage.

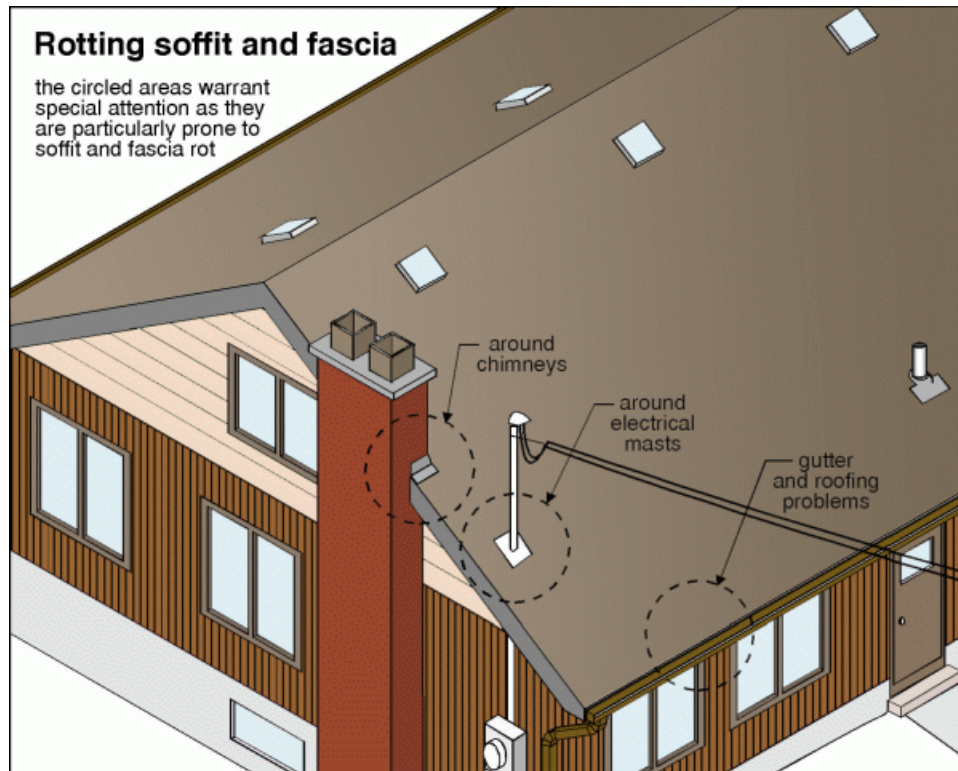
4. Condition: • [Loose or missing pieces](#)

Missing soffit and fascia, fascia needs to be covered with aluminum to prevent rot. Repair needed around whole house.

Implication(s): Chance of pests entering building | Chance of water damage to structure, finishes and contents

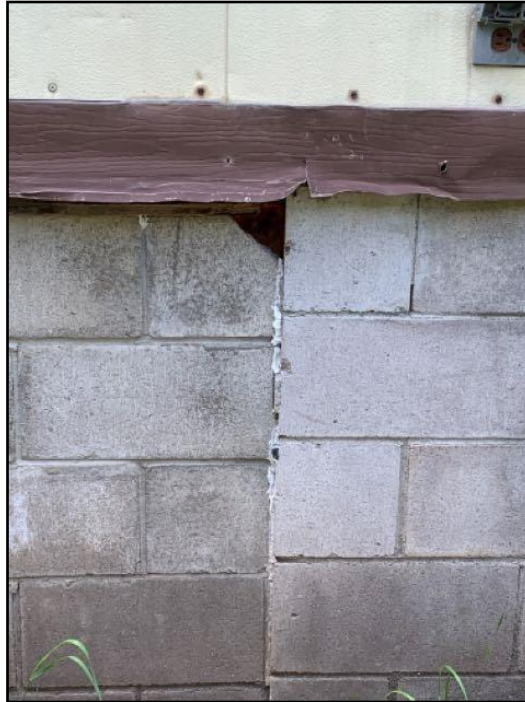
40. Caulking missing or ineffective

6. Condition: • [Caulking missing or ineffective](#)

Hole should be sealed up.

Implication(s): Chance of water damage to structure, finishes and contents

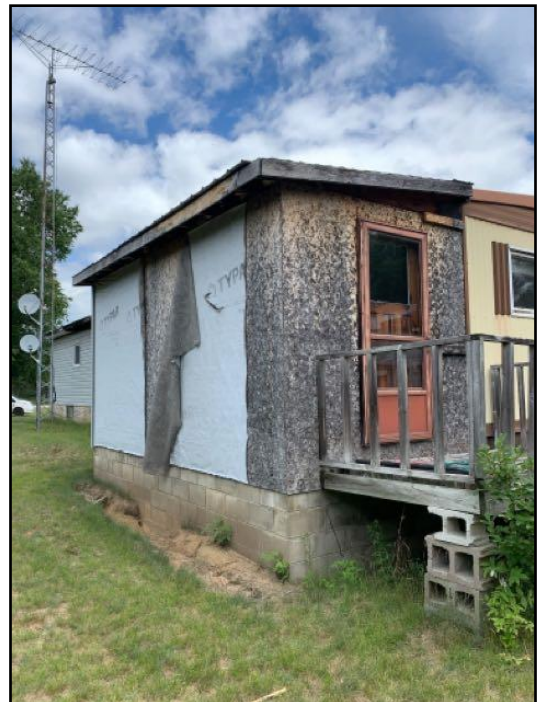
50.

11. Condition: • Exposed OSB starting to deteriorate from the weather, this area needs to be covered with weatherproof material. These sheets may need to be replaced.

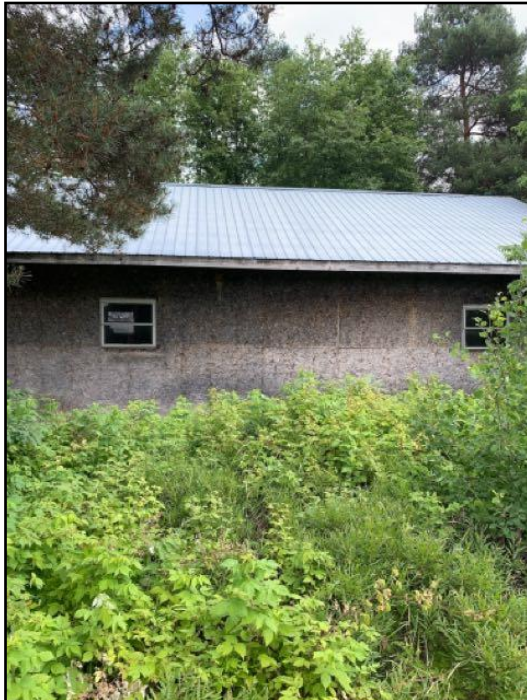
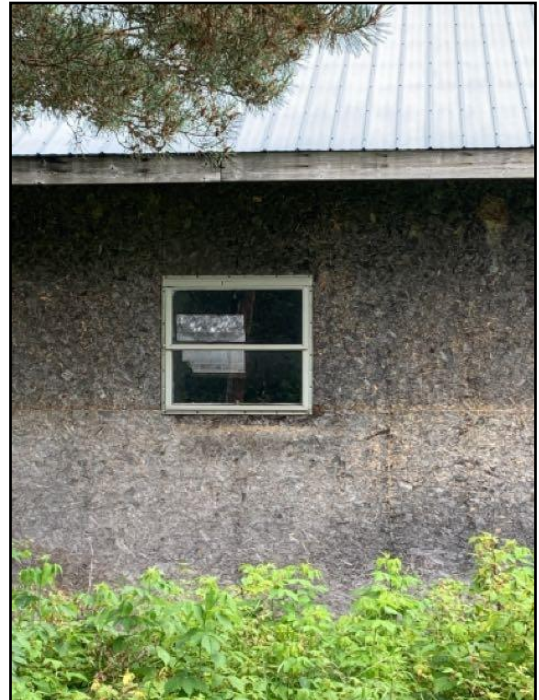
14. Condition: • Exposed OSB walls and wood fascia on garage need to be covered before they get rotten. Repair needed.

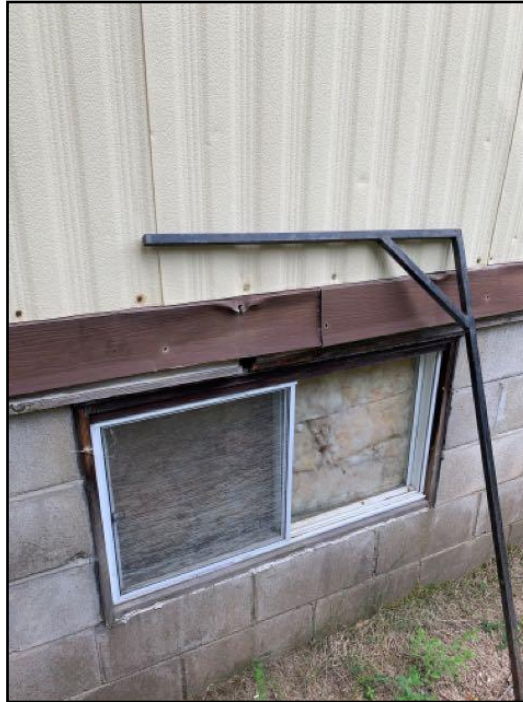
56. Damage

15. Condition: • [Damage](#)

Implication(s): Chance of water damage to structure, finishes and contents

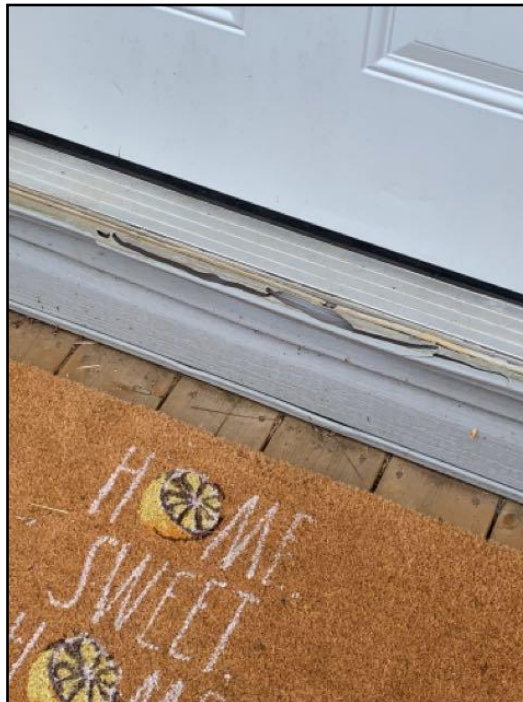
59. Mechanical damage

17. Condition: • [Mechanical damage](#)

Implication(s): Chance of water damage to structure, finishes and contents

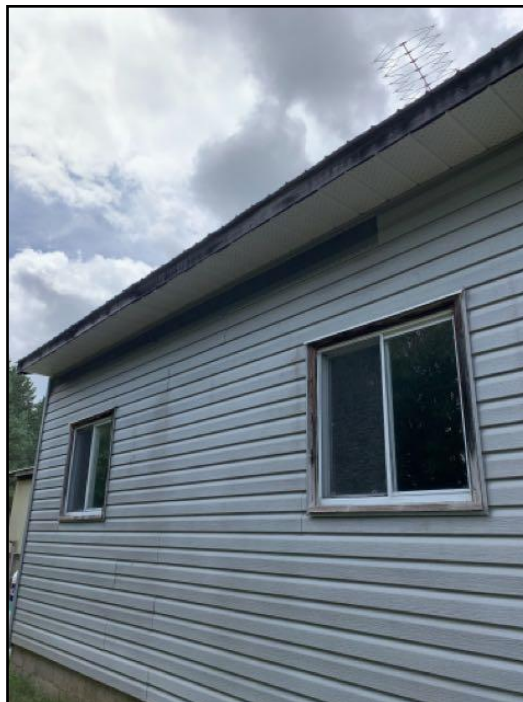
62. Loose or missing pieces

19. Condition: • [Loose or missing pieces](#)

Implication(s): Chance of water damage to structure, finishes and contents

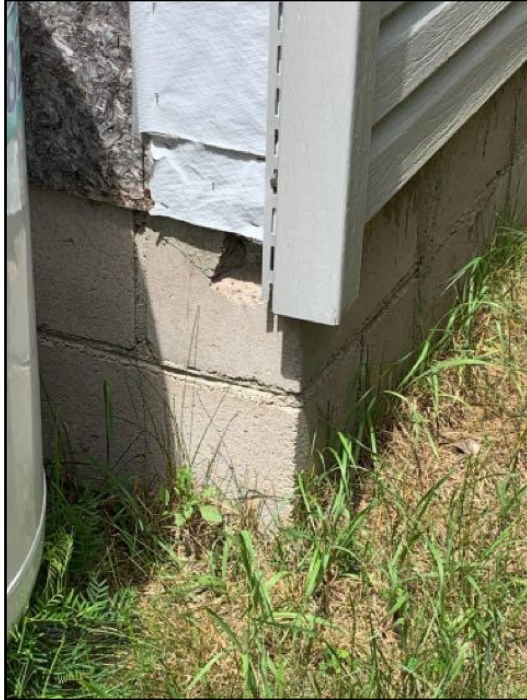
63. Masonry deterioration

20. Condition: • [Masonry deterioration](#)

Implication(s): Weakened structure | Chance of structural movement

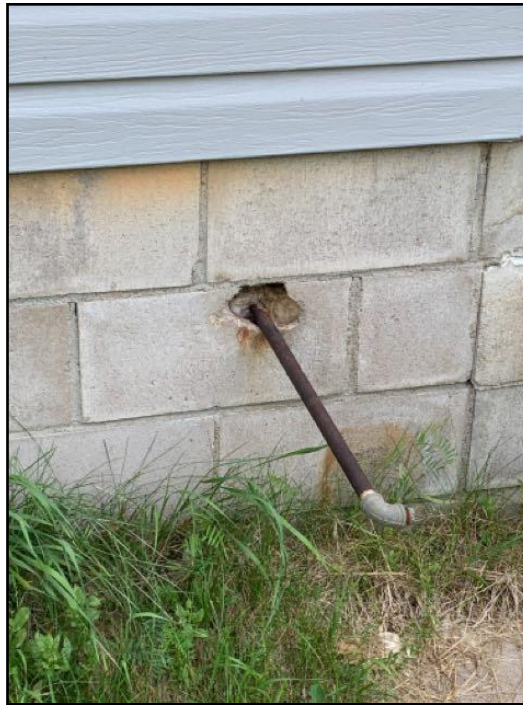
71.

23. Condition: • Hole in foundation wall needs to be filled and repaired

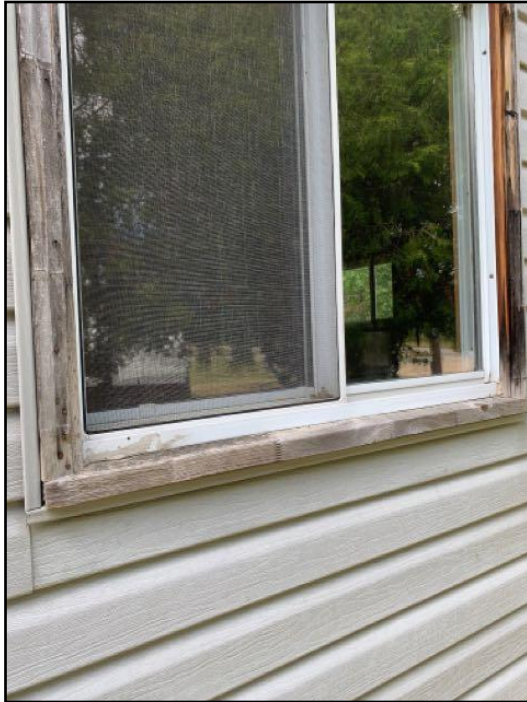
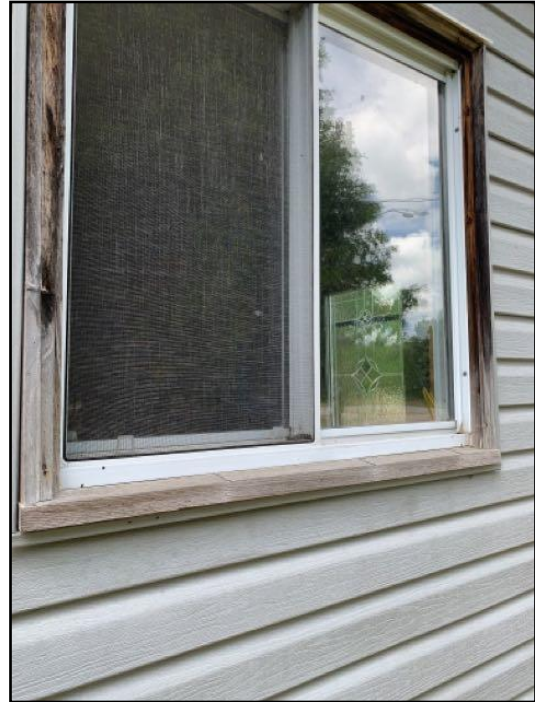
72. Paint or aluminum cap window frames. Seal...

24. Condition: • Paint or aluminum cap window frames.

Wood frames will rot if not painted or capped with aluminum, repair needed.

Seal with caulk to prevent air leaks and moisture intrusion.

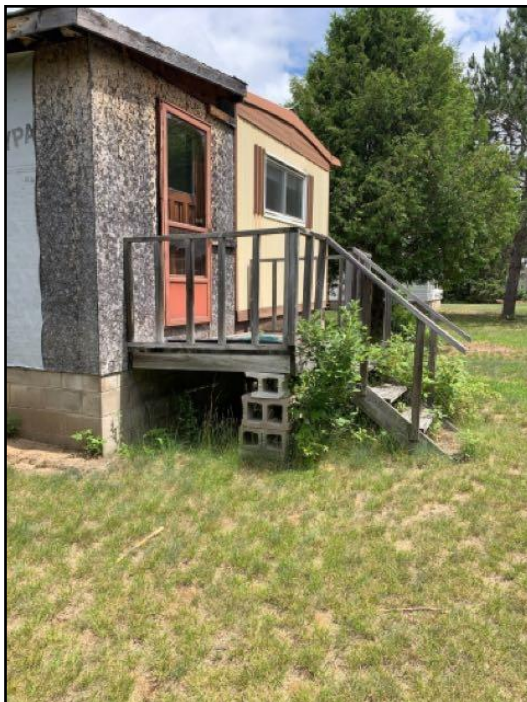
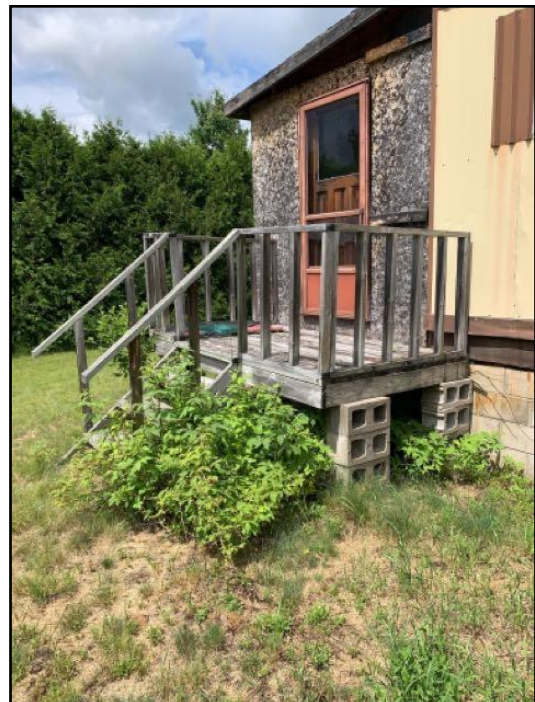
74. Disrepair

25. Condition: • Disrepair

Deck is rotten and poorly built, do not use. Removal needed

Implication(s): Weakened structure

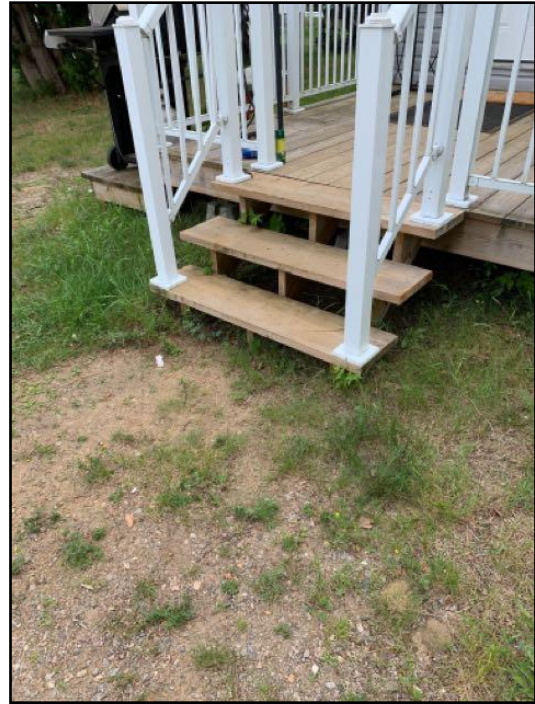
77. Wood/soil contact

26. Condition: • [Wood/soil contact](#)

Implication(s): Rot | Insect damage

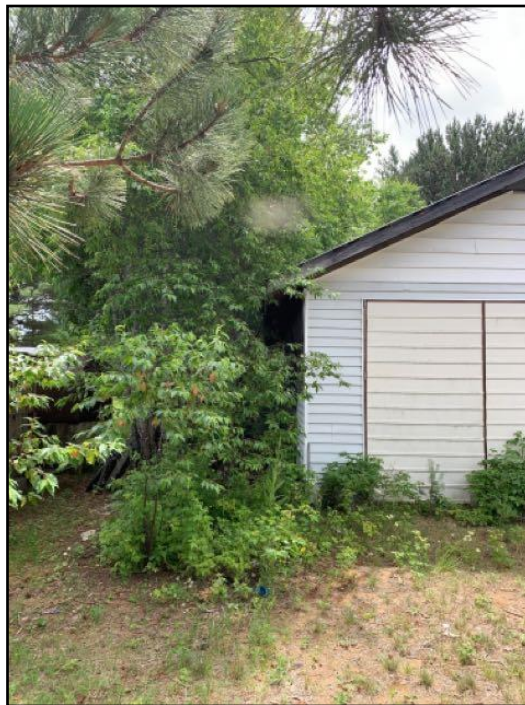
78. *Trees or shrubs too close to building*

27. Condition: • [Trees or shrubs too close to building](#)

Implication(s): Chance of pests entering building | Material deterioration | Chance of water damage to structure, finishes and contents

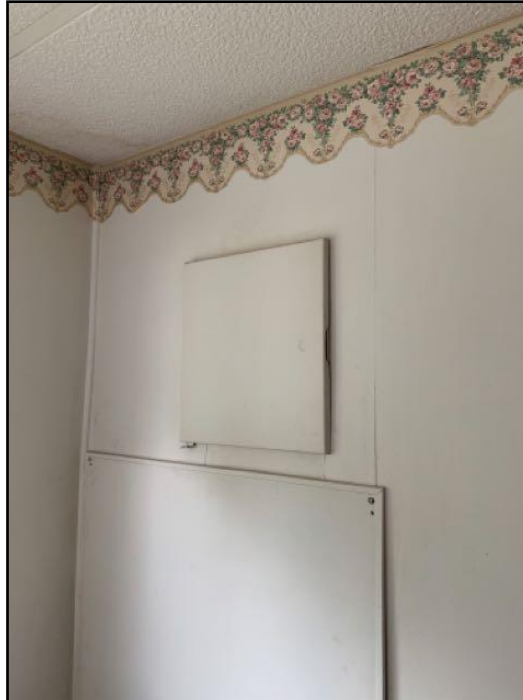
85.

28. Condition: • Panel cover is loose.

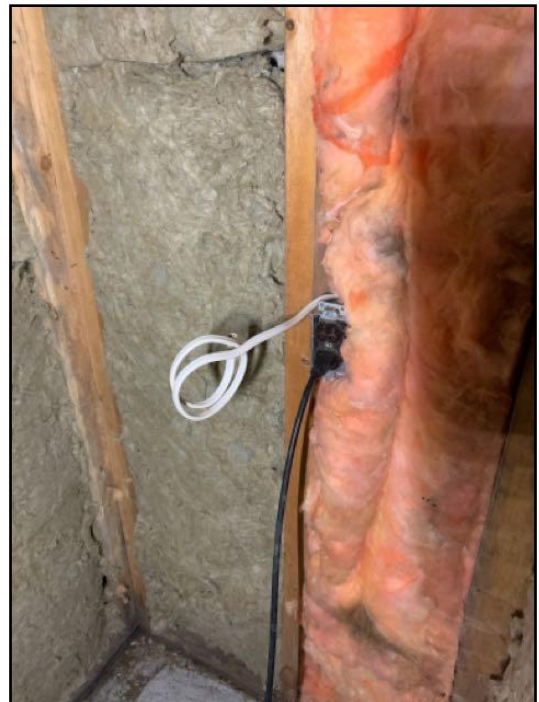
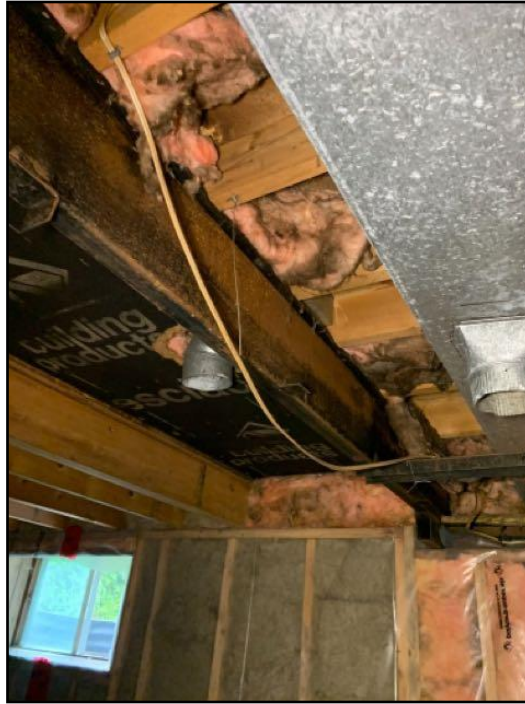
30. Condition: • Info and loose wiring in rear of basement, these wires should be looked at by an electrician to ensure it was done properly.

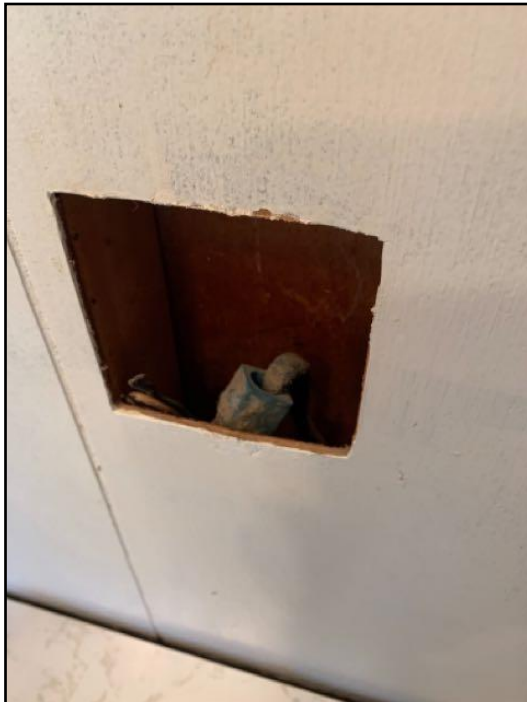
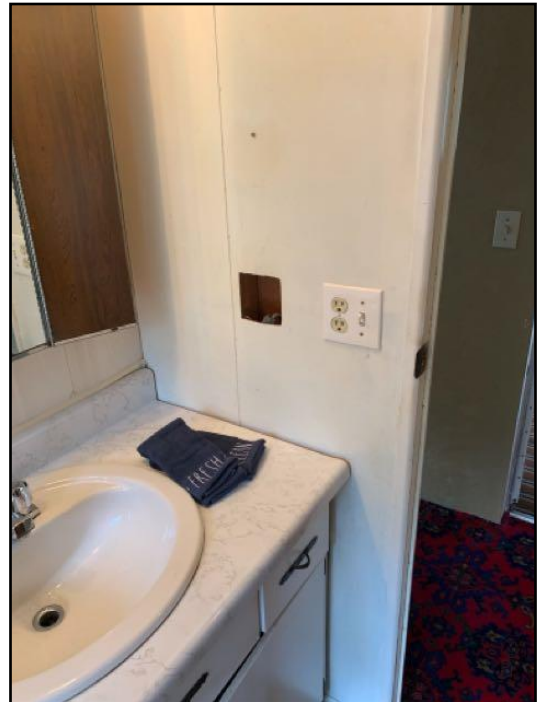
90. Exposed on walls or ceilings

31. Condition: • [Exposed on walls or ceilings](#)

Implication(s): Electric shock

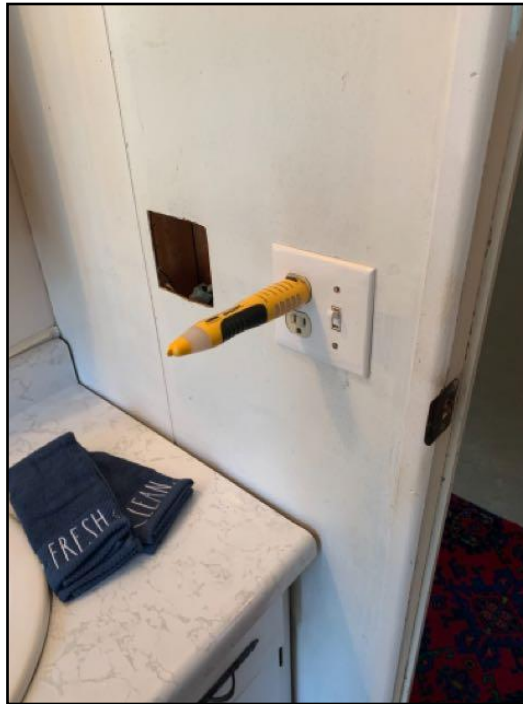
94. Inoperative

33. Condition: • [Inoperative](#)

Bathroom outlet is inoperative, this outlet needs to be gfci protected.

Implication(s): Equipment inoperative

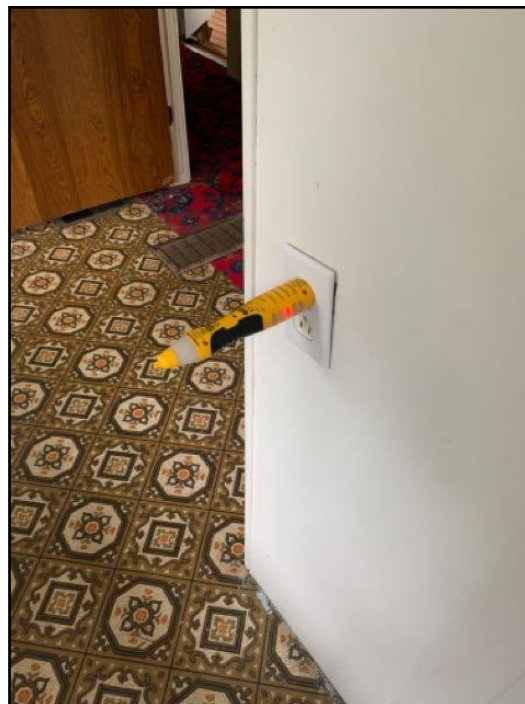
95. Reversed polarity

34. Condition: • [Reversed polarity](#)**Implication(s):** Electric shock**Reversed polarity**

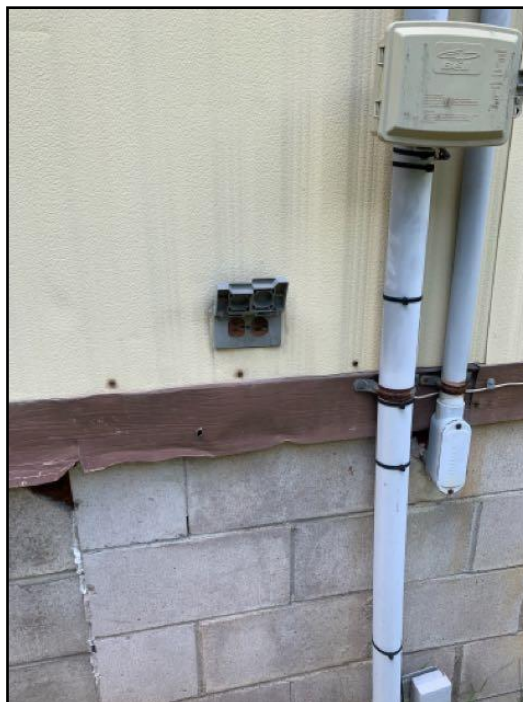
96. GFCI/GFI needed (Ground Fault Circuit...

35. Condition: • [GFCI/GFI needed \(Ground Fault Circuit Interrupter\)](#)

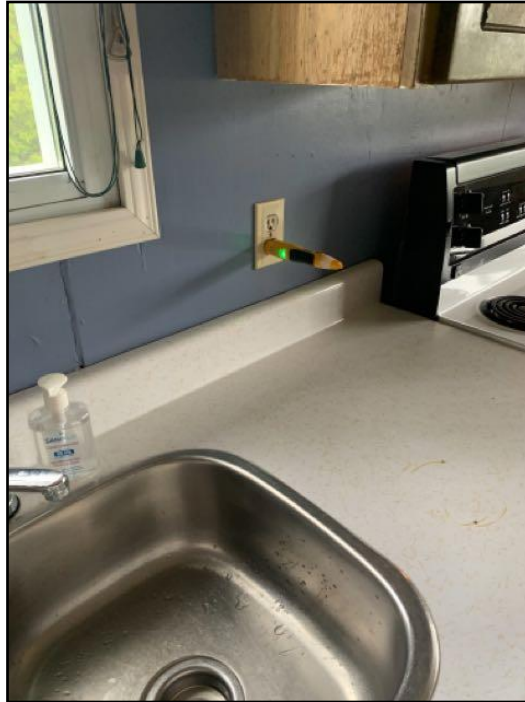
97. GFCI/GFI needed (Ground Fault Circuit...

36. Condition: • [GFCI/GFI needed \(Ground Fault Circuit Interrupter\)](#)

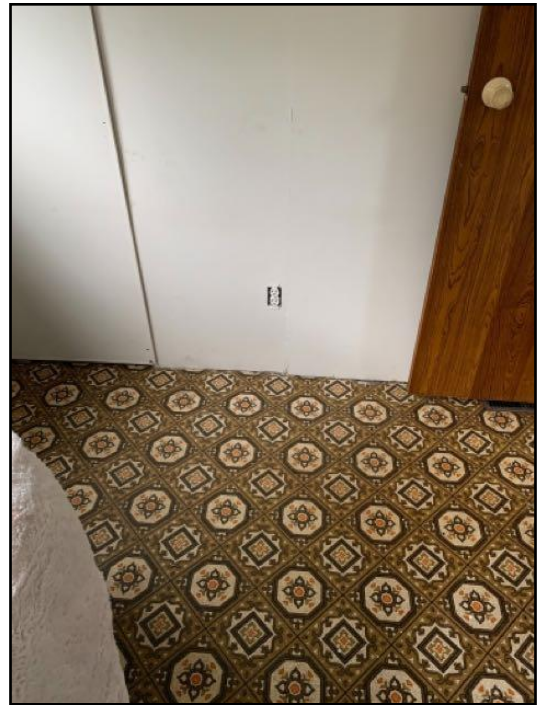
100.

38. Condition: • Painted outlet should be replaced, needs cover plate.

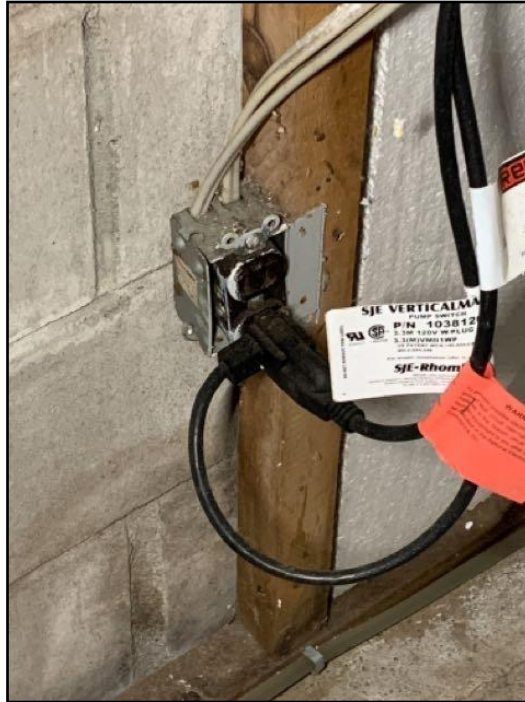
101. Missing

39. Condition: • [Missing](#)

Cover plates missing throughout

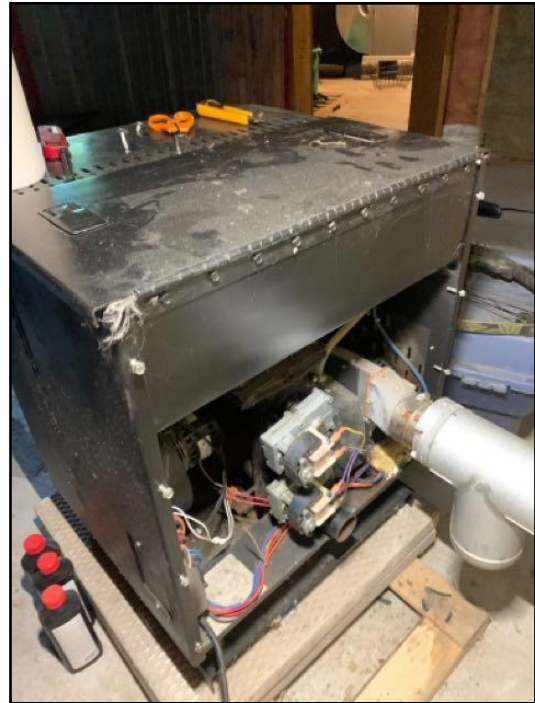
107.

Auxiliary heat: • Pellet stove in basement. Did not test, appears to be under repair.

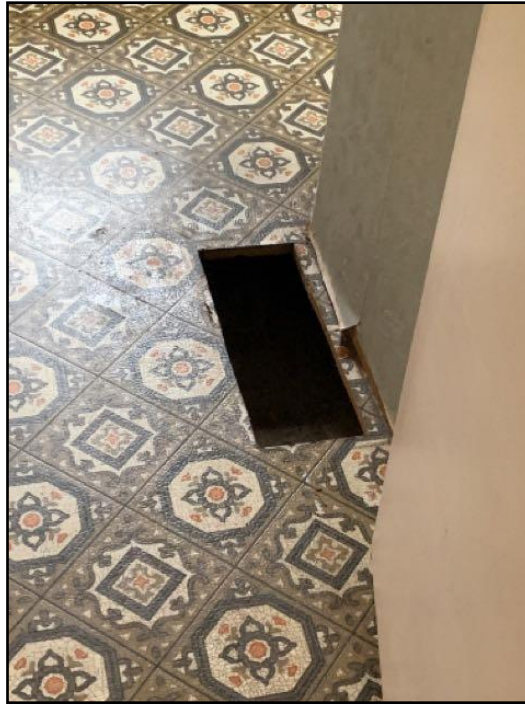
108. *Missing*

41. Condition: • Missing

Missing grills in some rooms.

Implication(s): Reduced comfort | Increased heating costs

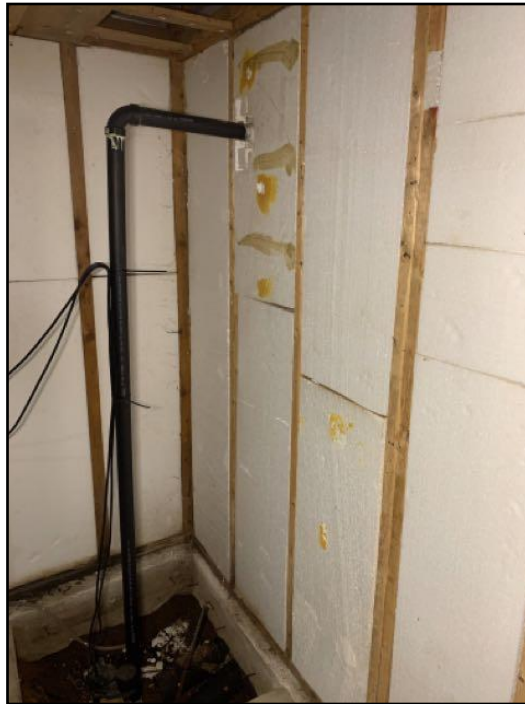
110. *Exposed combustible insulation*

42. Condition: • [Exposed combustible insulation](#)

Implication(s): Fire hazard

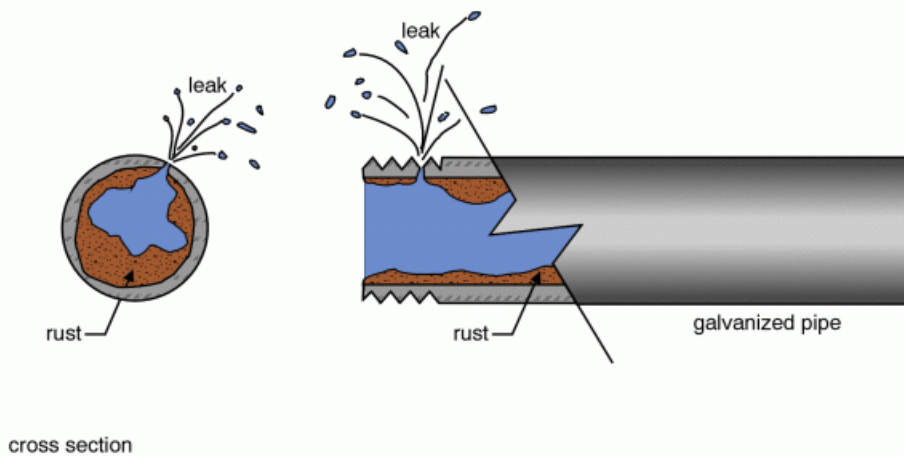
115. Rust

43. Condition: • [Rust](#)

Water supply for bathroom has rusted clamps and is a plastic line with very little support, recommend replacement of water line to bathroom

Implication(s): Chance of water damage to structure, finishes and contents | Leakage | Reduced system life expectancy | Equipment failure

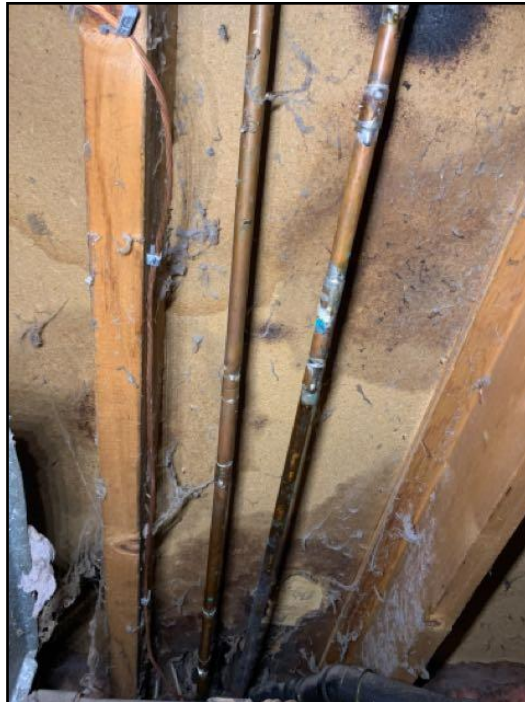
118.

44. Condition: • Multiple joints in copper lines to vanity, recommend replacement

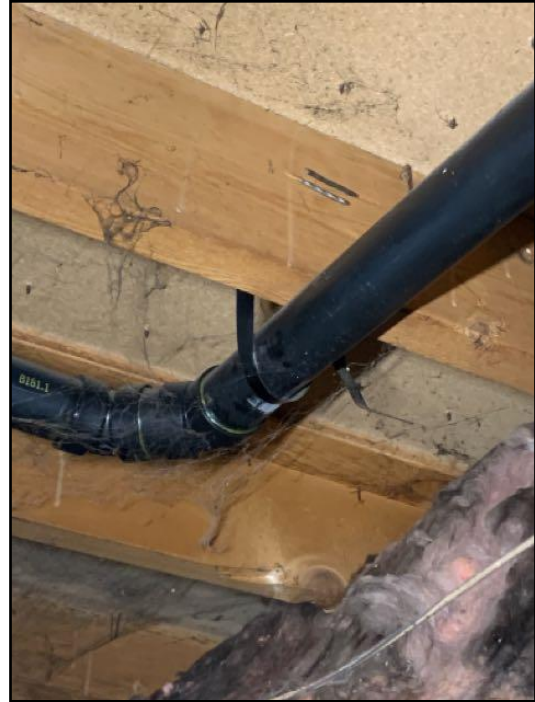
120. Poor support

45. Condition: • [Poor support](#)

Plumbing lines from kitchen are not properly supported, repair needed

Implication(s): Sewage entering the building | Chance of water damage to structure, finishes and contents

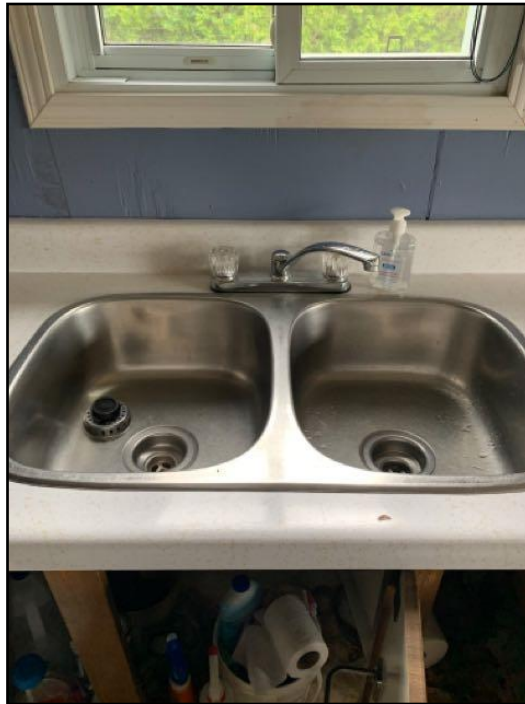
121. Loose

46. Condition: • [Loose](#)

Implication(s): Equipment failure

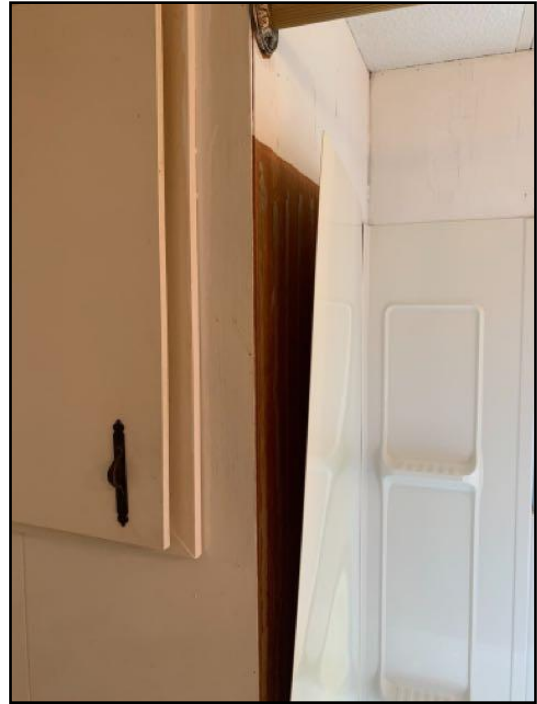
124.

48. Condition: • Shower stall enclosure is falling off and not properly caulked, recommend repair or replacement.

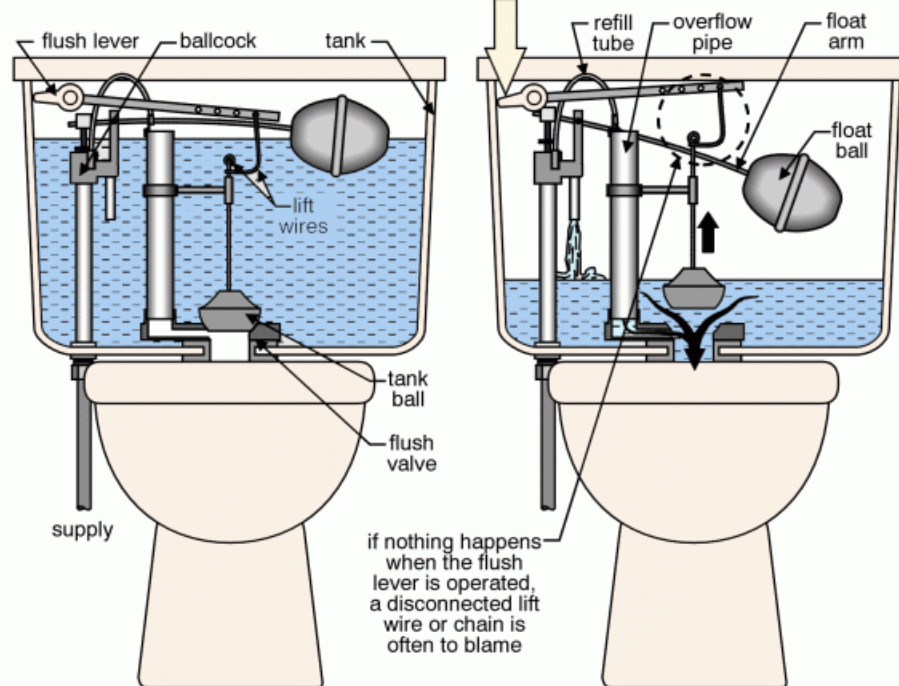
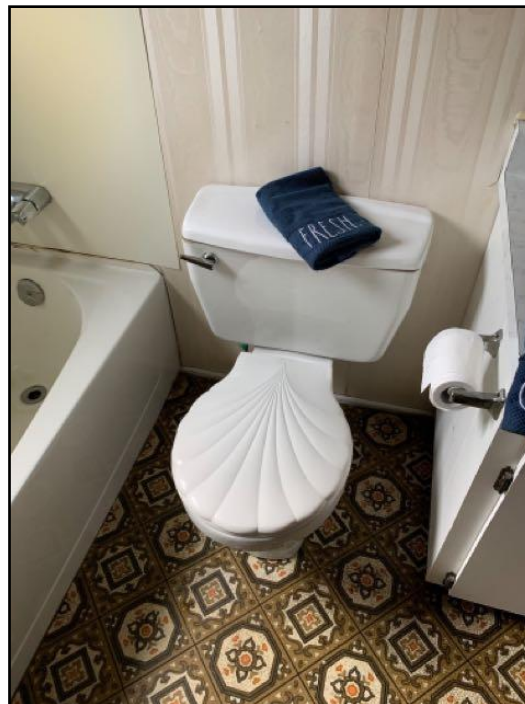
125. Running continuously

49. Condition: • [Running continuously](#)

Implication(s): Chance of condensation damage to finishes and/or structure | Increased water consumption

Toilet flush mechanism

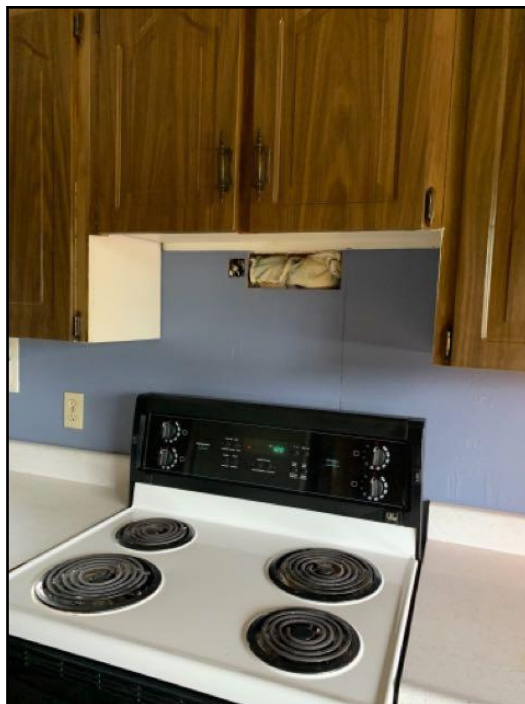
151. Range hood

- Range hood Missing

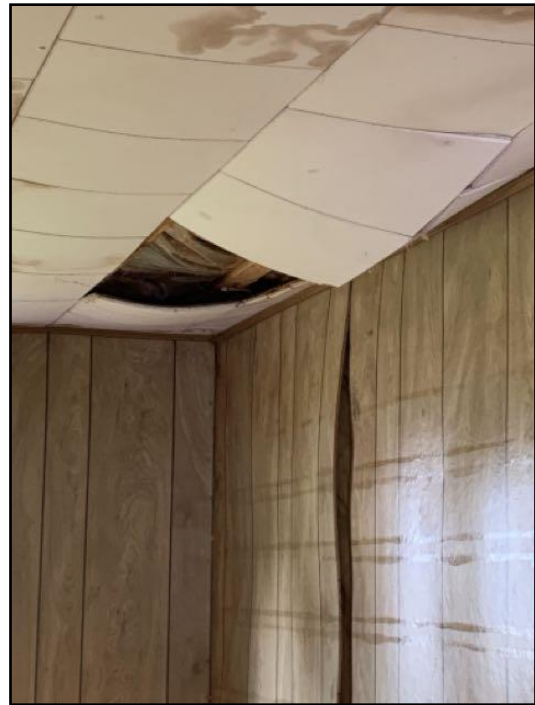
158.

51. Condition: • Extensive signs of water damage in back room, recommend removal of paneling and insulation to investigate further.

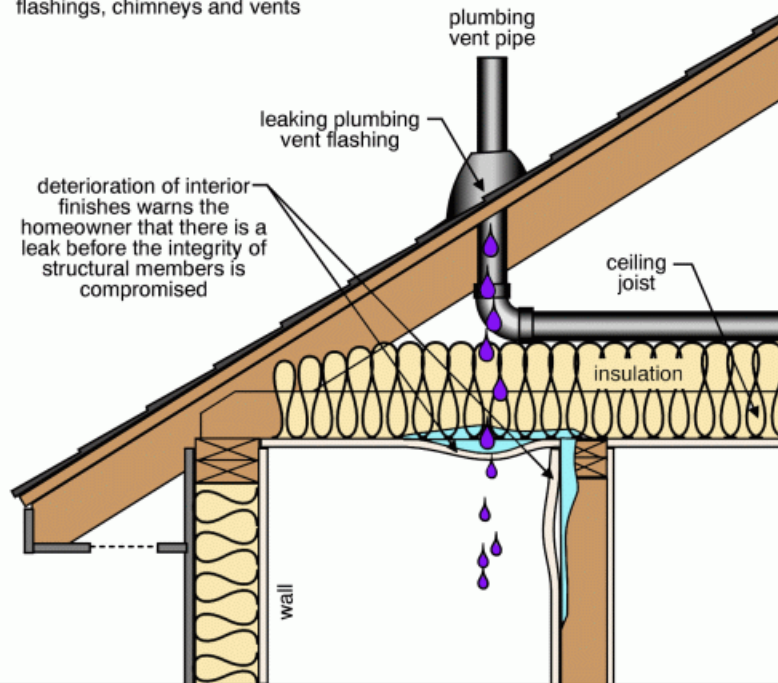
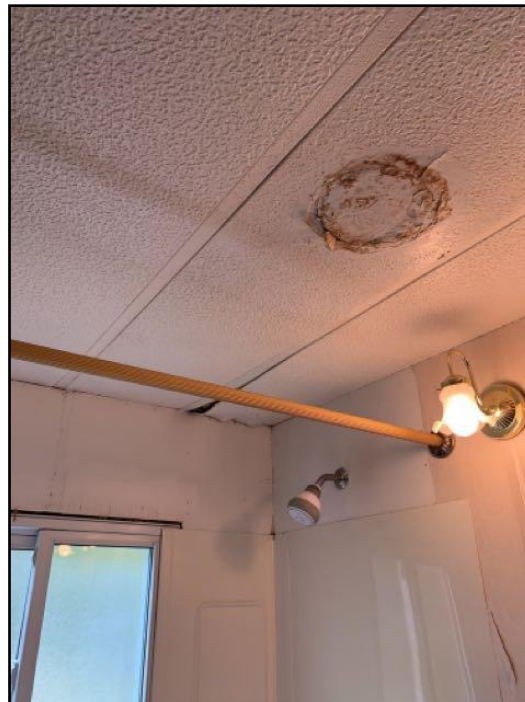
161. Water damage

52. Condition: • [Water damage](#)

Water damage in ceiling of bathroom.

Implication(s): Rot | Leakage | Chance of movement

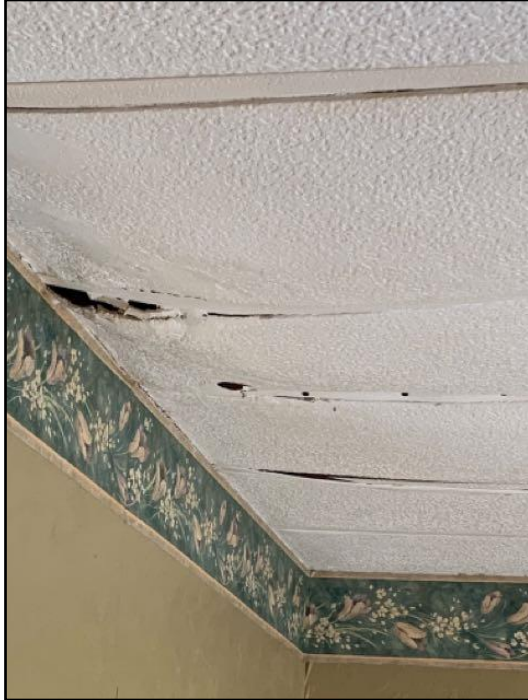
162. Water damage

53. Condition: • [Water damage](#)

Living room.

Implication(s): Rot | Leakage | Chance of movement
