YOUR INSPECTION REPORT

89 Major Lake Road
Madawaska, ON K0J 2E0

Dunbar
Home Inspections

RE: Report No. 10333
89 Major Lake Road
Madawaska, ON
K0J 2E0

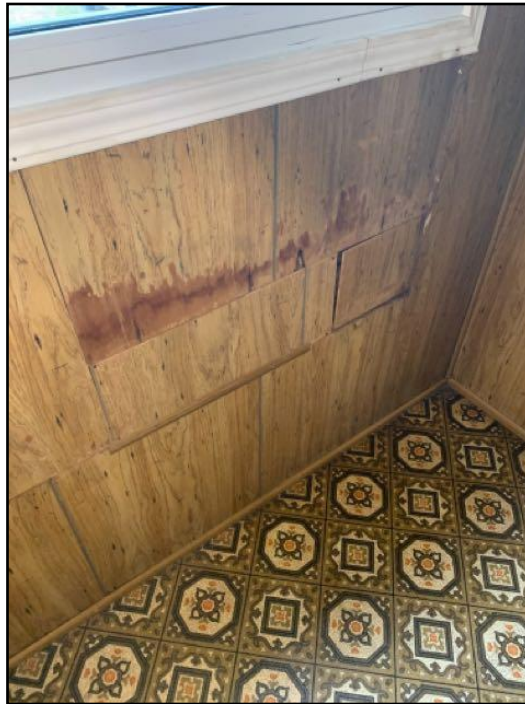
164. Patched

54. Condition: • Patched

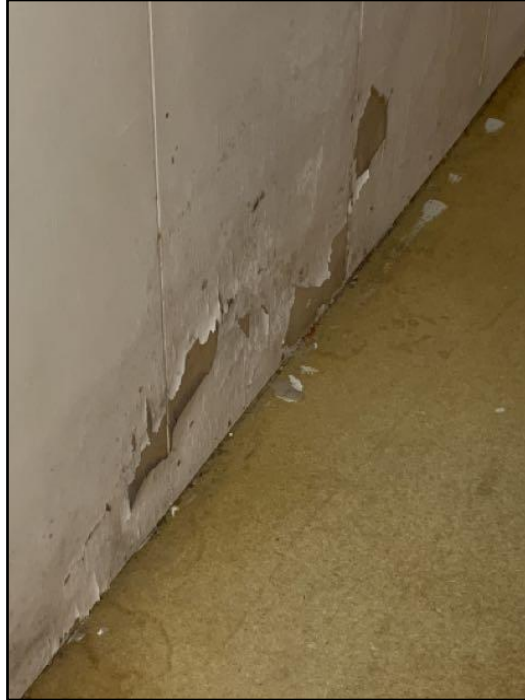
167. *Water damage*

56. Condition: • Water damage

Closet

Implication(s): Chance of water damage to structure, finishes and contents

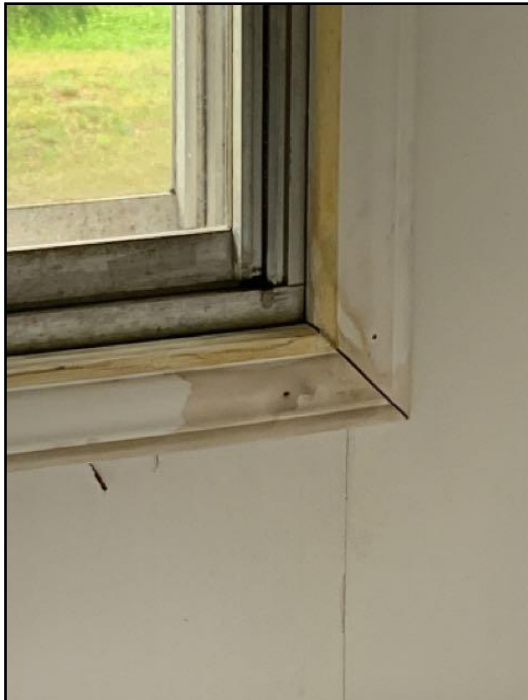
170. Water stains

58. Condition: • Water stains

Implication(s): Chance of water damage to structure, finishes and contents

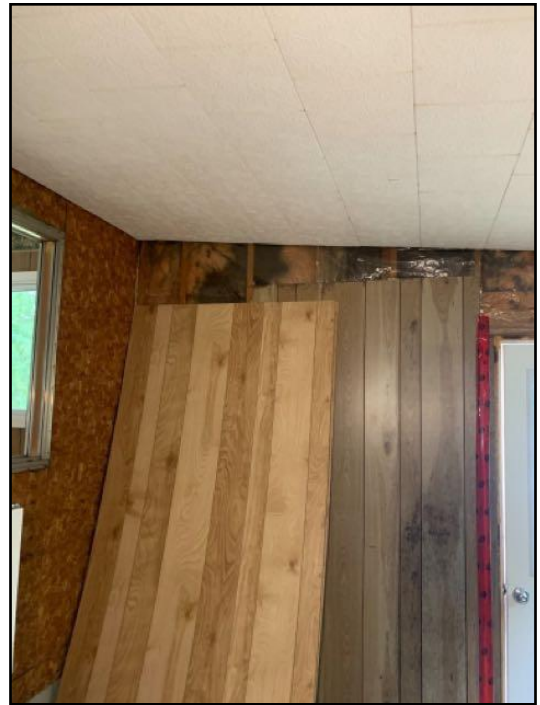
173.

59. Condition: • Unfinished walls, discoloured insulation should be replaced.

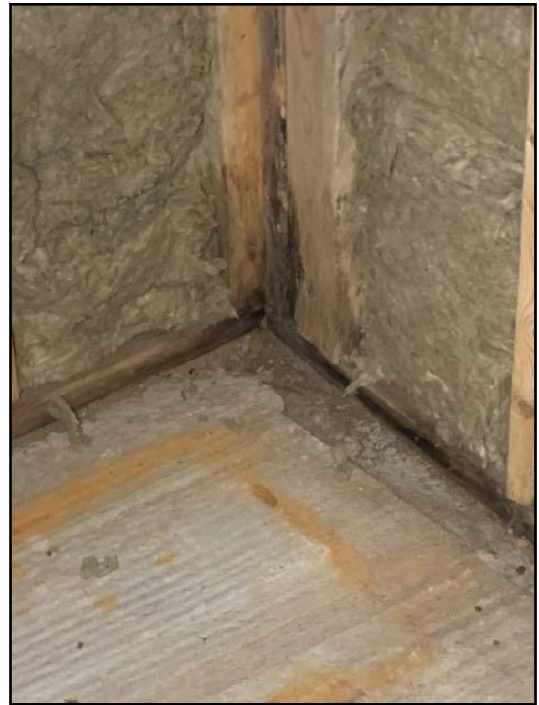
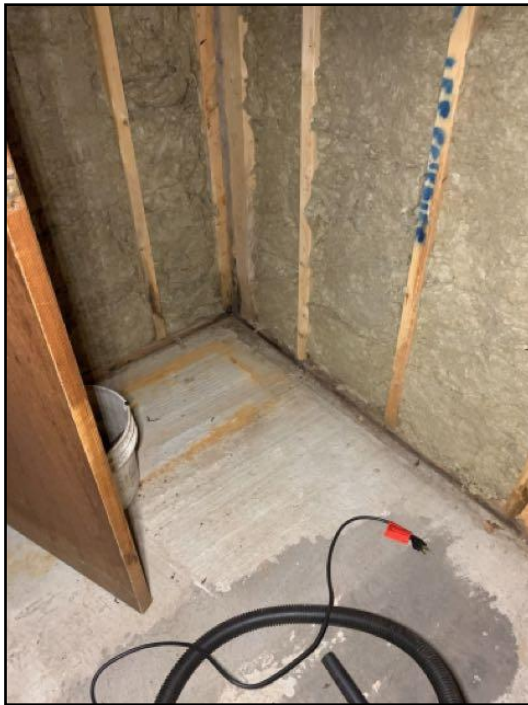
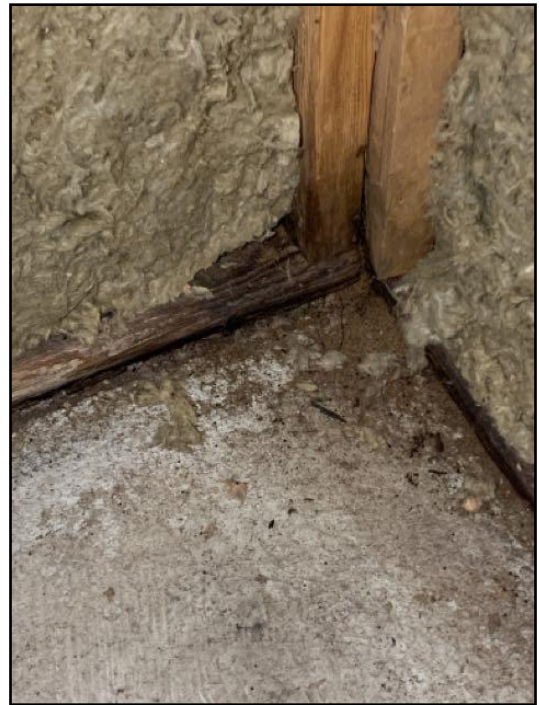
62. Condition: • Water stains and rot on wall plates in basement .

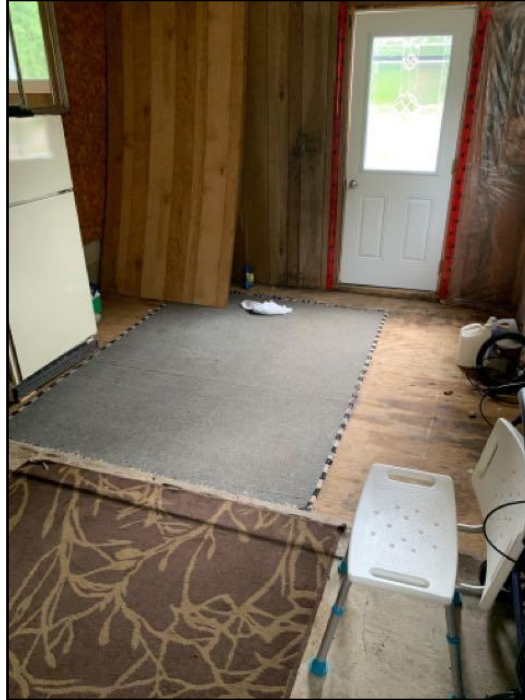
182. Bouncy

63. Condition: • Bouncy

Wood floor at front entrance is not attached to existing foundation, it is bouncy and in need of extra support. Repair or replace.

Implication(s): Nuisance

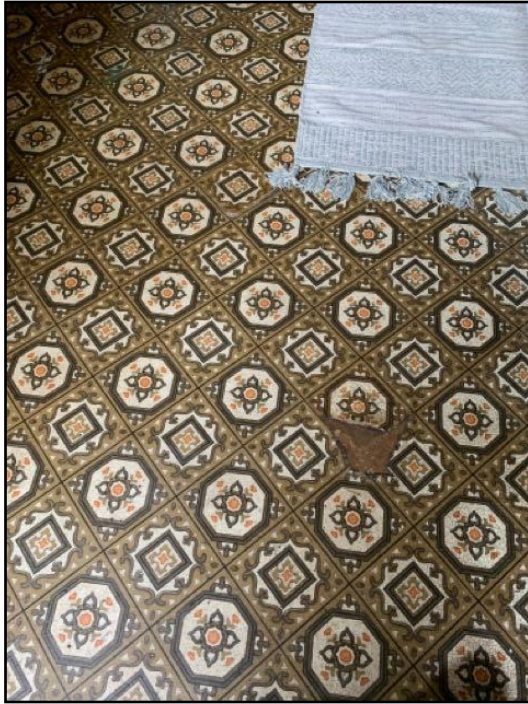
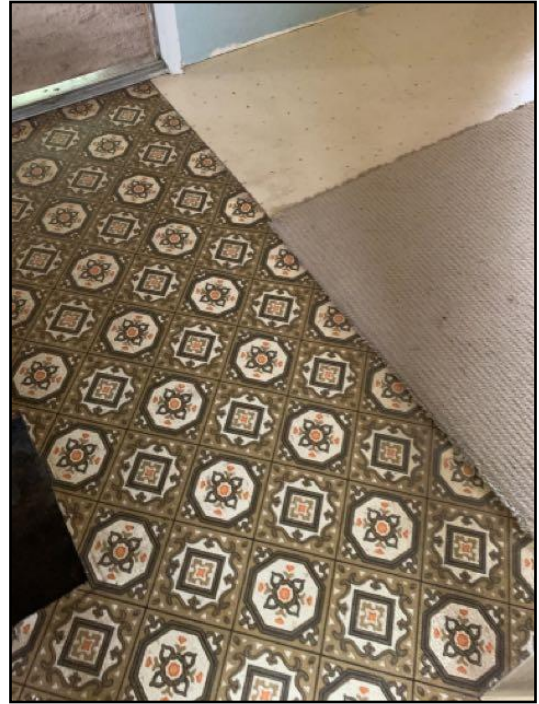
64. Condition: • Weak spots in kitchen floor, and between kitchen and living room, repair needed ,could break through floor in these spots.

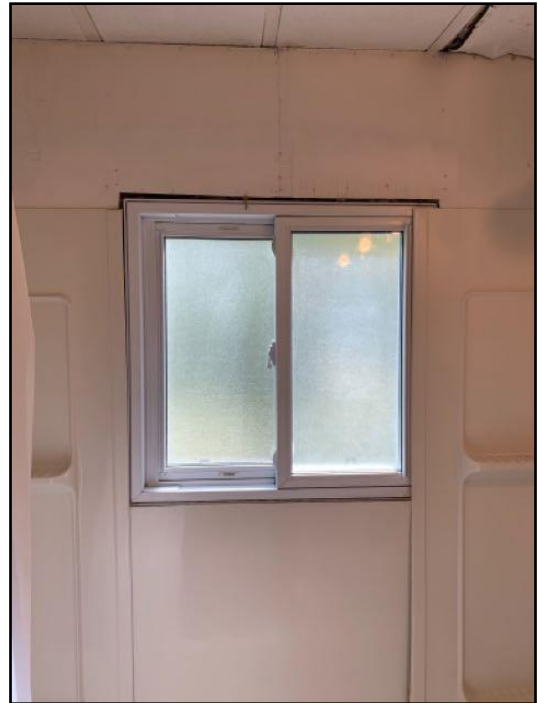
186.

65. Condition: • Window in shower is poorly sealed, this will let water in behind walls and cause rot, repair needed.

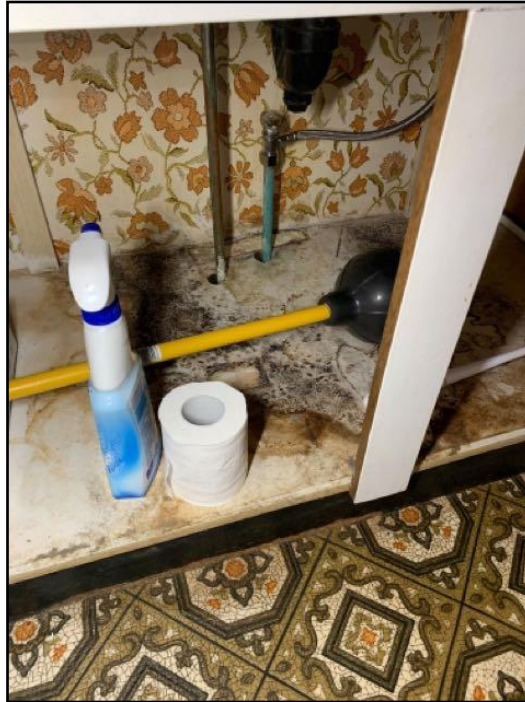
189. Water damage

67. Condition: • [Water damage](#)

Bottom of bathroom vanity is damaged from water, possible mold. Replacement recommended.

Implication(s): Material deterioration

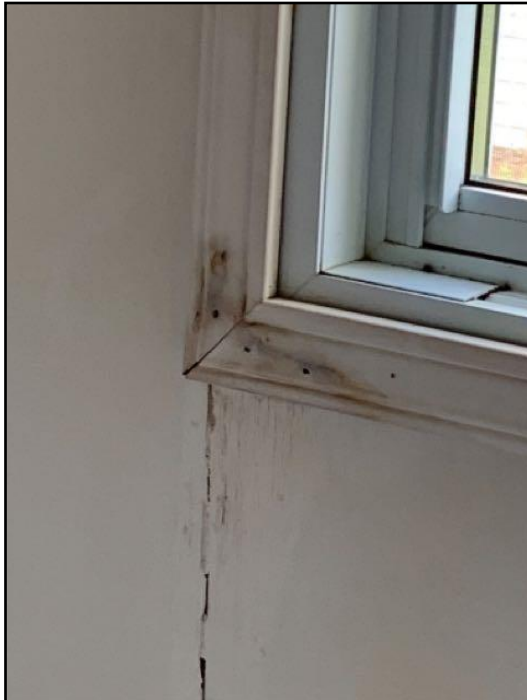
190. Water damage

68. Condition: • [Water damage](#)

Implication(s): Material deterioration

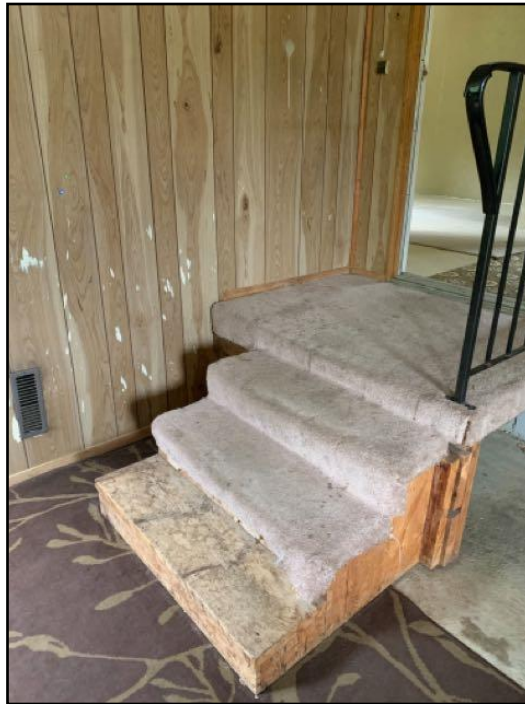
192. Missing

69. Condition: • [Missing](#)

Implication(s): Fall hazard

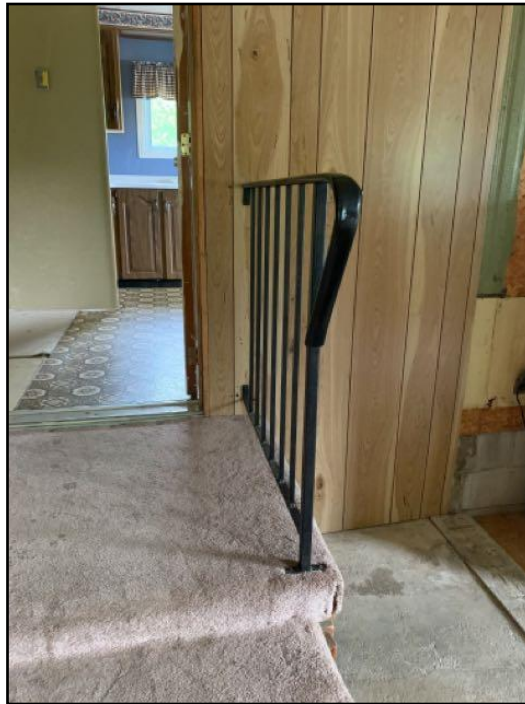
193. Loose

70. Condition: • [Loose](#)

Implication(s): Fall hazard

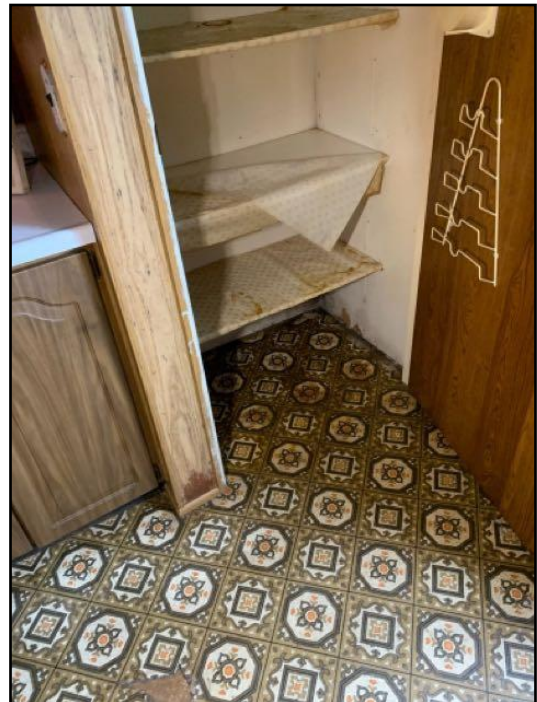
195. Mold

71. Condition: • Mold

Implication(s): Health hazard

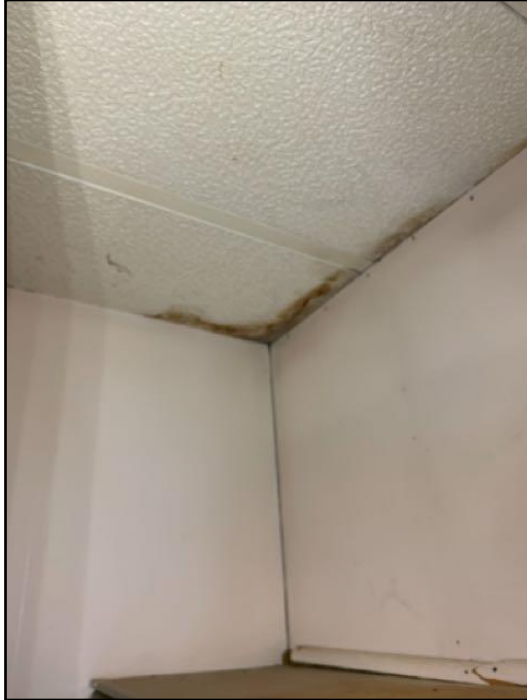
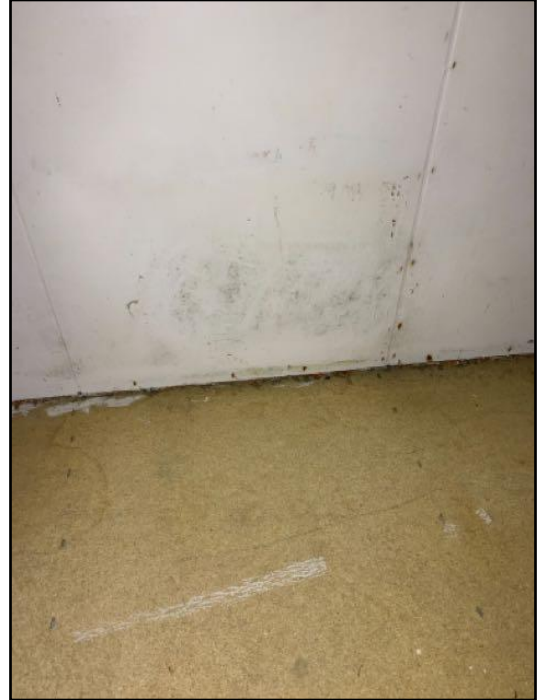
72. Condition: • Mold

Closet

Implication(s): Health hazard
