# YOUR Inspection Report

97 Main st  
Example Report, ON

MOULD STAIN REMOVAL - ATTIC

Thursday, January 1, 2015

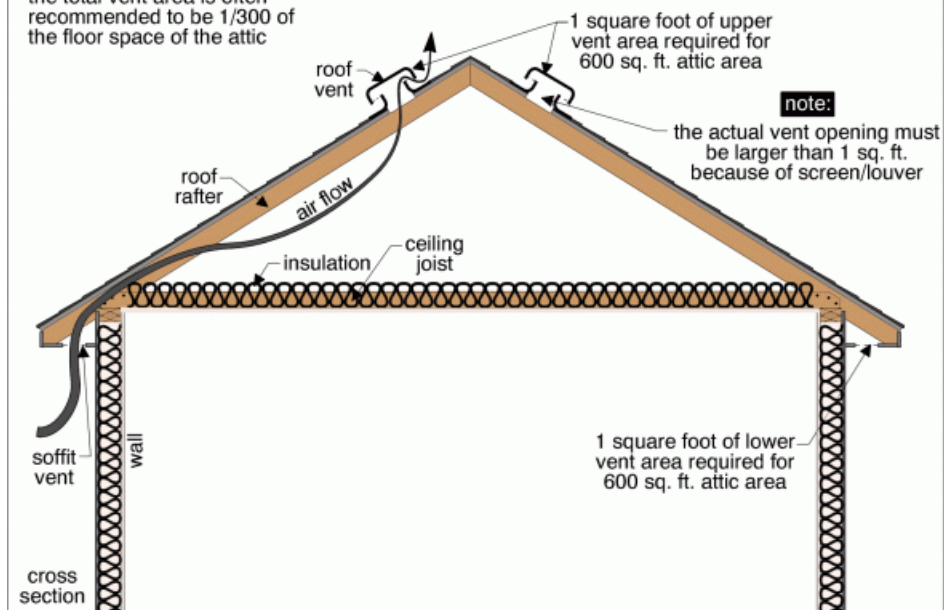
## Recommended amount of attic ventilation

the total vent area is often recommended to be 1/300 of the floor space of the attic

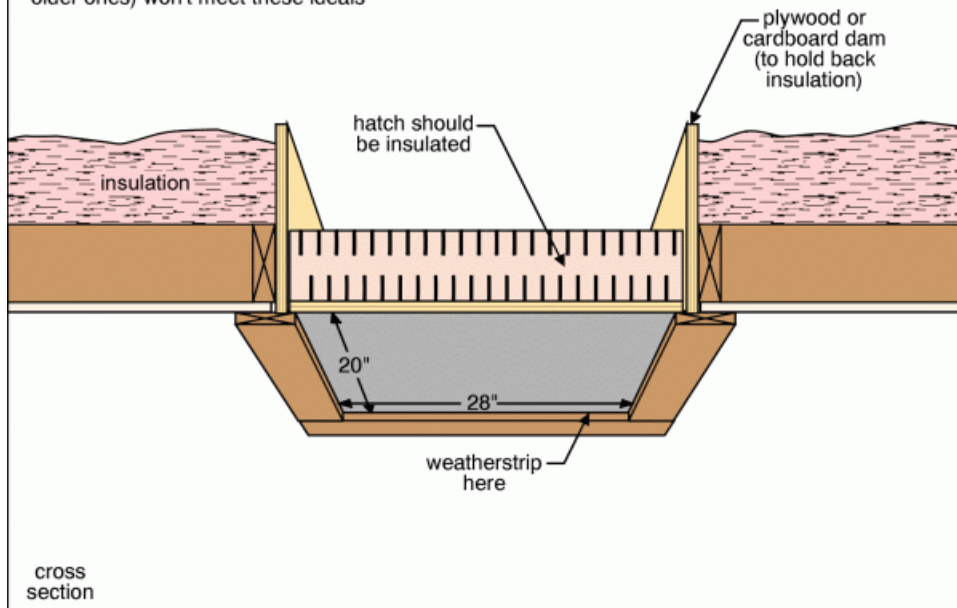
**Condition:** • [Not insulated and not weatherstripped](#)

the illustration shows a good attic access hatch design

hatches in many houses (especially older ones) won't meet these ideals

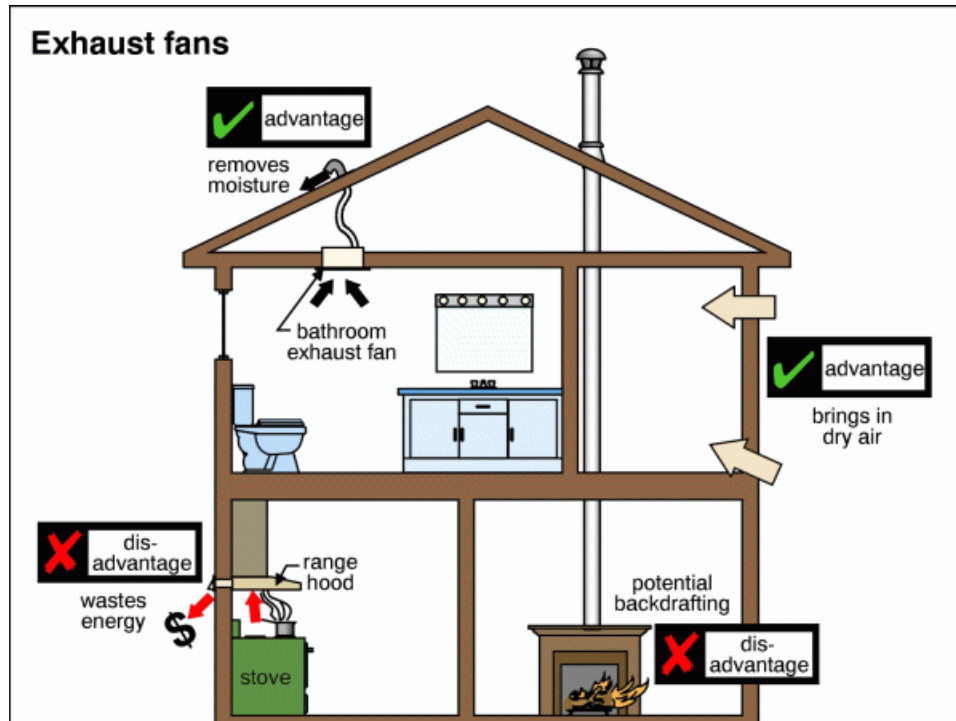
**Condition:** • [Not vented to exterior](#)

**Implication(s):** Chance of condensation damage to finishes and/or structure

Provide exhaust termination point to exterior of home for bathroom vent.
