# Your Inspection Report

2518 East Elsienna Way  
Anaheim, CA 92806

INSPECTION DATE:  
Saturday, March 2, 2024

Report No. 1529, v.3

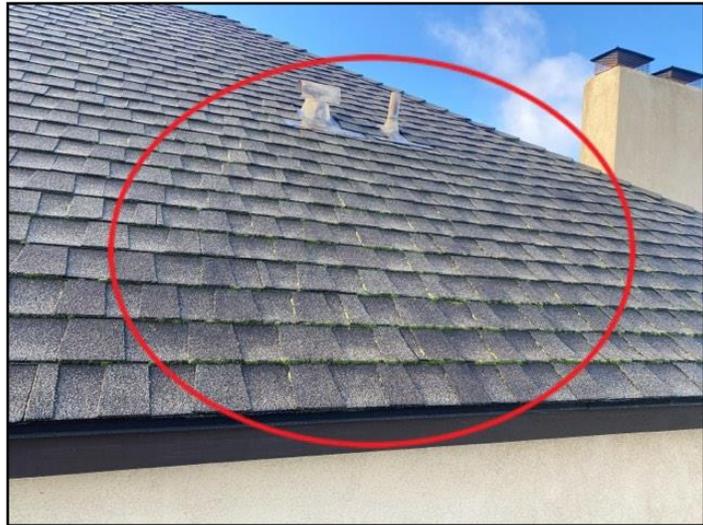
5. Debris/moss

**Condition:** • Debris/moss

Moss holds moisture against the surface of the roof, which can accelerate the deterioration of roofing materials over time. This prolonged moisture exposure can lead to the deterioration of shingles, tiles, or other roofing materials, potentially causing leaks and water damage to the underlying structure.

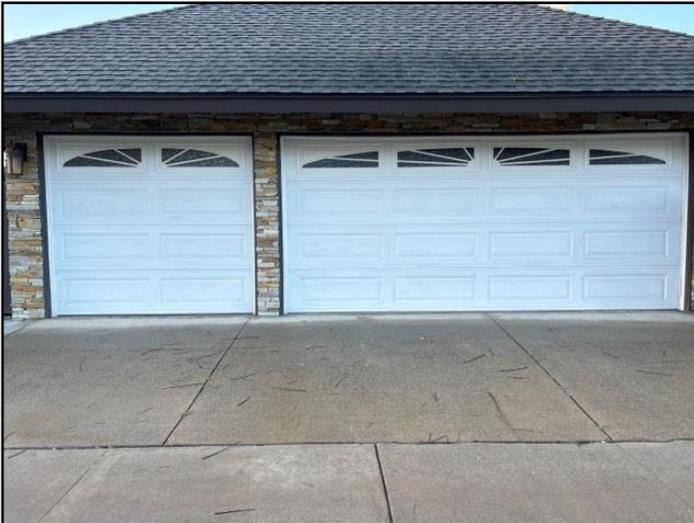
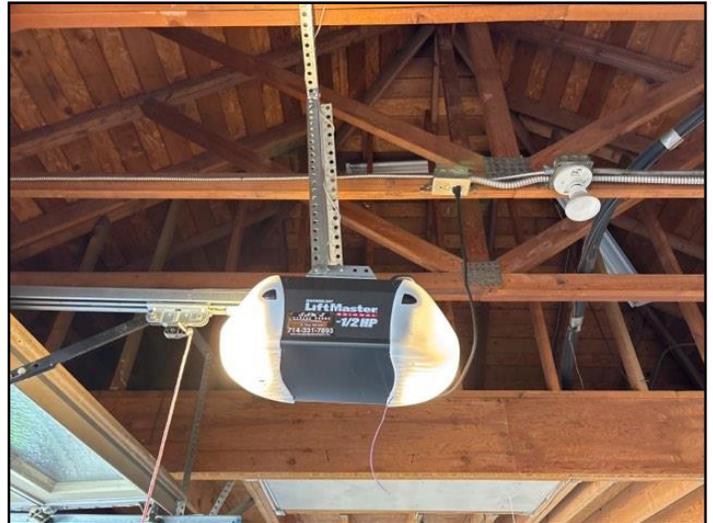
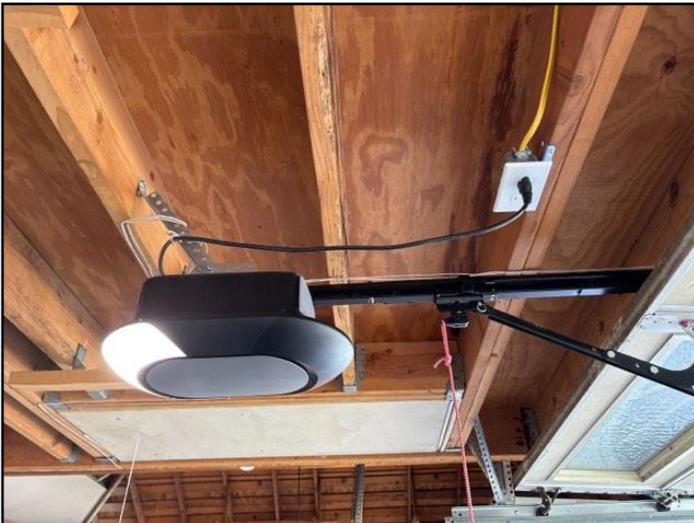
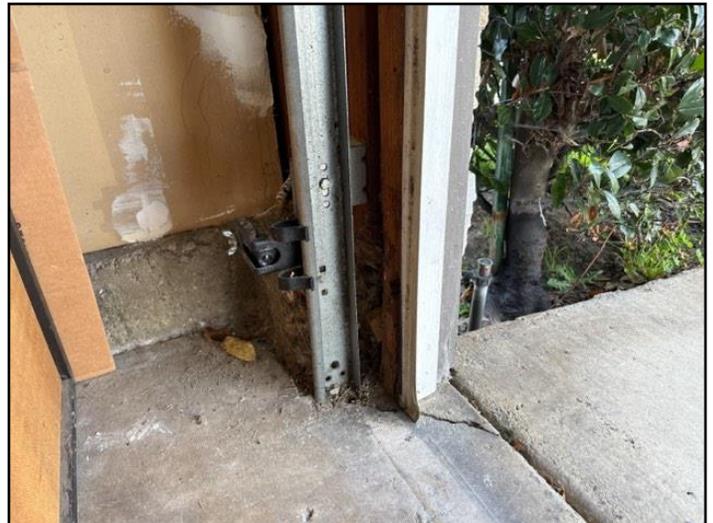
The garage door and safety sensors were in serviceable condition at the time of inspection

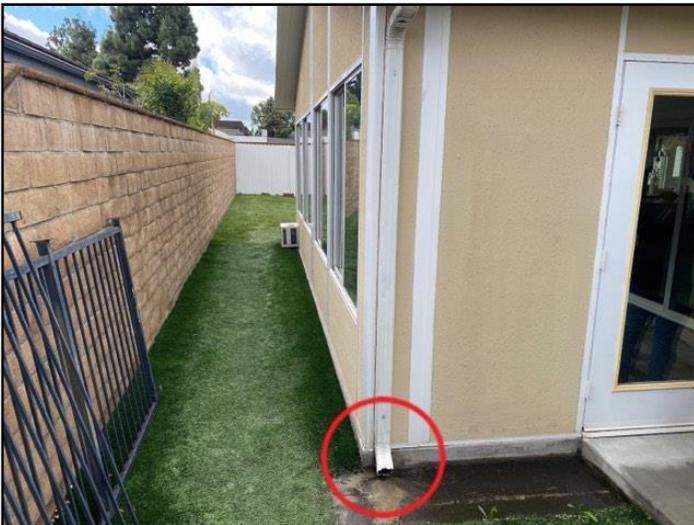
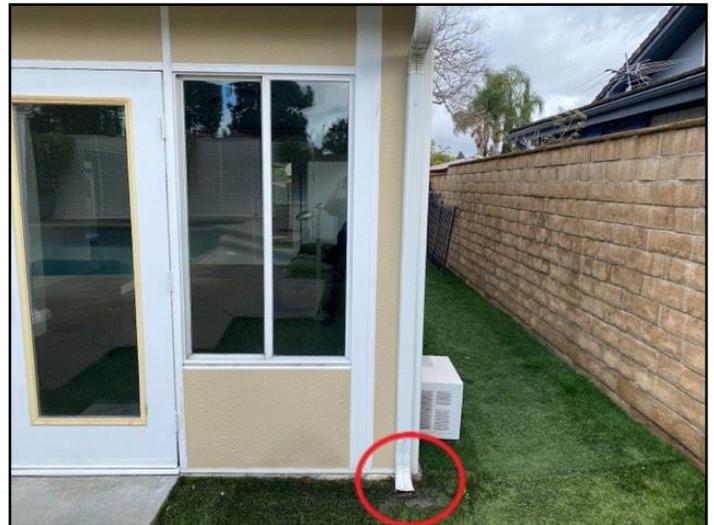
**Condition:** • [Discharge too close to building](#)

17. Discharge too close to building

18. Discharge too close to building

Recommend adding extensions to downspouts to push water away from wall siding and to avoid future damage.

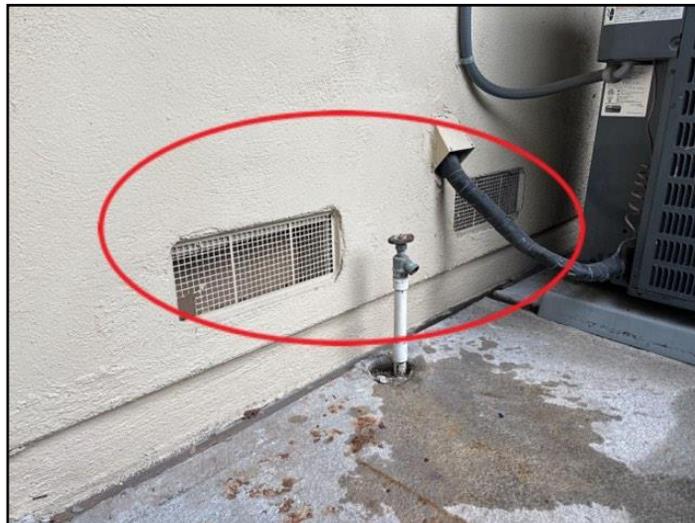
**Condition:** • Vents obstructed

22. Vents obstructed

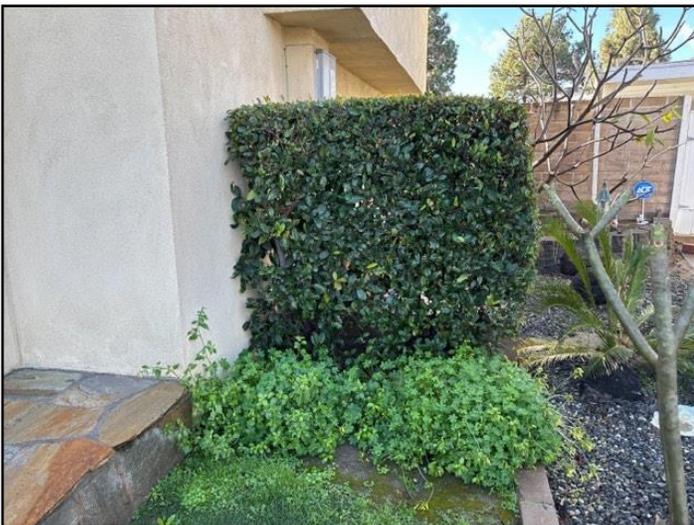
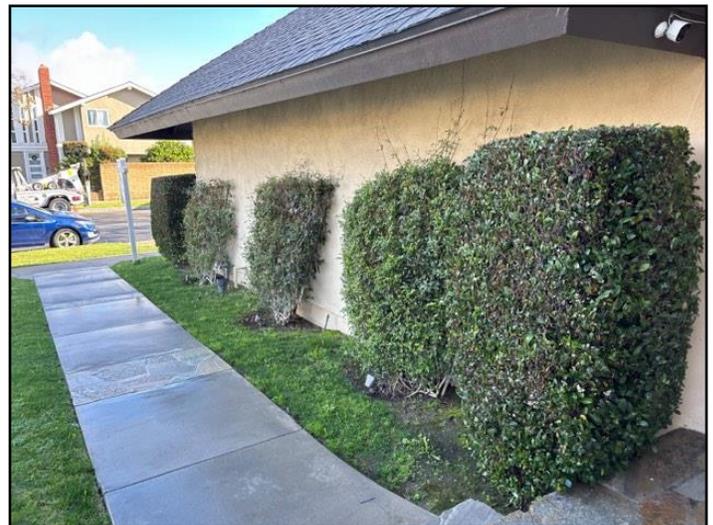
**Condition:** • [Trees or shrubs too close to building](#)

Vegetation such as trees, shrubs and/or vines was in contact with or close to the building exterior. Vegetation can serve as a pathway for wood-destroying insects and can retain moisture against the exterior after it rains. This is a conducive condition for wood-destroying organisms. Recommend pruning, moving or removing vegetation as necessary to maintain at least 6 inches of space between it and the building exterior. A 1-foot clearance is better.

25. Trees or shrubs too close to building

26. Trees or shrubs too close to building

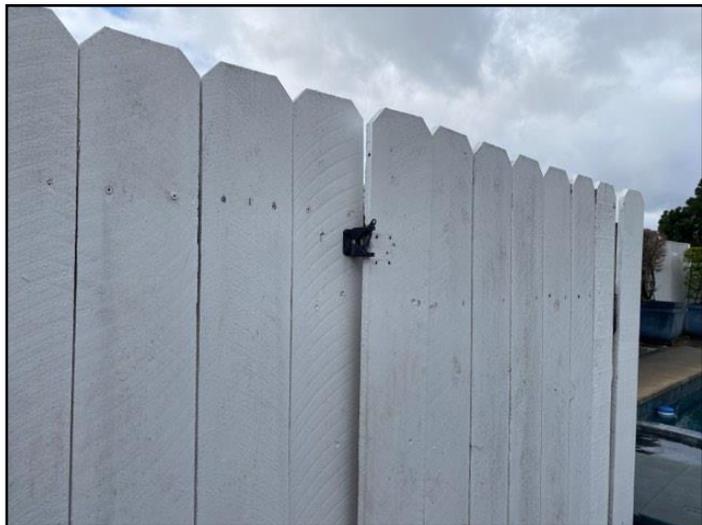
**Condition:** • Gate latch inoperative  
 The gate latch to the pool equipment is damaged  
**Location:** Backyard  
**Task:** Repair  
**Time:** As soon as practical

29. Gate latch inoperative

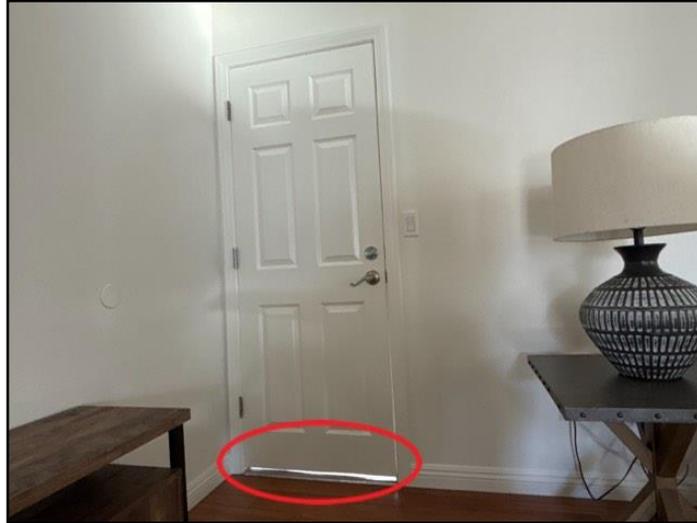
**Condition:** • [Door not tight-fitting and weatherstripped](#)

31. Door not tight-fitting and weatherstripped

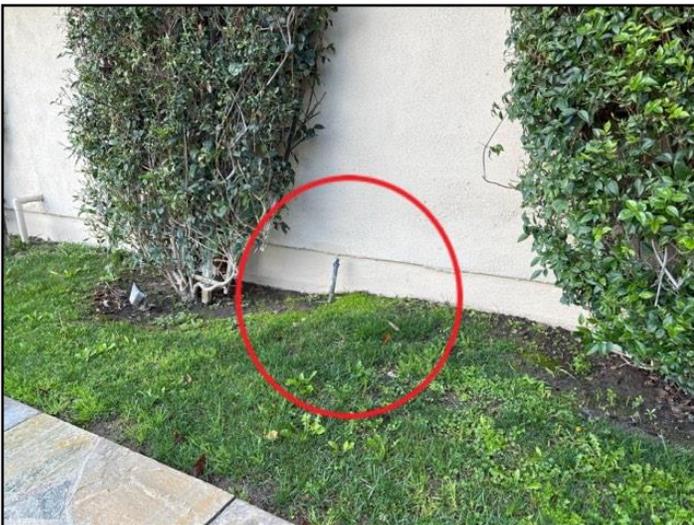
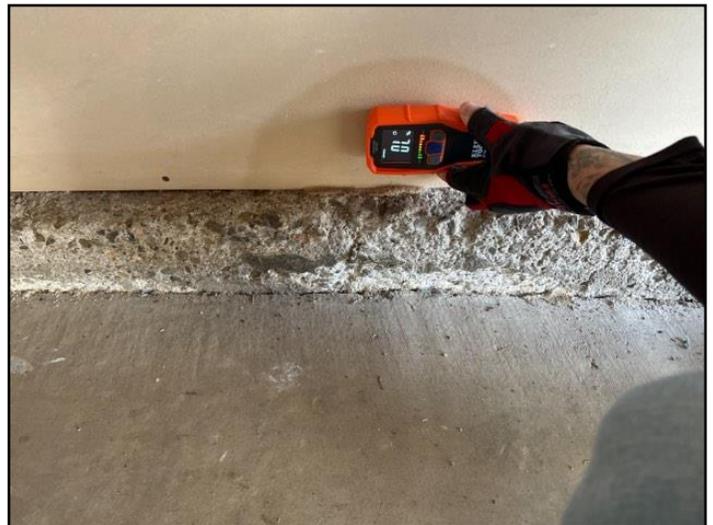
**Condition:** • Overspray onto building

32. Overspray onto building

33. Overspray onto building

Sprinklers are too close to the building and it is recommended that they be relocated to avoid water damage to siding and potential water seepage into building

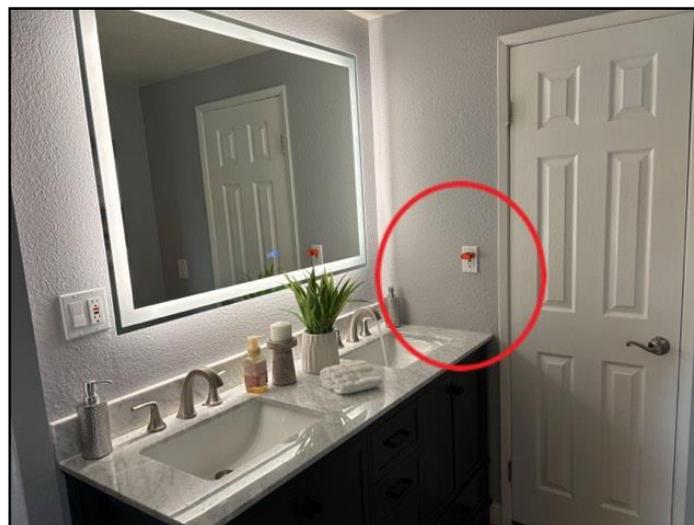
**Condition:** • Bathroom

54. Bathroom

Recommend electrical receptacles located within 6 feet of plumbing fixtures be provided with GFCI protection for safety purposes.

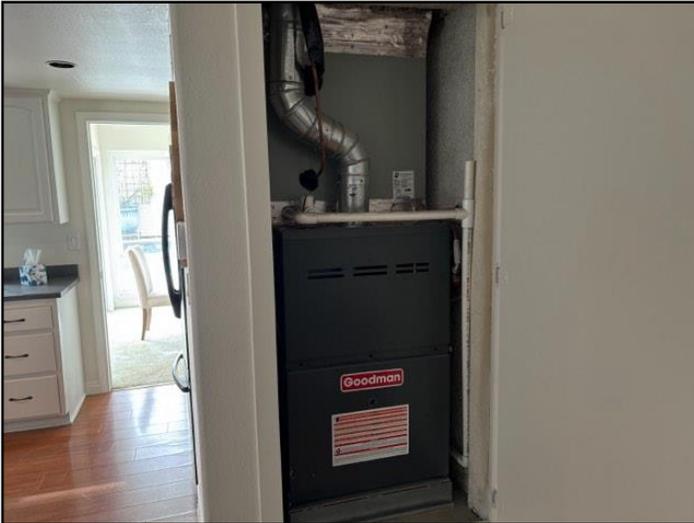
The furnace was in serviceable condition at the time of inspection, based off the temperatures taken

56. Furnace

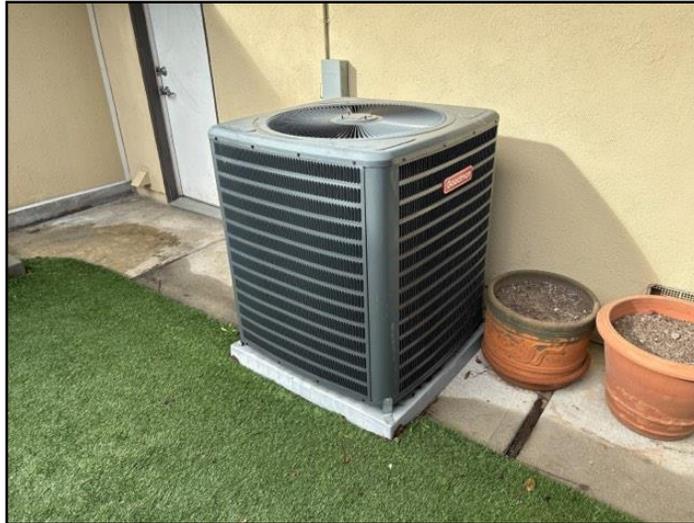
68. Central

AC units in serviceable condition at the time of Inspection based off of temperatures taken.

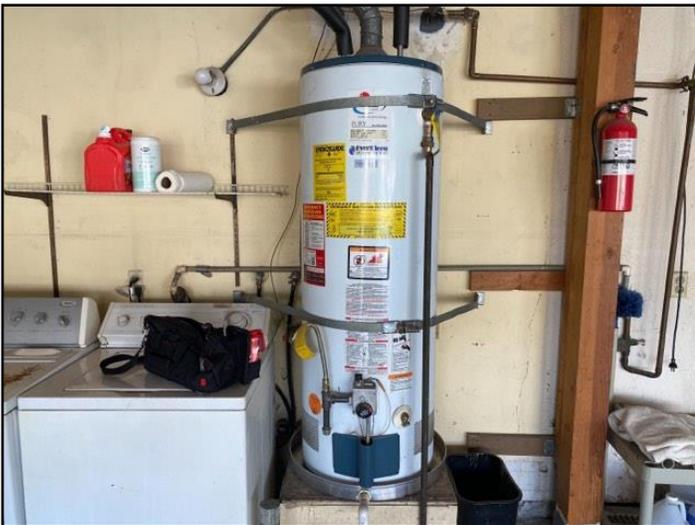
81. Tank

- Pressure Regulator: • None
- Water heater type:
  - Tank
- Water heater was in serviceable condition at the time of inspection.

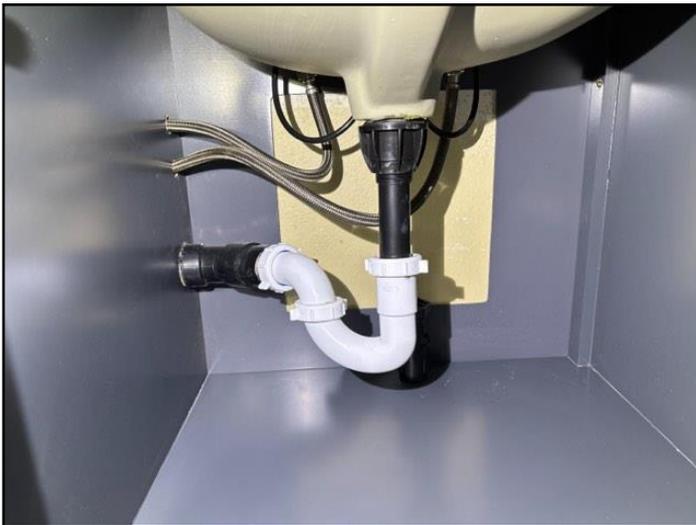
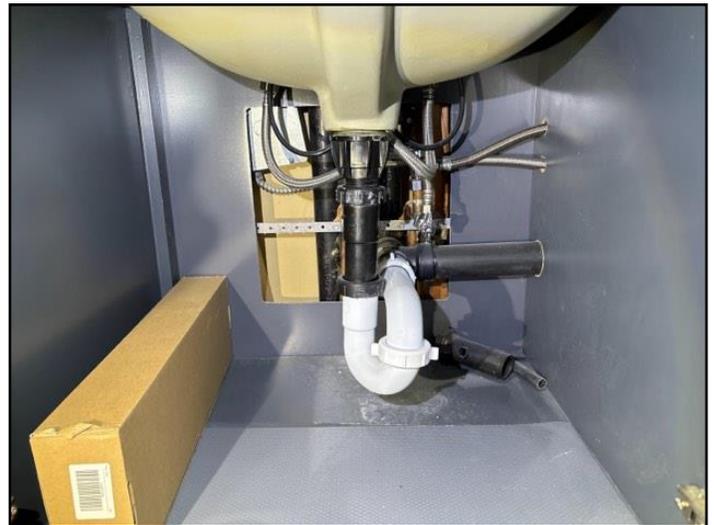
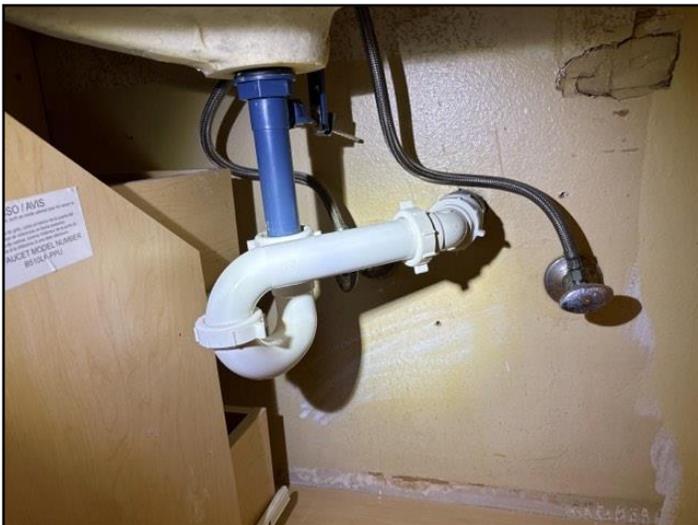
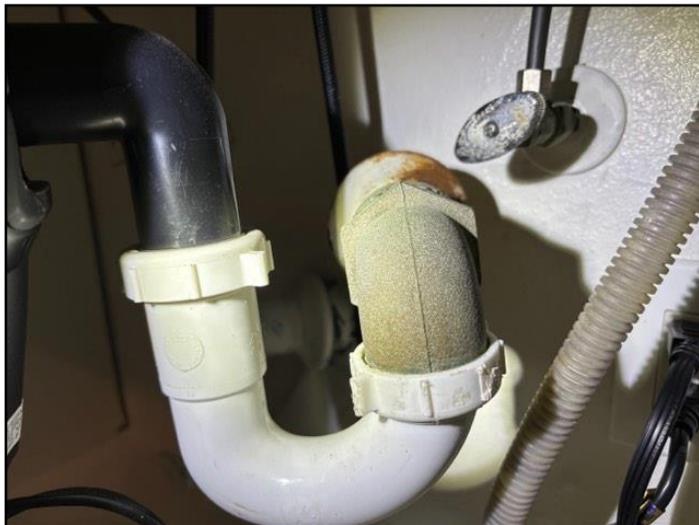
All plumbing below sinks was in serviceable condition at the time of inspection

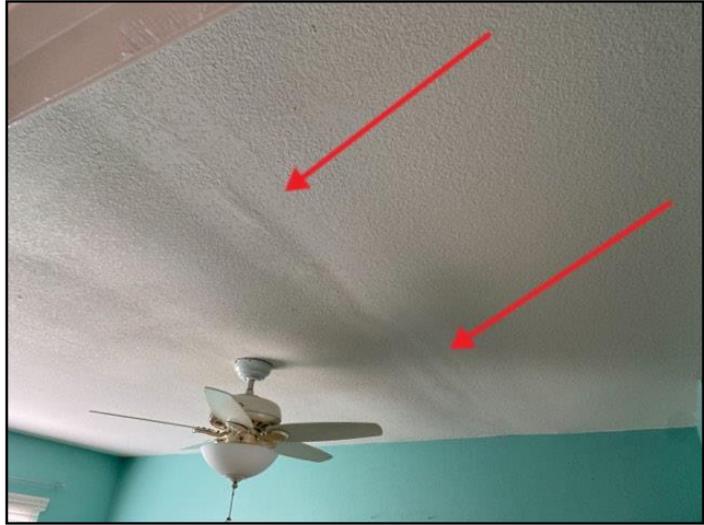
112. Patched

**Condition:** • Patched

Signs of patching repairs noted. Recommend seller disclosure.

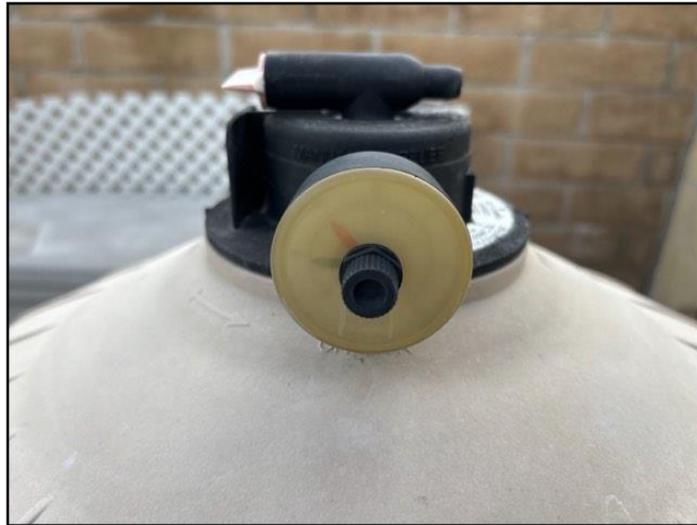
124. Foggy

- Foggy

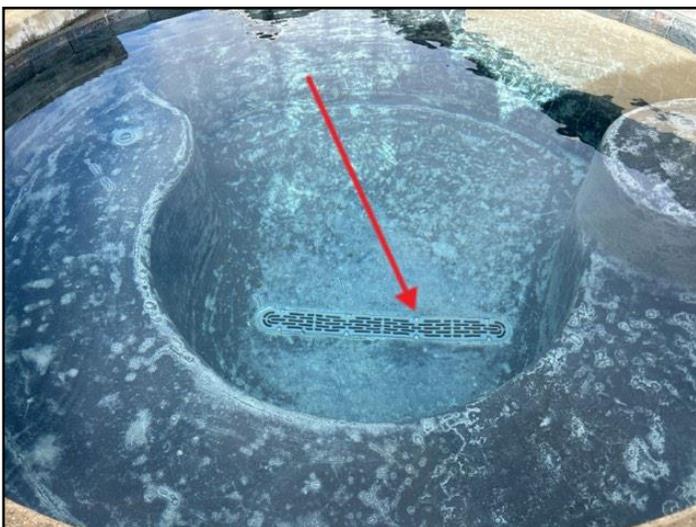
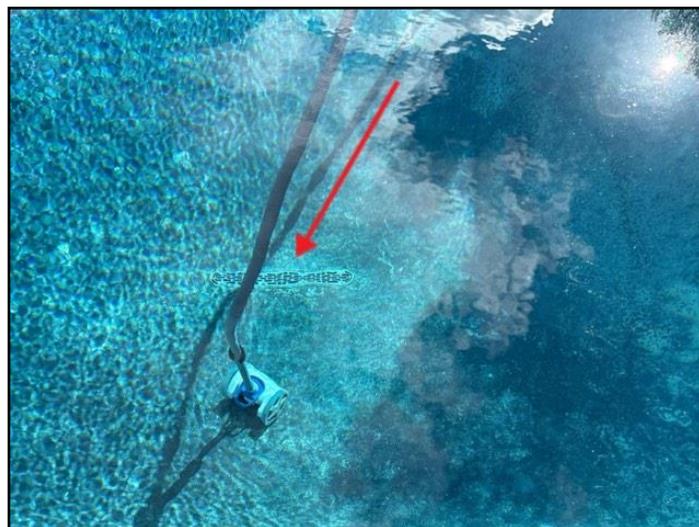
**Condition:** • Not Anti-Vortex Type

**Time:** as soon as possible

**Cost:** 750.00

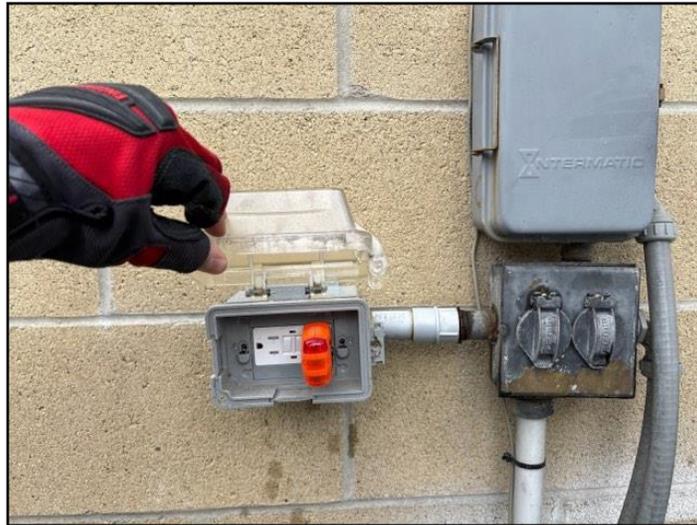
128. Responded to test button

**Condition:** • Responded to test button
